APPENDIX F

REPORTS ON EIGHTEEN INVESTIGATED FIELD SITES

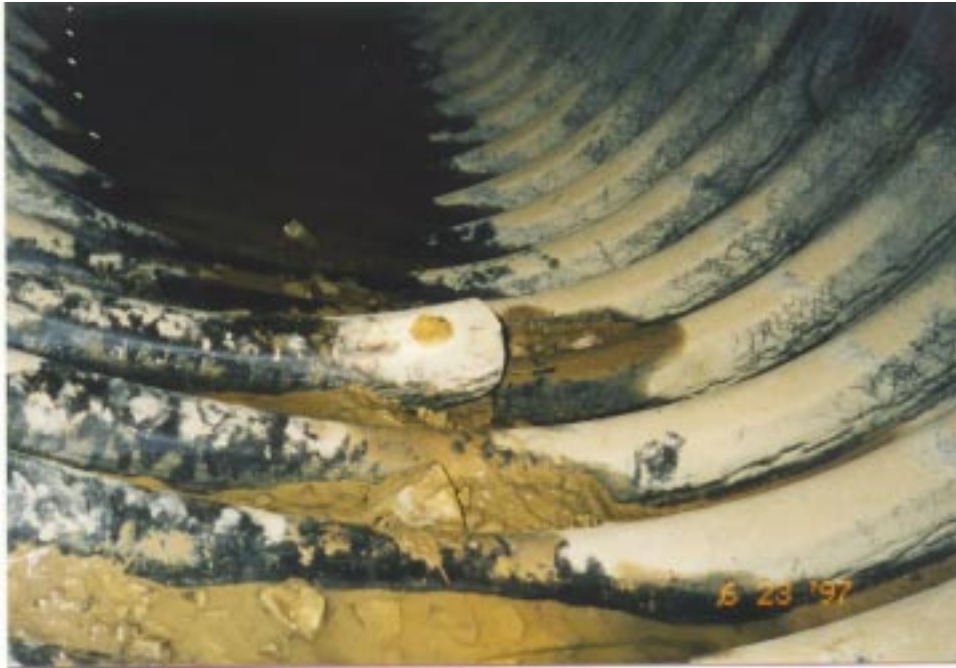
The storm drain was inspected in June 1997, and showed that the pipe has experienced deflection and cracking at the invert near the inlet of the pipe, as shown in Figure 1, and summarized in Table 1.

| Distance from point of inlet (m) | Deflection measurements | | Cracks |
|---|---|---|--|
| 5.2 | - 12.5% | + 8.3% | circumferential and longitudinal cracks, at the invert of the pipe |
| 1.2 | - | - | circumferential crack at invert of the pipe |

The microstructure examination of the fracture surface of the crack verifies that the slow crack growth was failure mechanism. The tensile stress that initiated the crack is likely due to deflection of the pipe.

Figure 1 – An interior view of the pipe in Site A

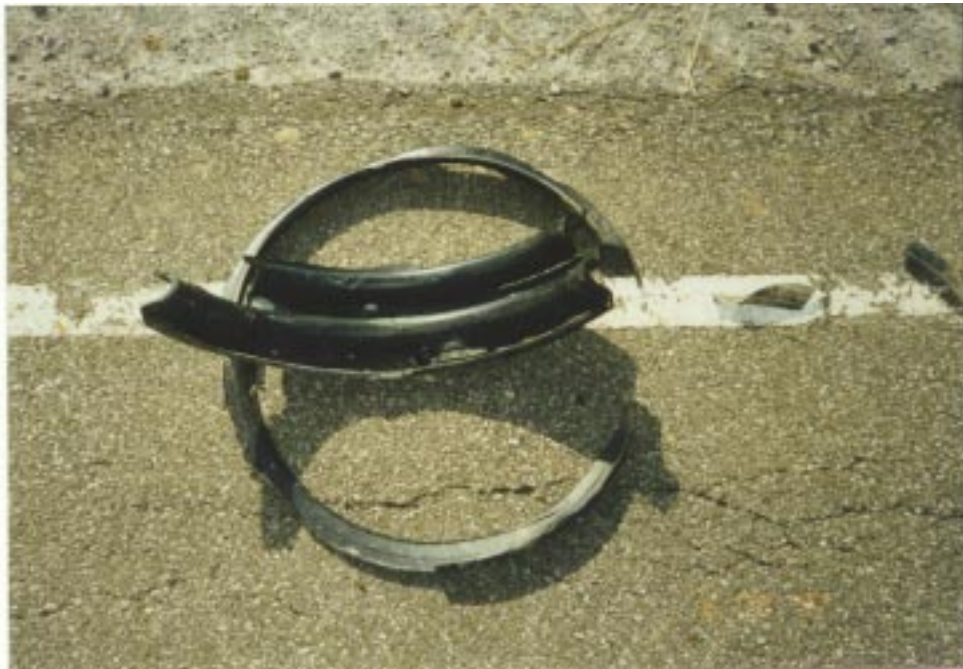
Three large samples and three small samples were removed from various locations of the pipe (Figure 2). Samples are coded A1 to A6. Samples A1 and A2 were taken at the location where the greatest deflection took place. Both samples contained a failure surface. Sample A3 was taken two corrugations away from the Samples A1 and A2 and also contained a failure surface. Three large samples, A4 to A6, were taken at the inlet of the pipe. Sample A4 also contained a fracture surface. The fracture surface of the cracks was examined using a scanning electron microscope (SEM) to verify the failure mechanism.

Figure 2 – Retrieved field samples from pipe in Site

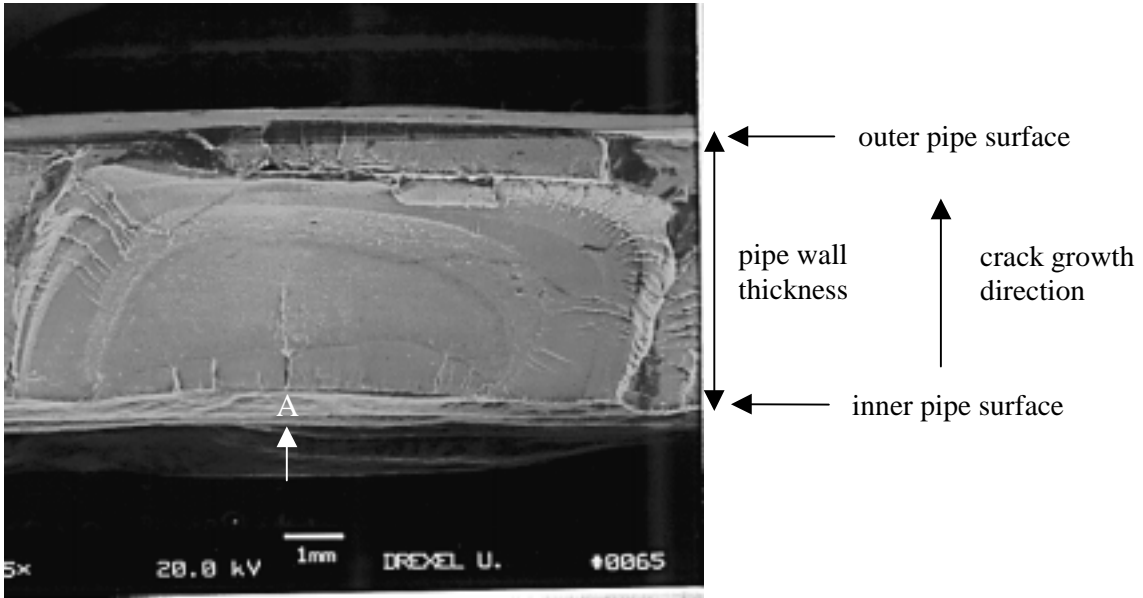
Three small SEM specimens were taken from web of Samples A1 and A4. Figure 3 shows the fracture surface of the crack in Sample A1. There is no sign of ductility associated with this crack, as indicated by the constant thickness along the fracture surface. The crack was initiated from the inner pipe wall at region marked "A". The crack started from the initiation region and grew outward. A close view of area near region "A" reveals many short fibrils (Figure 4). The fracture surface of the specimen taken from Sample A4 is shown in Figure 5. Fibrous morphology again covers the fracture surface, as can be seen in Figure 6. The fibrous morphology signifies that both cracks were caused by the slow crack growth mechanism.

Figure 3 – Fracture surface of the crack in Sample A1

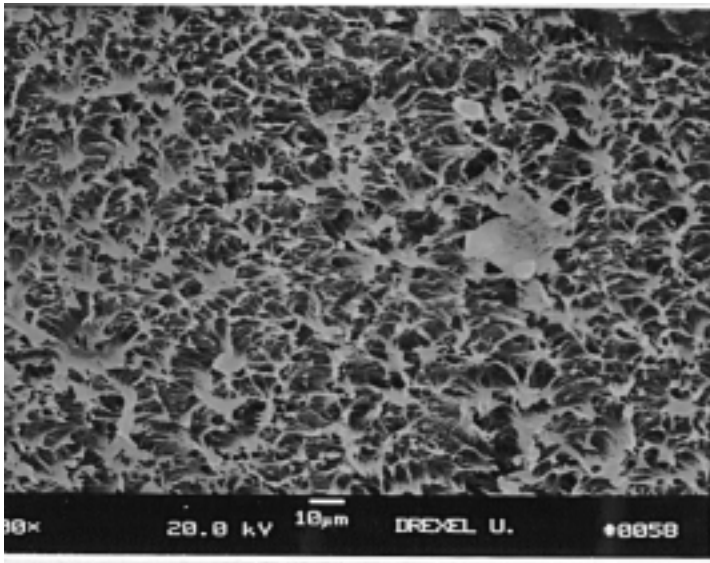
Figure 4 – A close view on the fracture surface of the crack in Sample A1, revealing fibrous morphology

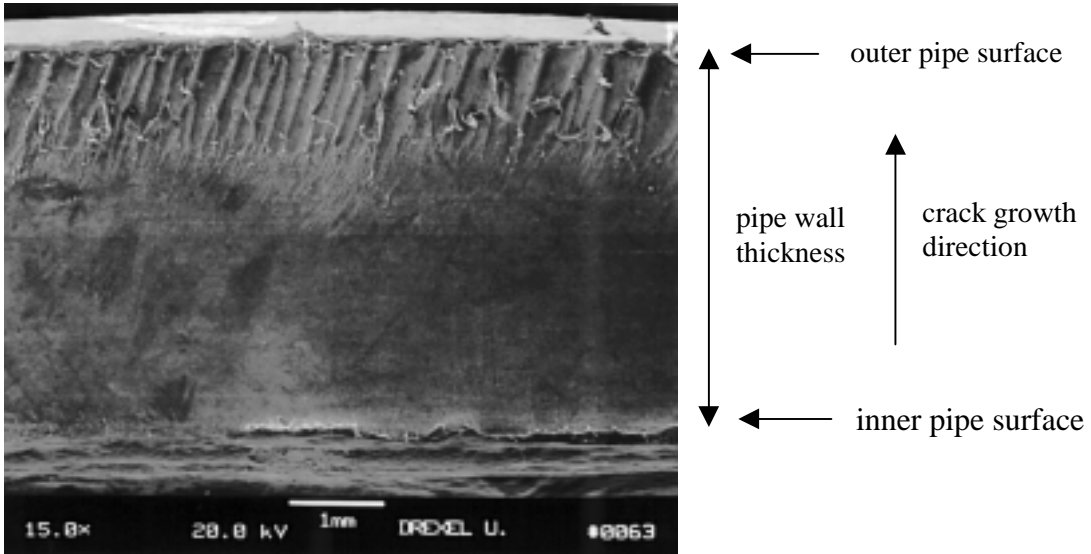
Figure 5 – Fracture surface of the crack in Sample A4

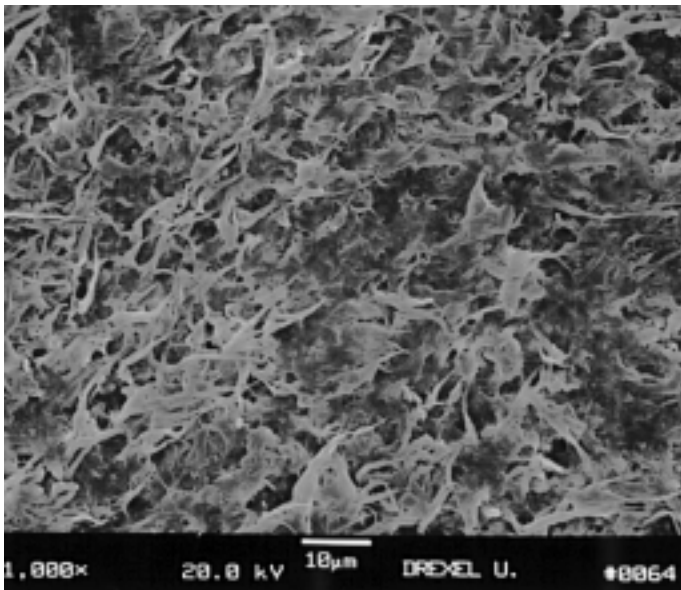
Figure 6 – A Close view on the fracture surface of the crack
In Sample A-4, revealing fibrous morphology

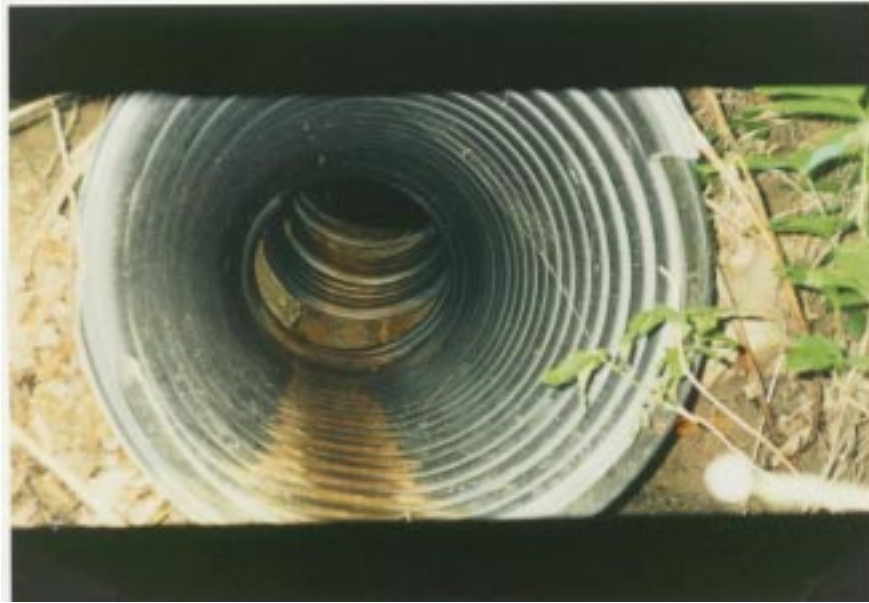
The storm drain was inspected in June of 1997. Figure 1 shows the condition of the pipe. There was no deflection; however, there was significant longitudinal bending in the pipe due to erosion at the outlet end. The bends led to circumferential cracking.

A type C - helical HDPE pipe was being used as a storm drain under 1.8 m of fill. During the inspection in June 1997, 13 years after the installation, circumferential cracks were observed in the inspected area near the outlet of the pipe. A significant amount of longitudinal bending was observed, which was caused by soil erosion under the pipe.

Figure 1 – General view of the pipe in Site B

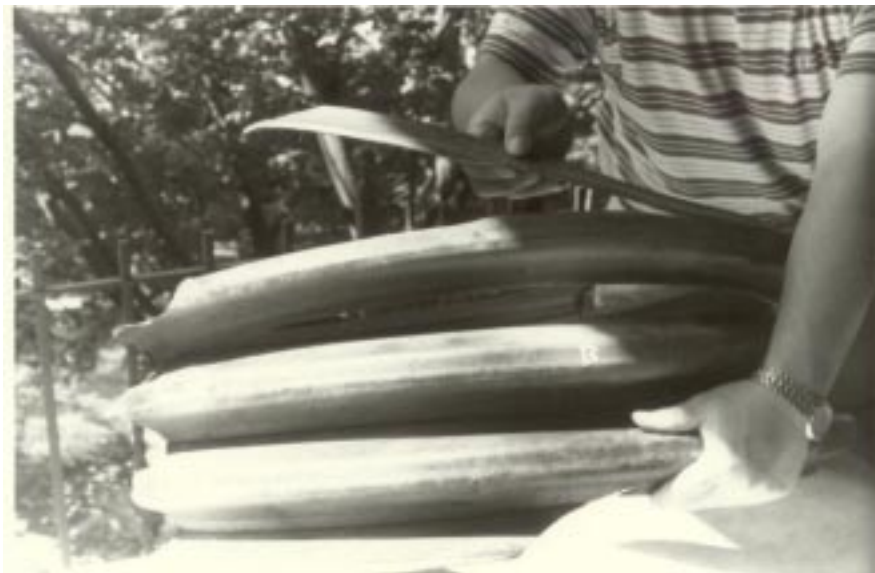
A section of the pipe was removed from the pipe, as shown in Figure 2. The sample is coded as Sample B1, which contains a long circumferential crack. The crack took place at the joint location between web and valley of the pipe. The fracture surface of the cracks was examined using a scanning electron microscope (SEM) in order to verify the failure mechanism.

Figure 2 – A retrieved field sample containing a circumferential crack

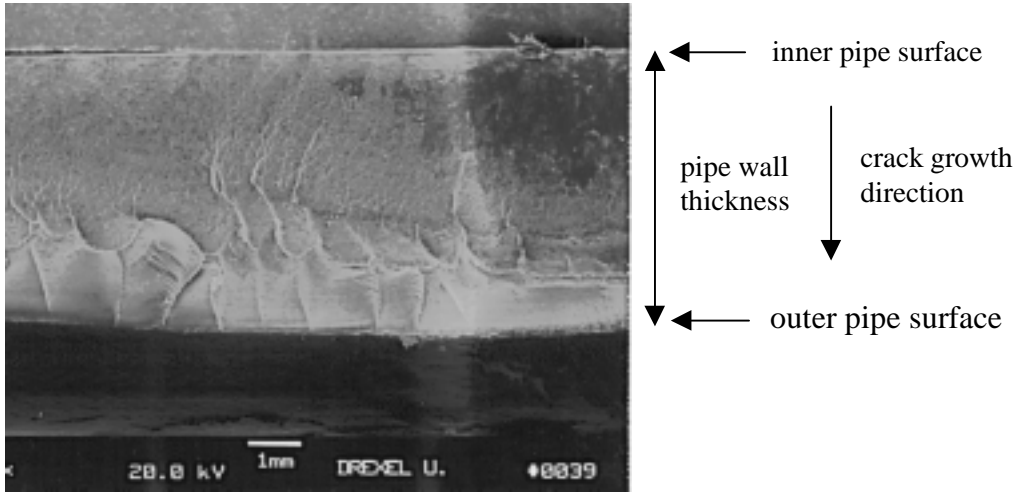
Two specimens were taken at different positions of the circumferential crack for evaluation. Their fracture morphology are very similar. Figures 3 show the overall appearing of the fracture surface of the crack. There is no sign of ductility associated with this crack, since the pipe wall thickness remained constant along the fracture surface. The crack was initiated from the inner surface of the pipe, and grew towards the outer surface. The fracture surface is covered with the morphology defined as the “flake” structure, as can be seen in Figure 4. The flake morphology is not the result of slow crack growth failure,

The microstructure examination of the fracture surface of the crack indicates that a rapid crack propagation was the cause of cracking. Cracks were initiated from the inner surface of the pipe. The longitudinal bending was the major cause of the cracking.

Figure 3 – Fracture surface of the crack in Sample B-1

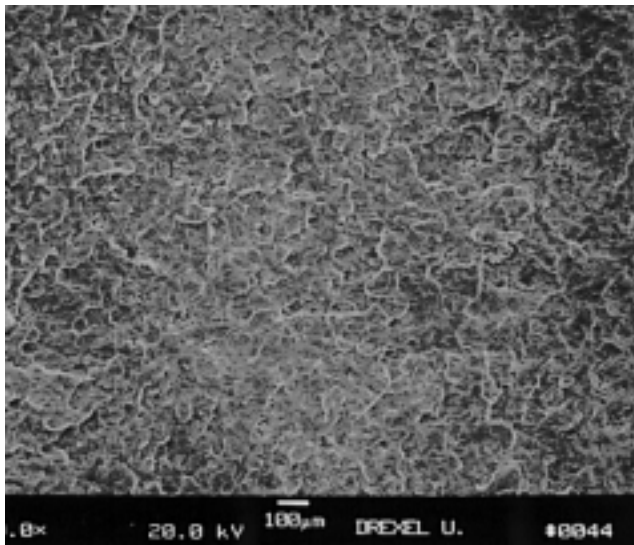
but is associated with a rapid crack propagation failure mechanism. Such cracking typically occurs very fast under a dynamic force.

Figure 4 – A close view on the fracture surface of the crack in Sample B1, revealing a flake morphology

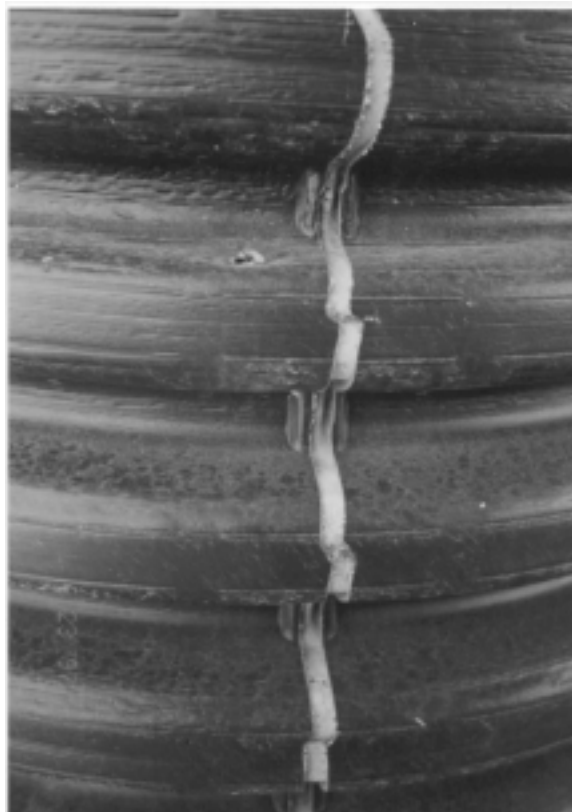
The pipe was inspected in June 1997, and showed that a single longitudinal crack occurred along the air channel of the pipe, as can be seen in Figure 2. This suggests that the pipe was subjected to a circumferential stress, which might be induced by the hydrostatic pressure of the wet concrete and the high thermal expansion coefficient of the polyethylene.

A Type C-annular HDPE pipe was being used as concrete column formwork under a highway bridge. During the inspection in June 1997, 2 years after the installation, a single longitudinal crack along the entire length of the pipe was observed. The microstructure examination of the fracture surface of the crack indicates that a slow crack growth was the cracking mechanism. Cracks might be initiated from the center of the pipe wall and grew toward the edges. The cracking was induced by a circumferential tensile stress likely the result of thermal expansion caused by the hydration of wet concrete.

Figure 2 – A close view of the longitudinal crack along the air channel of the pipe

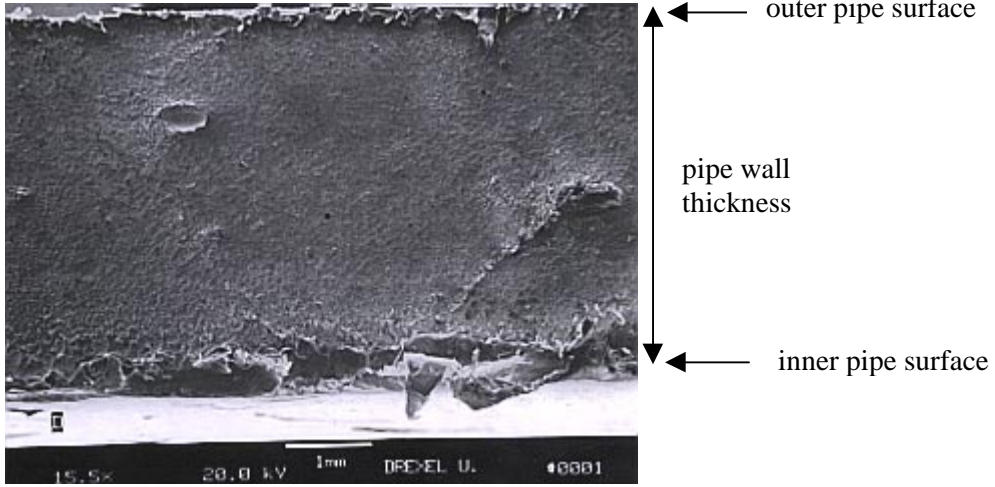
A SEM specimen was taken from the crack for evaluation. Figure 3 shows the overall appearing of the fracture surface of the crack. There is no sign of ductility associated with this crack, as indicated by the constant thickness along the fracture surface. The initiation of the crack was not identified. The crack probably started at the center of the pipe wall and grew toward the edges, since small amount of ductile pullout can be observed on both edges of the pipe. The fracture surface, however, is heavy covered with

Figure 3 – Fracture surface of the crack in Sample D1

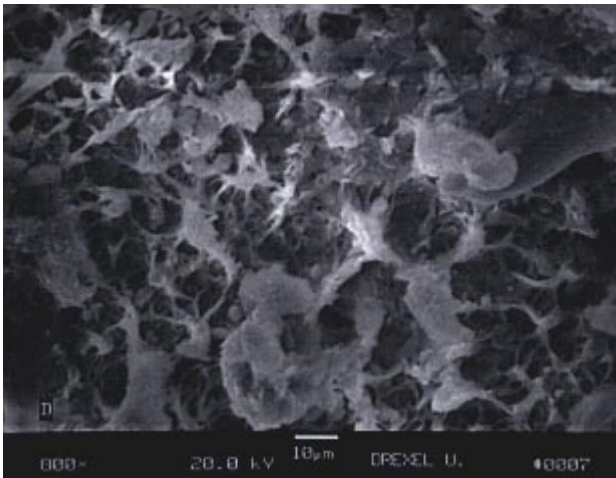
soil particles, causing difficulty in examining the morphology. Figure 4 shows the fibrous morphology on the surface of the crack. The size of the fibrils is fairly small; suggesting the applied stress is relatively small.

Figure 4 – A close view on the fracture surface of the crack in Sample D1, revealing a fibrous morphology

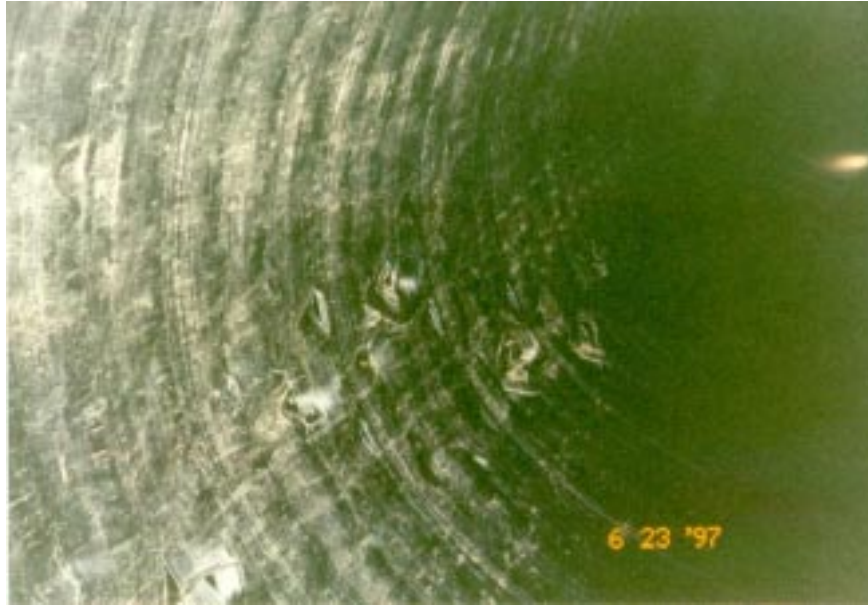
The culvert was inspected in June 1997, and showed that the pipe has experienced deflection, buckling, and cracking (Figure 1).

Deflection measurements were taken at several locations along the culvert's length. In addition to deflection, the culvert pipe also exhibited localized buckling through much of its length. The buckling can be described as having a short wavelength, sinusoidal pattern and commonly occurred within the liner, around the pipe circumference. The buckling first appeared in the second length of pipe from the inlet and increased with increasing depth of fill. Two types of cracking was observed in this pipe. The first resembles a splitting of the liner at the corrugation/liner intersection (Figure 2). The other is related to the inner wall buckling and forms an elliptical crack around a buckle (Figure 1) and sometimes in the longitudinal direction. Table 1 summarizes the information regarding deflection, buckling and cracking under the deeper fill sections.

Figure 1 – Buckling and cracking along the springline of the pipe

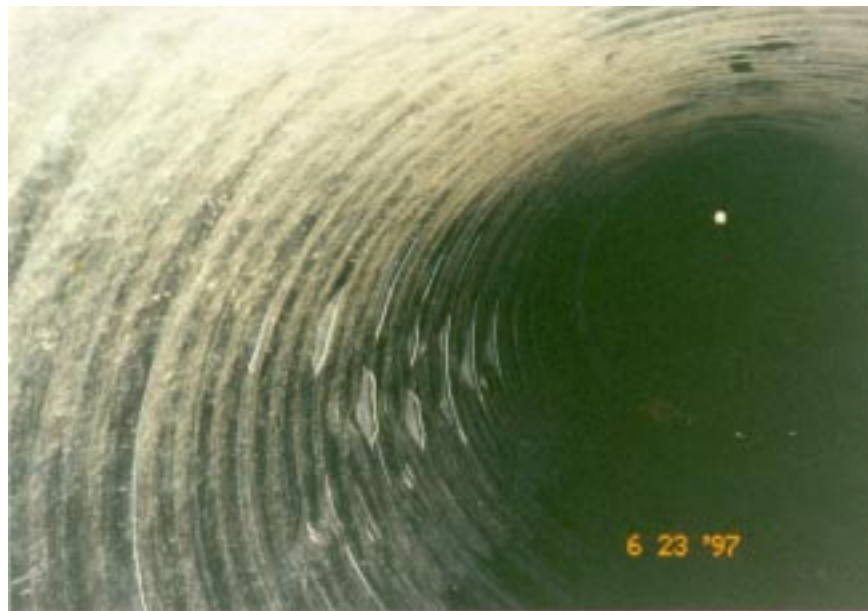
Figure 2 – Splitting cracking along the liner and corrugation

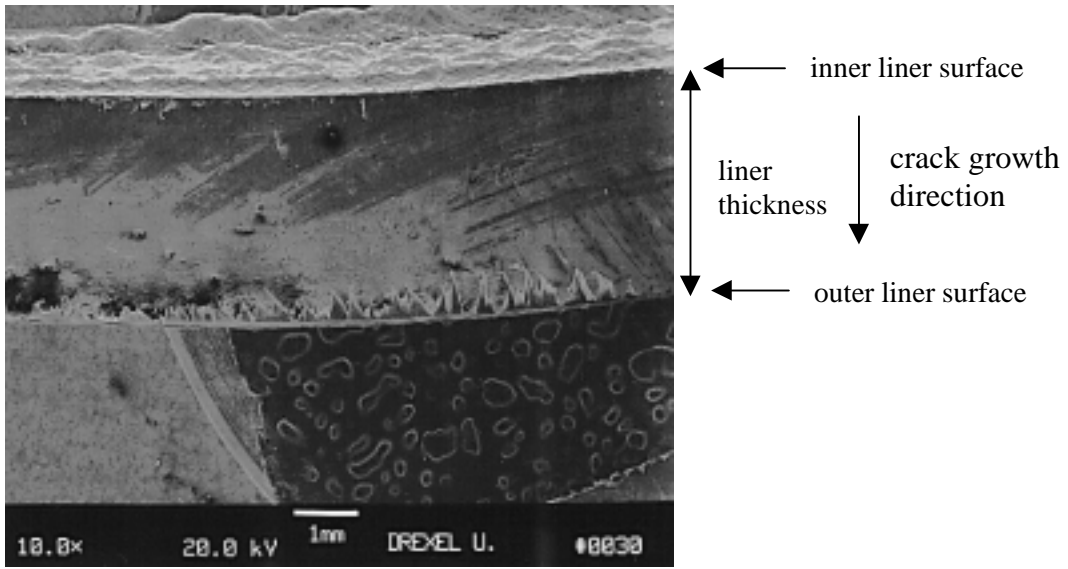
The microstructure examination of the fracture surface of the crack indicates that slow crack growth was the cause of cracking. Cracks were initiated from the inner liner surface and grew through the thickness of the liner. The majority of the cracks occurred around the localized buckling regions.

Figure 3 – Fracture surface of the crack in Sample E1

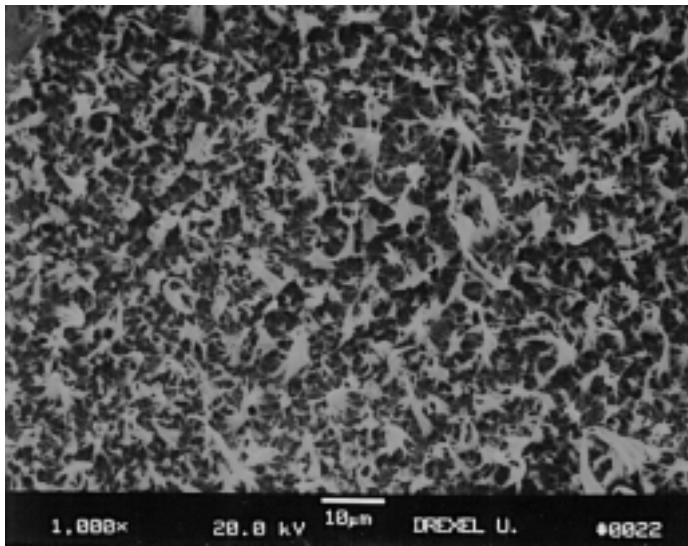
SEM specimens were taken from the crack of Samples E1 and E3 for evaluation. Their fracture morphologies are very similar. Figure 4 shows the overall appearance of the fracture surface of the crack. The fracture surfaces exhibit no sign of ductility. The crack was initiated from the inner surface of the liner, and grew towards the outer surface. Fibrous morphology can be seen on both fracture surfaces, as revealed in Figure 5, indicating that cracking in this pipe was caused by the slow crack growth mechanism.

Figure 4 – A close view on the fracture surface of the crack
In Sample E1, revealing a fibrous morphology

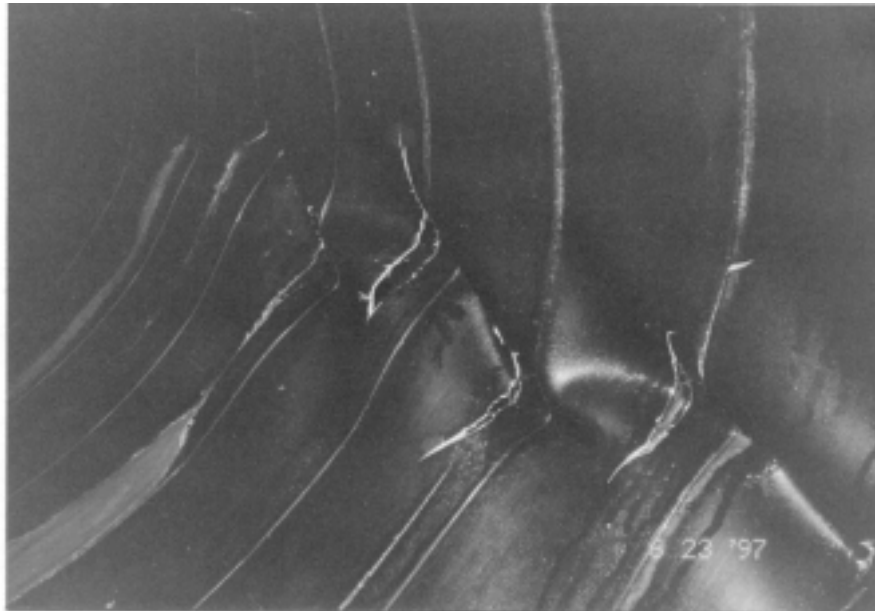
The storm drain was inspected in June 1997. The inspection discovered that the pipe has experienced deflection, buckling, and cracking, as shown in Figure 1. The groundwater table was above the pipe springline and some cracks were leaking. Table 1 summarizes the pipe information regarding these three behaviors along the inspected section of the pipe.

A Type S-helical HDPE pipe was being used as a storm-drain under 2.7 m of fill. During the inspection in June 1997, 1 year after the installation, deflection, buckling, and cracking were observed near the outlet of the pipe. Severe buckling was found 9 m from the outlet, leading to both circumferential and longitudinal cracking.

Figure 1 – Buckling and cracking in the liner of the pipe

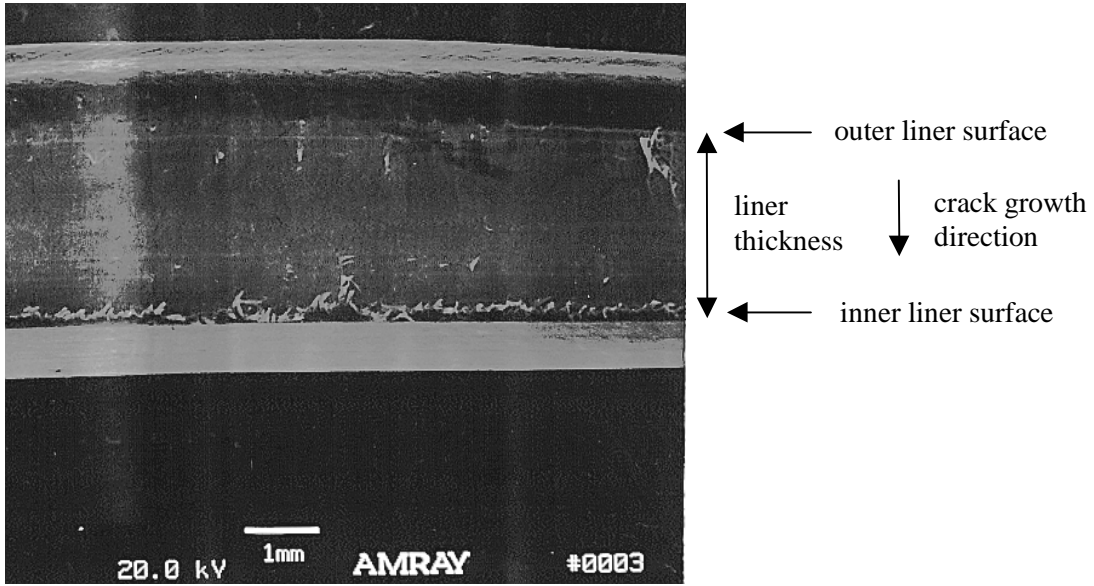
A specimen was taken from Sample F1 of the circumferential crack for evaluation. Figure 2 shows the overall appearance of the fracture surface of the crack. There is no sign of ductility associated with this crack. The crack was initiated from the outer surface of the pipe, and grew through the thickness of the liner. A fibrous morphology is revealed on the fracture surface, as can be seen in Figure 3. This reflects that the crack was caused by a slow crack growth failure mechanism.

The microstructure examination of the fracture surface of the crack indicates that slow crack growth was the cause of cracking. Cracks were initiated from the outer surface of the liner and grew towards the inner surface.

Figure 2 – Fracture surface of the crack in Sample F1

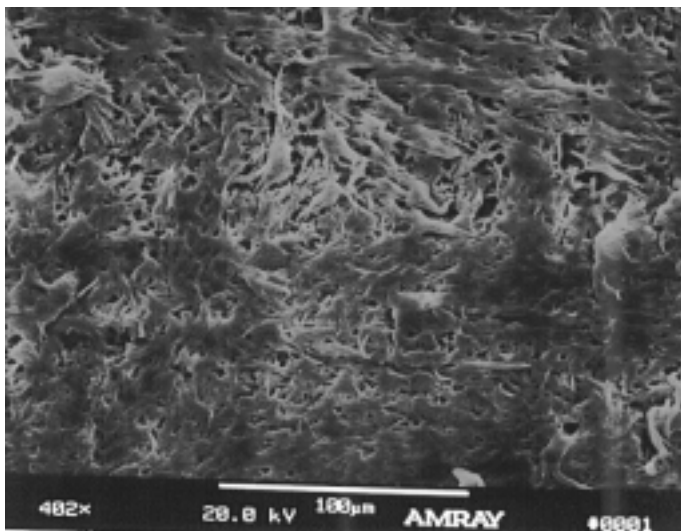
Figure 3 – A close view on the fracture surface of the crack in Sample F1, revealing a fibrous morphology

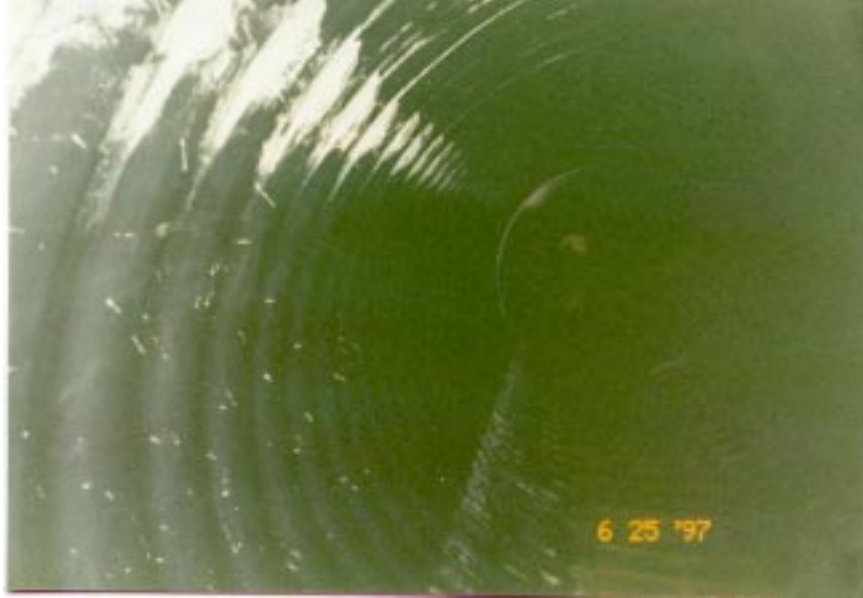
The storm drain was inspected in June 1997. Figure 1 shows the condition of the pipe. The inspection discovered that the pipe exhibited a small deflection and contained one short crack. Table 1 summarizes the pipe information regarding deflection and cracking along the inspected section of the pipe.

Figure 1 – A general view in the interior of the pipe at Site G

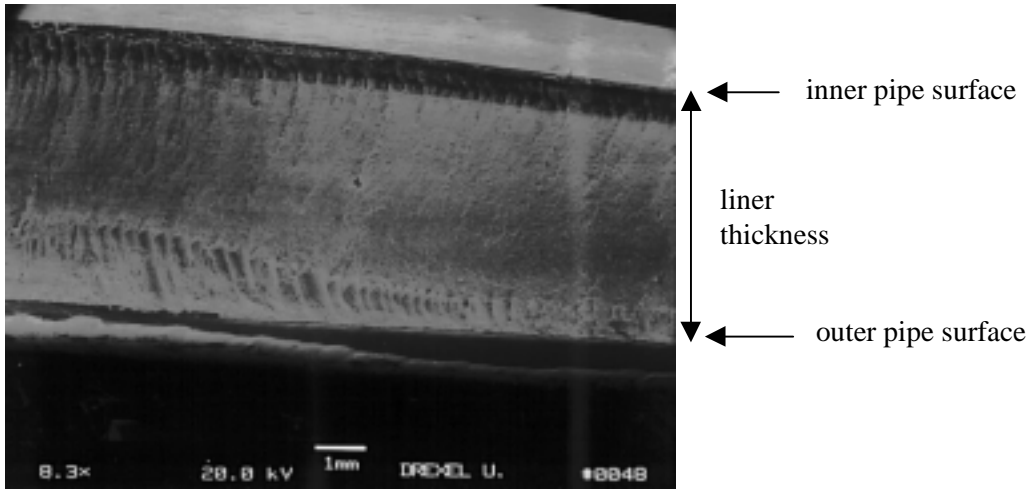
Two specimens were taken from Sample G5 of the circumferential crack for evaluation. The fracture surfaces of both specimens are very similar. Figure 2 shows the overall appearance of the fracture surface of the crack. There is no sign of ductility associated with this crack. However, the crack initiation was not identified. The fracture morphology of the crack is found to be a flake structure (Figure 3), indicating that cracking was caused by a rapid crack propagation failure mechanism. The close view on the flake morphology is depicted in Figure 4.

The microstructure examination of the fracture surface of the crack indicates that a rapid crack propagation was the cause of cracking.

Figure 2 – Fracture surface of the crack in Sample G5

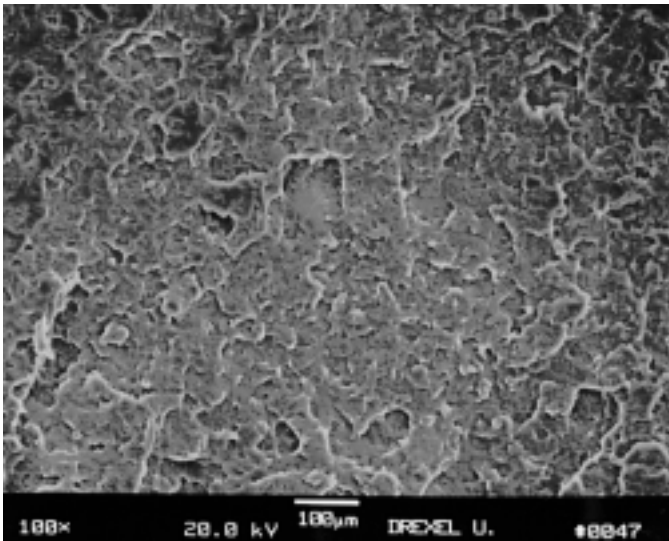
Figure 3 – A close view on the fracture surface of the crack in Sample G5, revealing a flake morphology

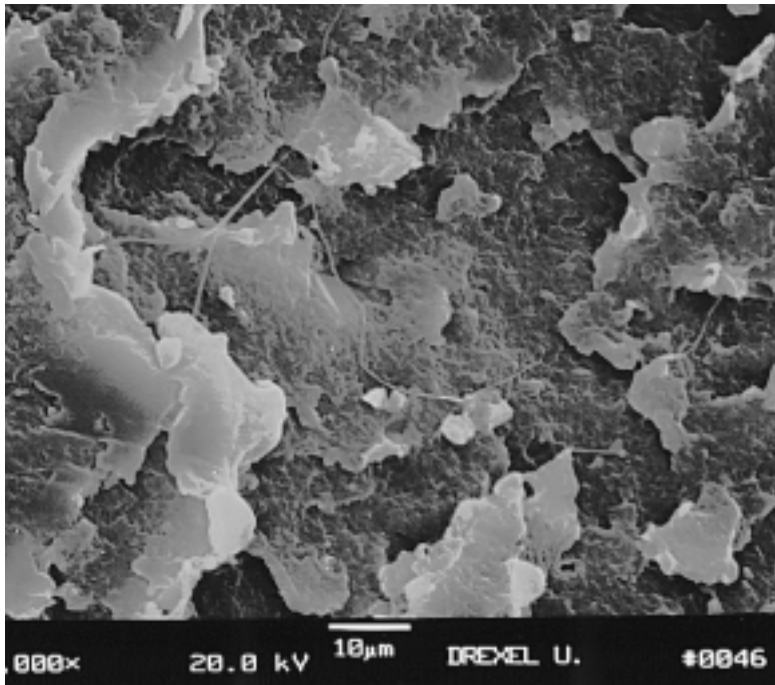
Figure 4 – A close view on the flake morphology on Figure 3

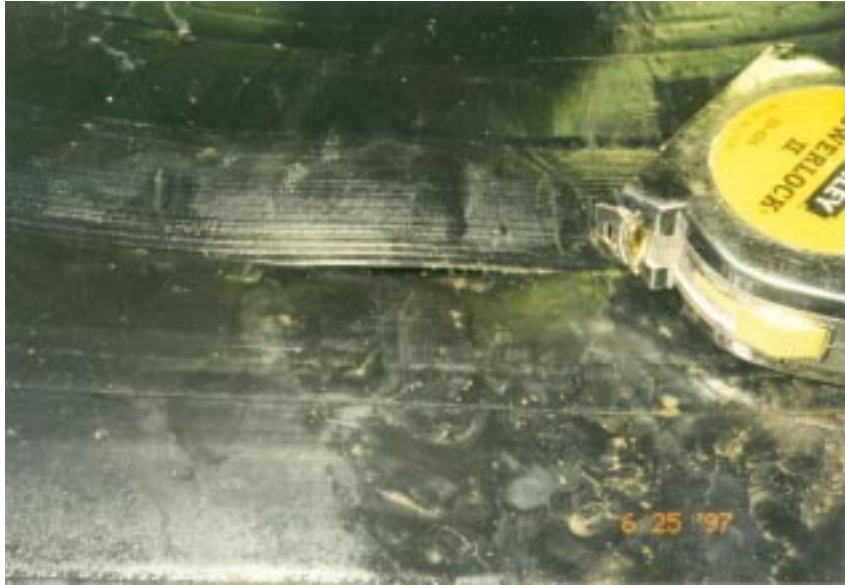
Three samples removed from this pipe were coded as Samples H1, H2 and H3. Samples H1 and H2 were taken at locations adjacent to two circumferential cracks, can be seen in Figures 1 and 2, respectively. The fracture surface of the cracks was examined using a scanning electron microscope (SEM) in order to verify the failure mechanism.

Figure 1 – Small circumferential crack in Sample H1

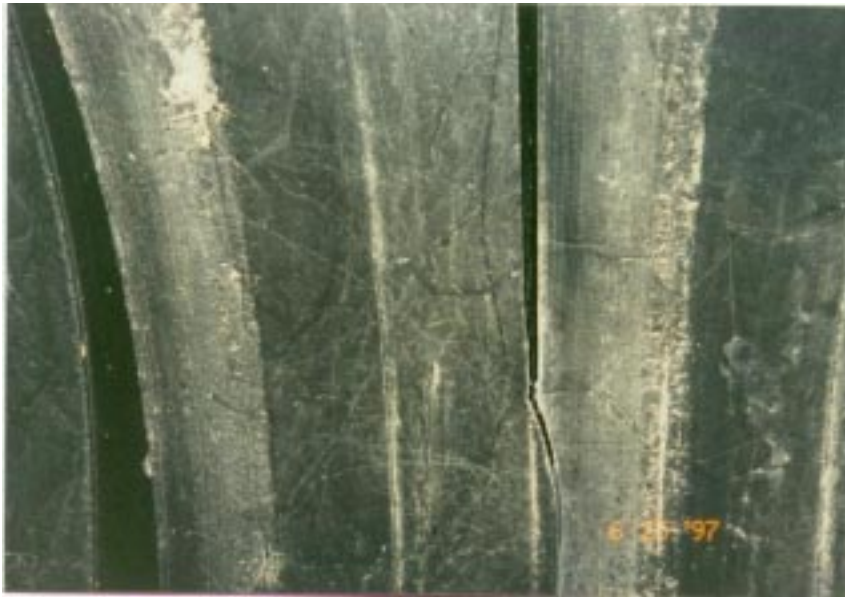
Figure 2 – Long circumferential crack in Sample H2

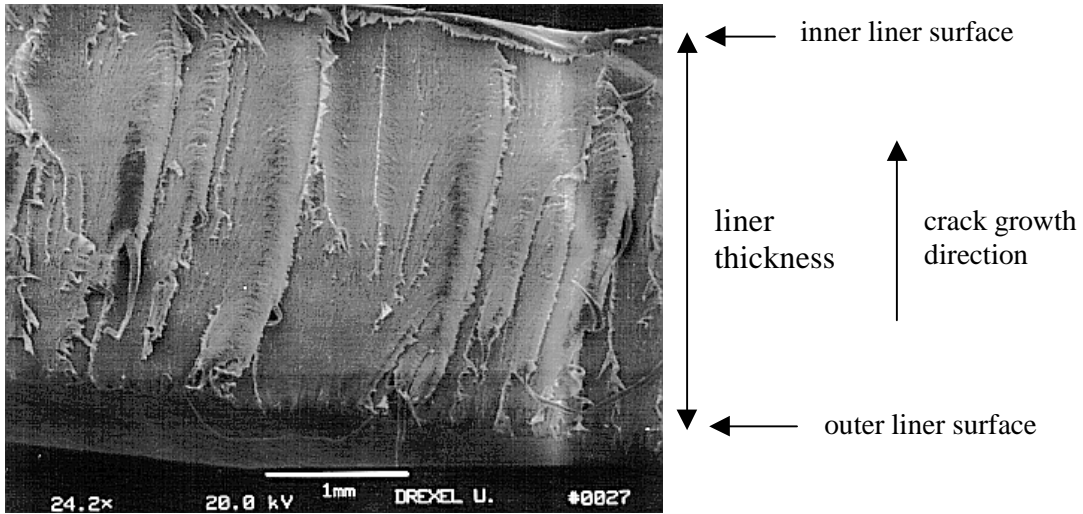
A SEM specimen was taken from the crack of Samples H1 and H2. Their fracture behavior were found to be very similar. Figure 3 shows the overall appearance of the fracture surface of the crack. There is no sign of ductility associated with this crack, as indicated by the constant thickness along the fracture surface. There are many rows of thin film structure across the thickness of the liner. This thin film structure suggests that the crack resulted by the joining of many small failure planes together, instead of a single failure plane. Each of the failure planes was generated by a micro-crack that propagated through the thickness of the liner; simultaneously, the micro-crack grew sideways. When the two adjacent failure planes met, a thin film structure formed.

The microstructure examination of the fracture surface of the crack verifies that a slow crack growth was the cause of cracking. The tensile stress that initiated the crack might be due to deflection and bending of the pipe.

Figure 3 – Fracture surface of the crack in Sample H1

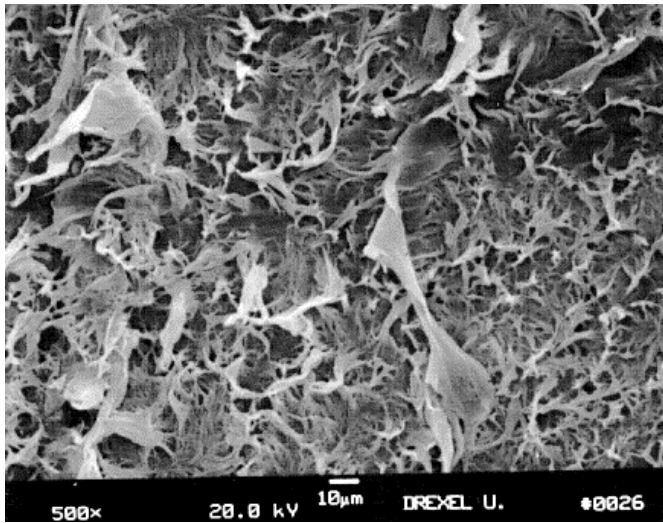
The subsurface structure on the fracture surface is depicted in Figure 4, revealing a fibrous morphology. This structure signifies a slow crack growth failure.

Figure 4 – A close view on the fracture surface of the crack in Sample H1, revealing a fibrous morphology

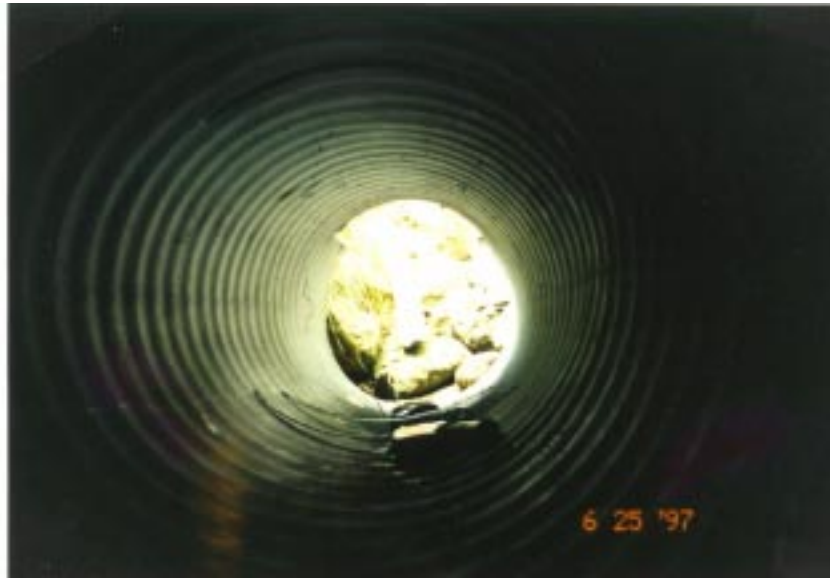
The storm drain was inspected in June of 1997. Figure 1 shows the condition of the pipe. The inspection discovered that the pipe exhibited some amount of deflection, longitudinal bending, ductile tearing, and circumferential cracking. Table 1 summarizes the pipe information regarding the behavior of the pipe along the inspected section.

A Type S - annular HDPE pipe was being used as a cross drain under 1 to 3 m of fill. During the inspection in June 1997, 1 year after the installation, some deflection, longitudinal bending and circumferential cracking were observed in the inspected area near the inlet of the pipe. Significant longitudinal bending leads to tearing in some of the corrugations.

Figure 1 – A general view on the interior of the pipe at Site I

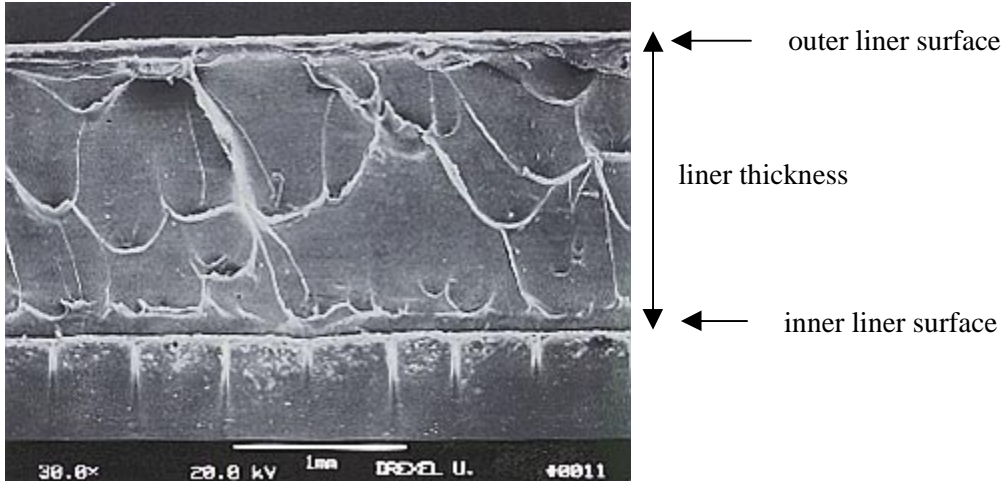
The microstructure examination of the fracture surface of the crack indicates a mixture failure modes, including ductile failure, slow crack growth and rapid crack propagation. Cracks were initiated from the outer surface of the liner at the junction between liner and corrugation.

Figure 2 – Fracture surface of the crack in Sample II

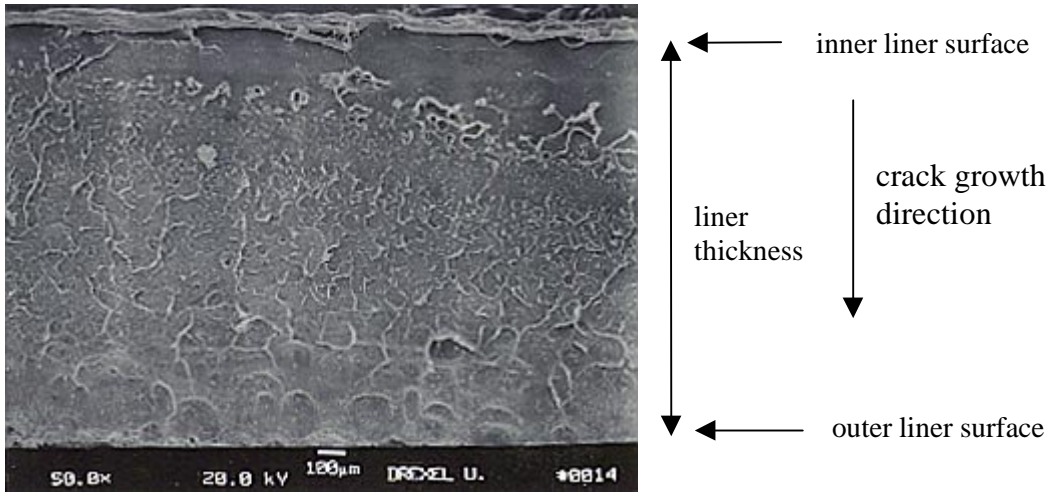
Figure 3 – Fracture surface of the crack in Sample I2

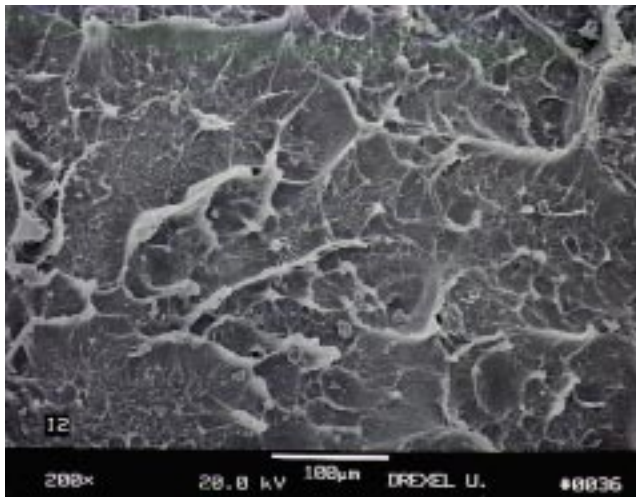
Figure 4 – A close view on the fracture surface of the crack in Sample I2, revealing a fibrous morphology

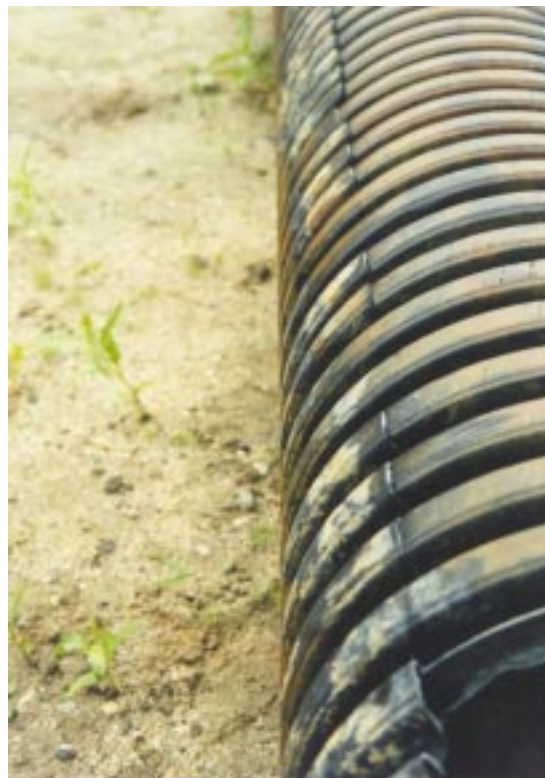
Figure 2 – A longitudinal crack along mold line in Sample J2

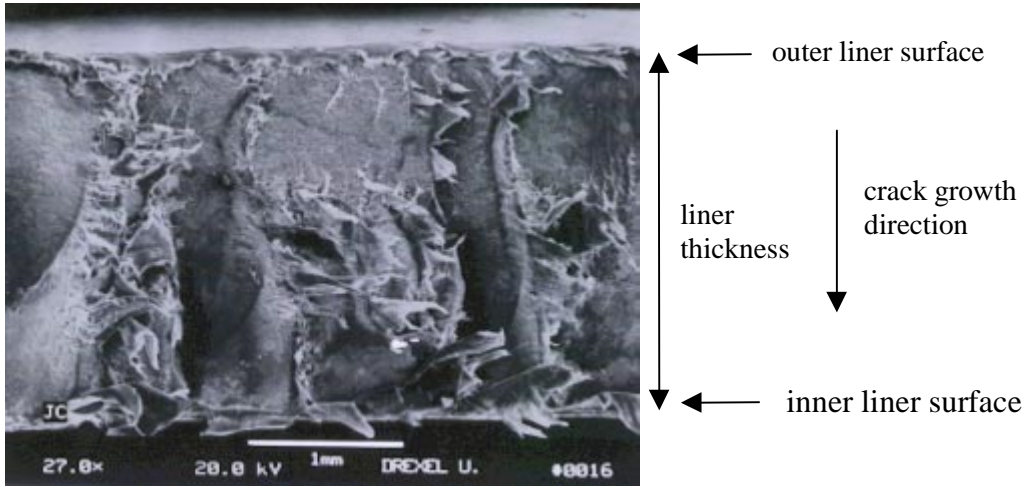
The microstructure examination of the fracture surface of the crack indicates that slow crack growth was the cause of circumferential cracking. Cracks were initiated from outer surface of the liner and grew towards the inner surface. The failure mechanism of the longitudinal crack in Sample J2 is not well defined, but has more of the morphology of the slow crack growth mechanism than rapid crack propagation.

Figure 3 – Fracture surface of a circumferential crack in Sample J2

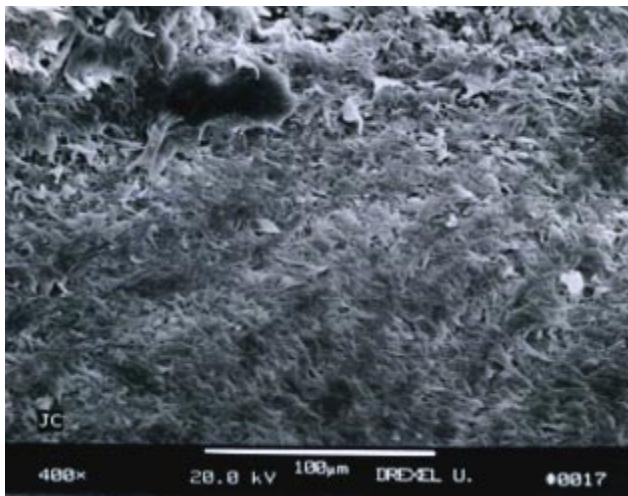
Figure 4 – A close view on the fracture surface of the circumferential crack in Sample J2, revealing a fibrous morphology

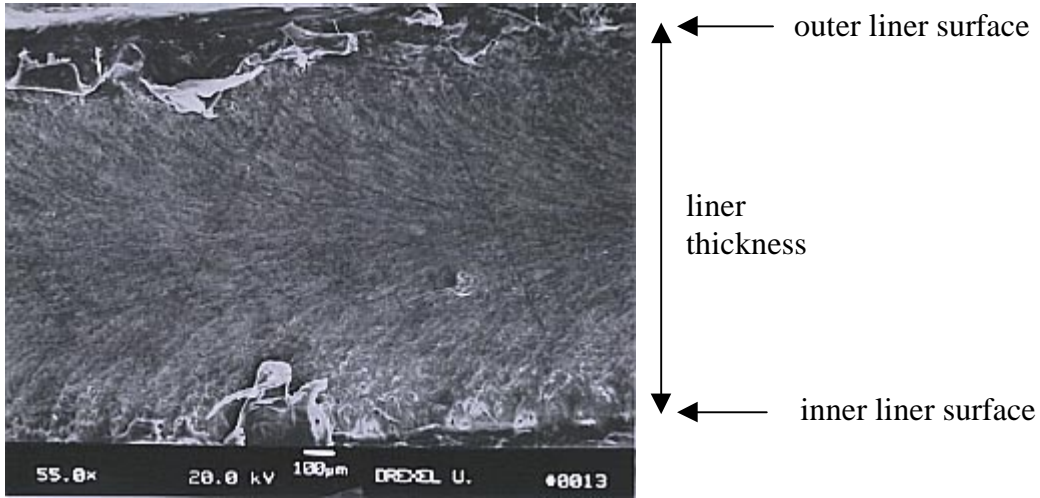
Figure 5 – Fracture surface of a longitudinal crack in Sample J2

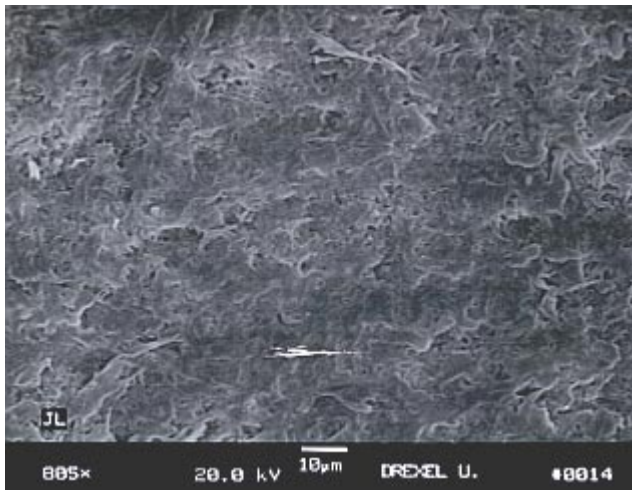
Figure 6 – A close view on the fracture surface of the longitudinal crack in Sample J2, revealing a fibrous morphology

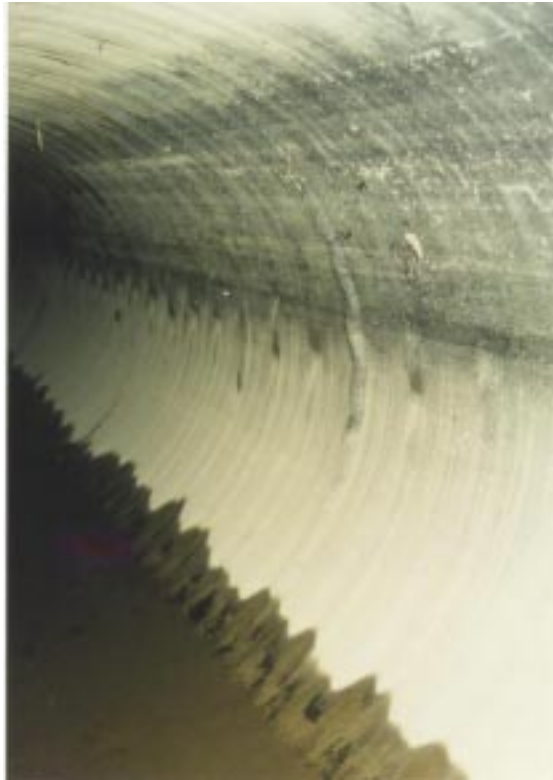
A Type S-helical HDPE pipe was being used as a storm drain under 3 m of fill. During the inspection in June 1997, 6 year after the installation, deflection, buckling, and cracking were observed in the pipe.

Figure 2 – Buckling on the liner of the pipe
