APPENDIX F

REPORTS ON EIGHTEEN INVESTIGATED FIELD SITES

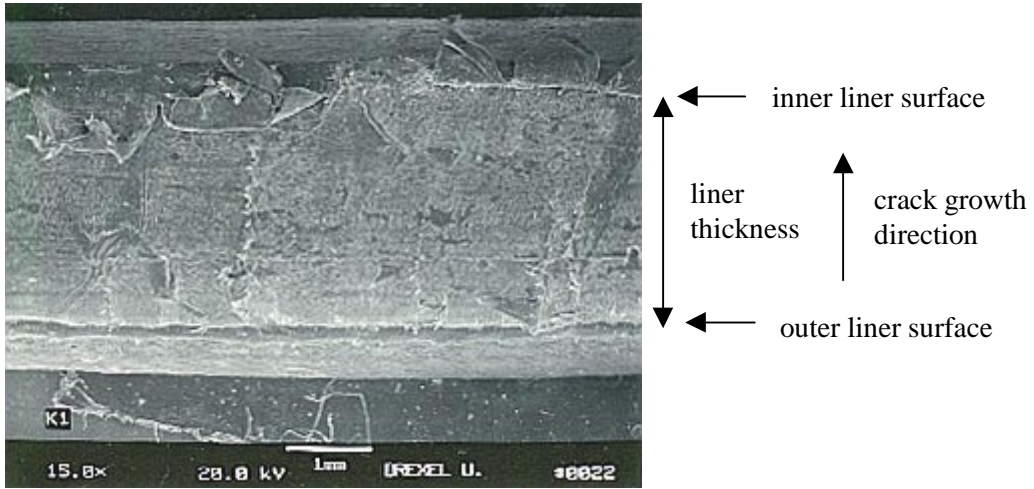
The microstructure examination of the fracture surface of the crack indicates that a slow crack growth was the cause of cracking. Cracks were initiated from the outer surface of the liner and grew towards the inner surface at the junction between liner and corrugation.

Figure 3 – Fracture surface of the crack in Sample K1

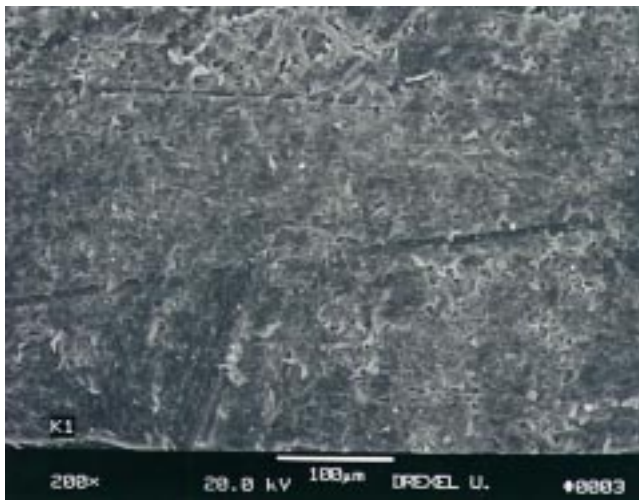
Figure 4 – A close view on the fracture surface of the crack in Sample K1, revealing a fibrous morphology

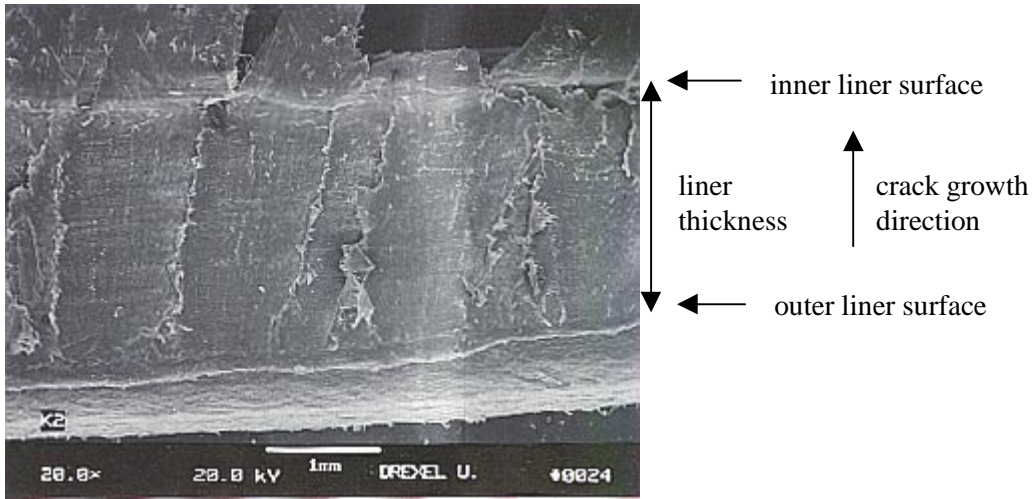
Figure 5 – Fracture surface of the crack in Sample K2

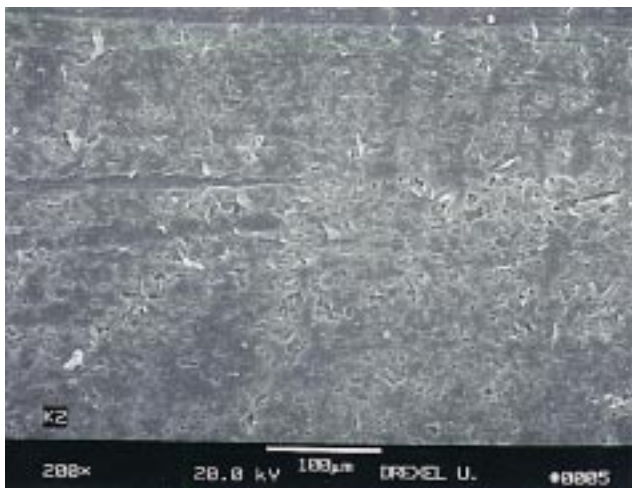
Figure 6 – A close view on the fracture surface of the crack in Sample K2, revealing a fibrous morphology

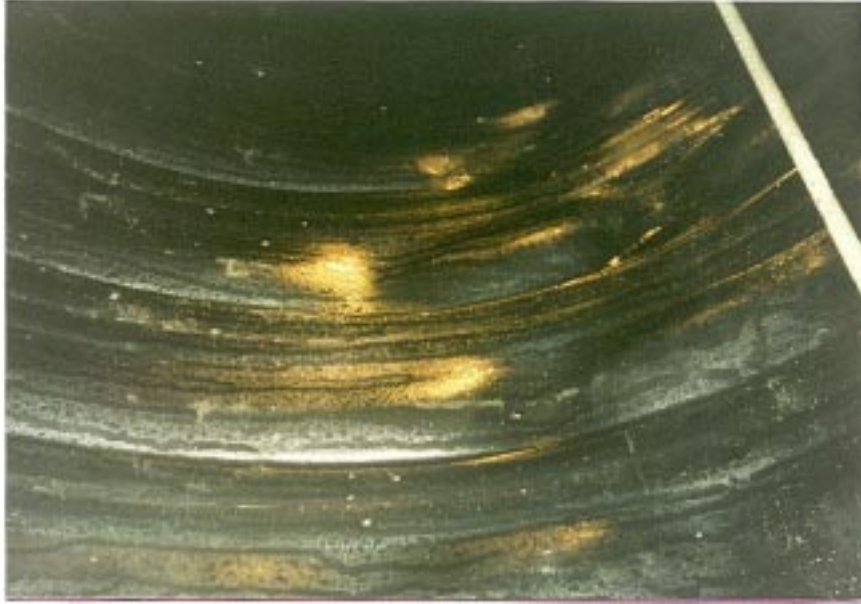
A 600 mm diameter of Type C - helical and Type S-helical HDPE pipes were being used as a cross drain under 30 m of fill. During the inspection in September 1997, 10 years after installation, deflection, buckling, and cracking were observed along the pipe.

Figure 1 – Buckling on the liner of the pipe at Site O

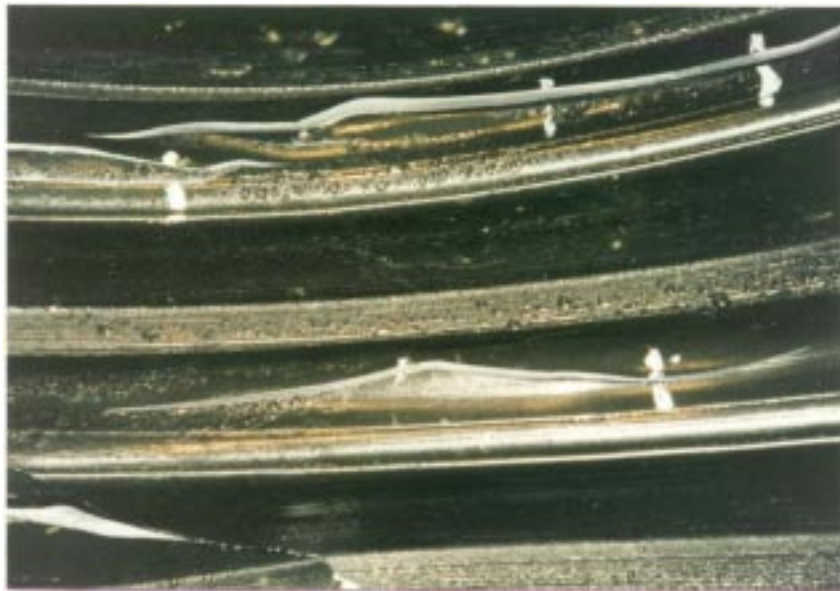
Figure 2 – Circumferential cracking in the TypeC-helical section of the pipe system

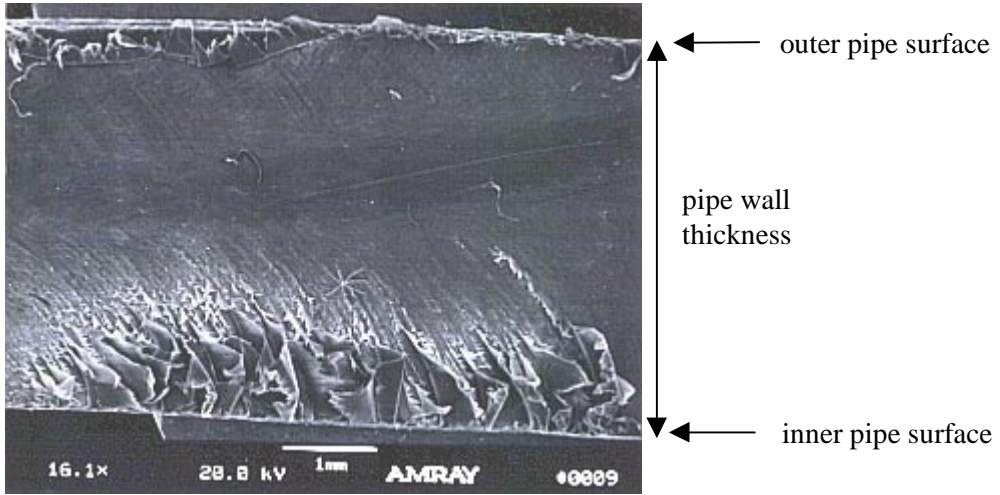
The microstructure examination of fracture surfaces of circumferential cracks indicates that slow crack growth was the failure mechanism.

Figure 3 – Fracture surface of the crack in Specimens #1

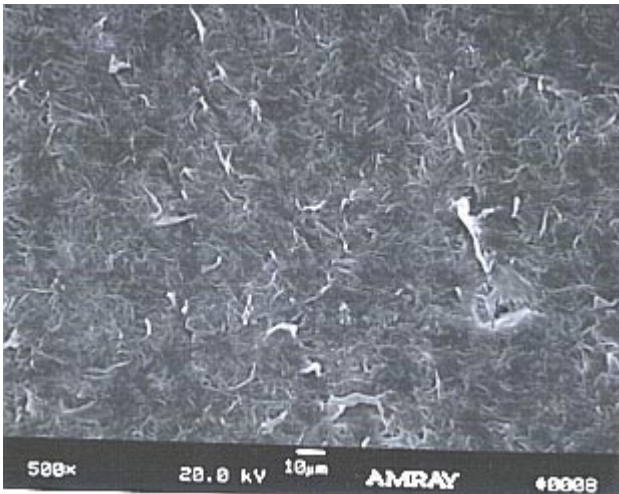
Figure 4 – A close view on the fracture surface of the crack in Specimen #1, revealing a fibrous morphology

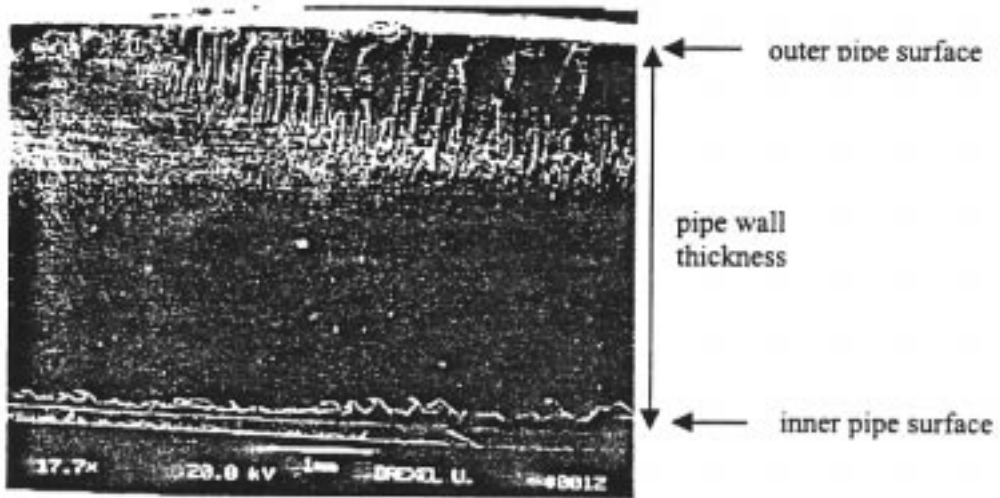
Figure 5 – Fracture surface of the crack in Specimen #2

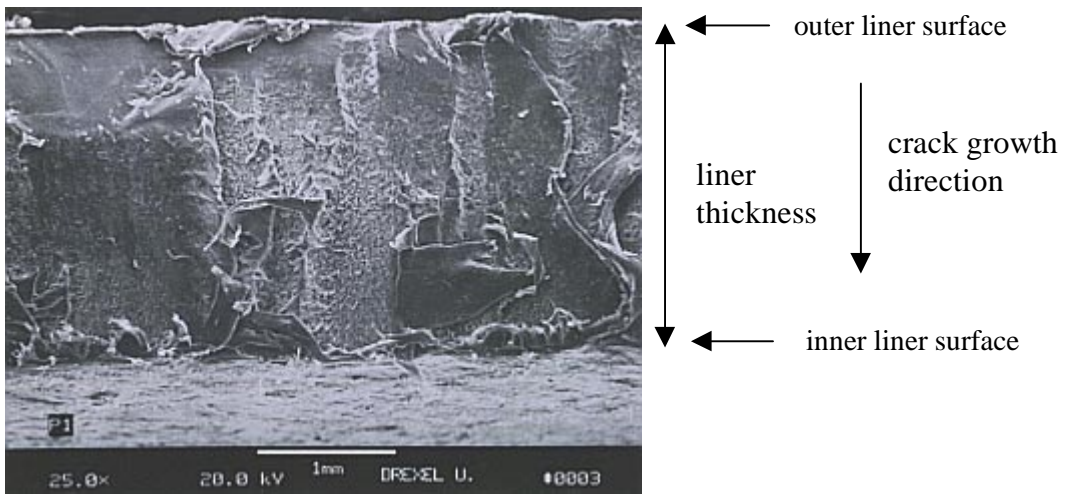
The microstructure examination of the fracture surface of the crack indicates that a slow crack growth was the cause of cracking. Cracks were initiated from the outer surface of the liner and grew towards the inner surface.

Figure 2 – Fracture surface of the crack in Sample P1

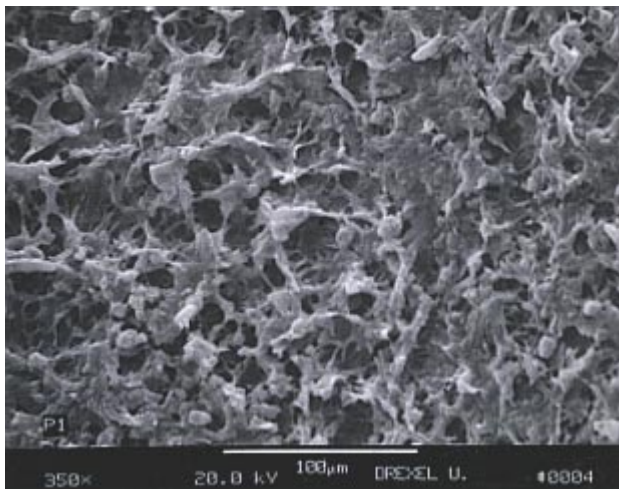
Figure 3 – A Close view on the fracture surface of the crack in Sample P1, revealing a fibrous morphology

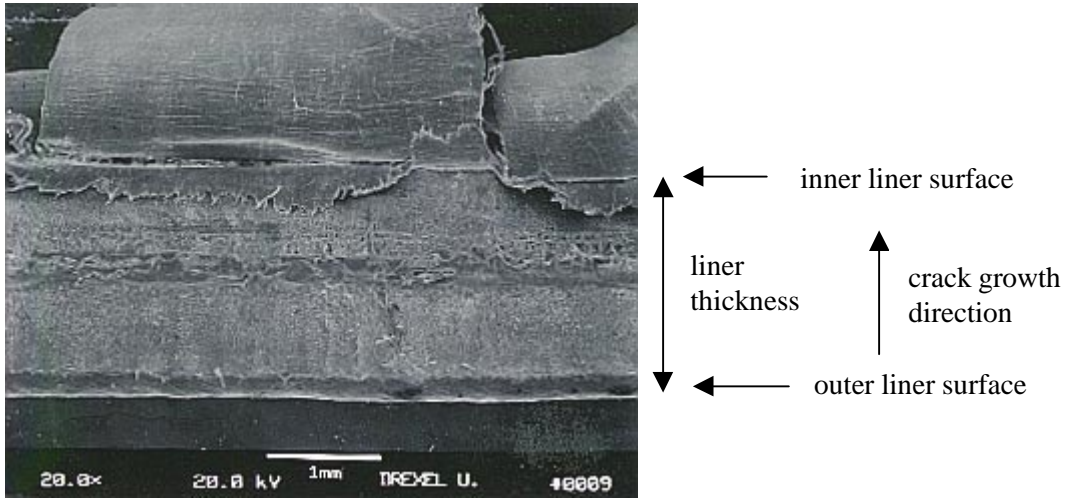
The microstructure examination of the fracture surface of the crack indicates that a slow crack growth was the cause of cracking. Cracks were initiated from the outer surface of the liner and grew towards the inner surface.

Figure 2 – Fracture surface of the crack in Sample R1

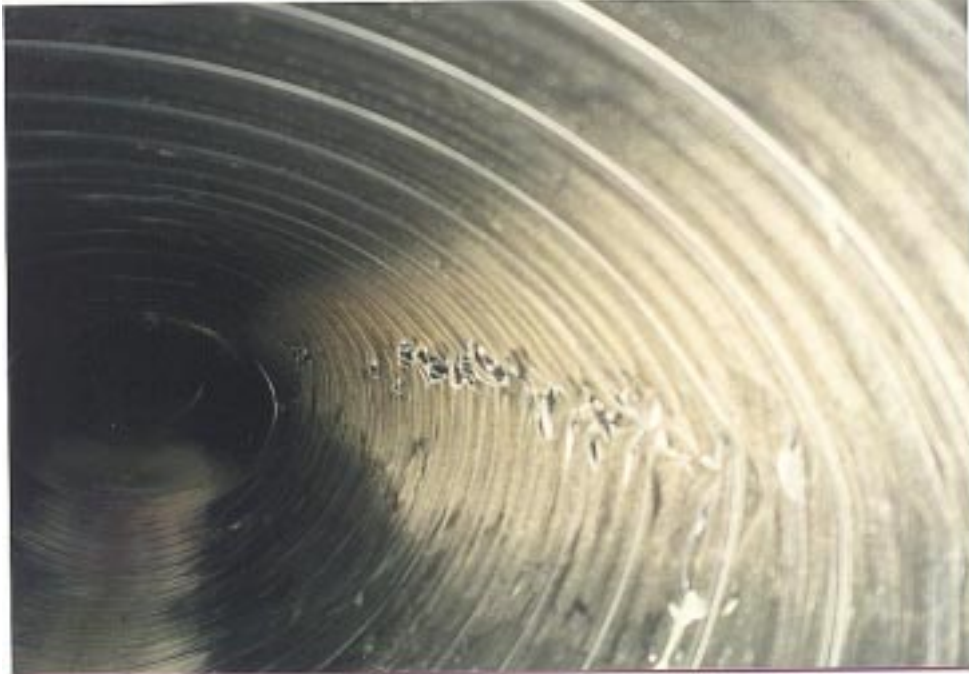
Figure 1 – An interior view of the pipe at Site U, showing cracking on the liner

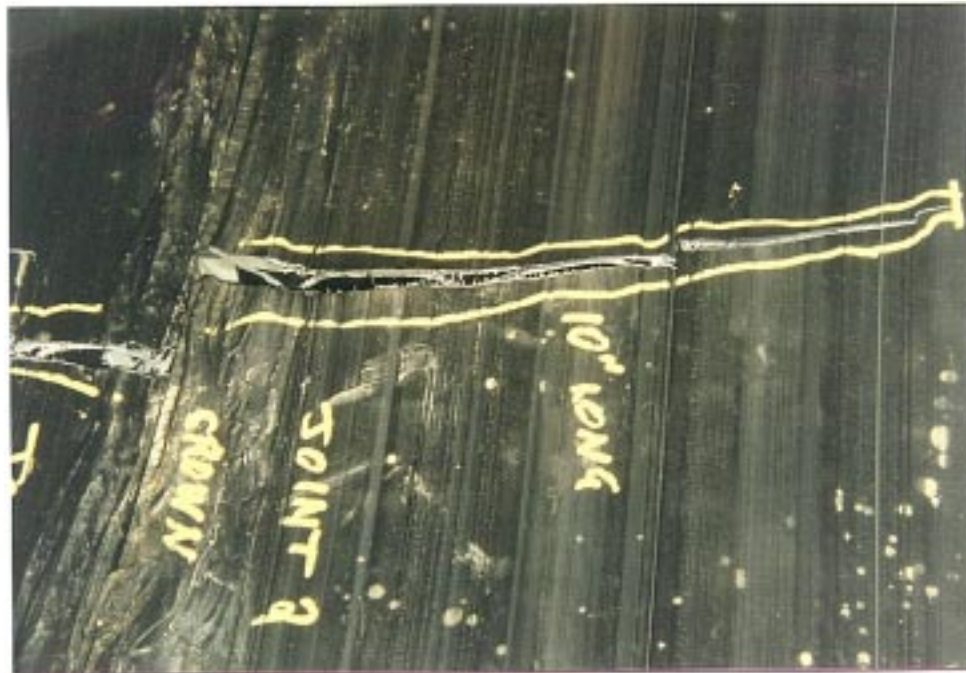
Figure 2 – A longitudinal crack in the pipe

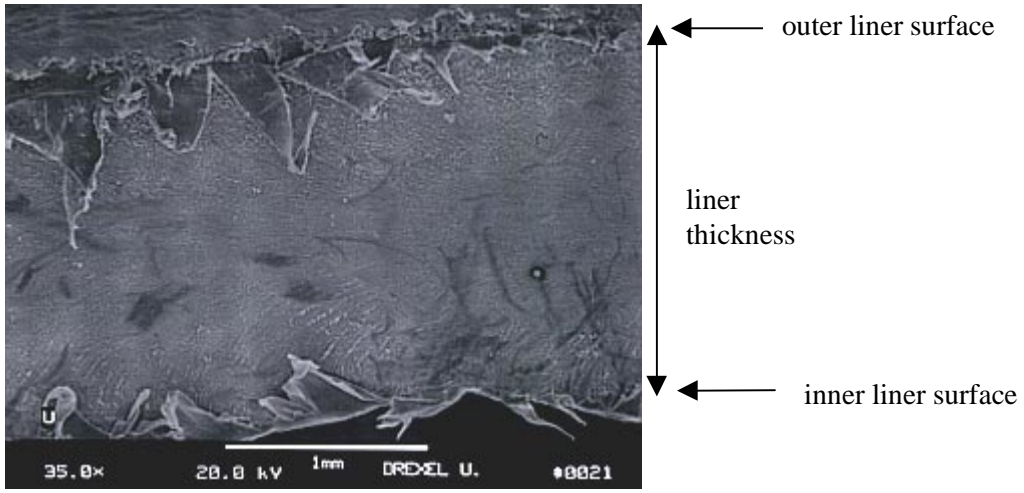
The microstructure examination of the fracture surface of the crack indicates that a slow crack growth was the cause of cracking. The initiation of these cracks was not able to identify, however, the crack propagated along the center towards edges of the liner.

Figure 3 – Fracture surface of the crack in Sample U2

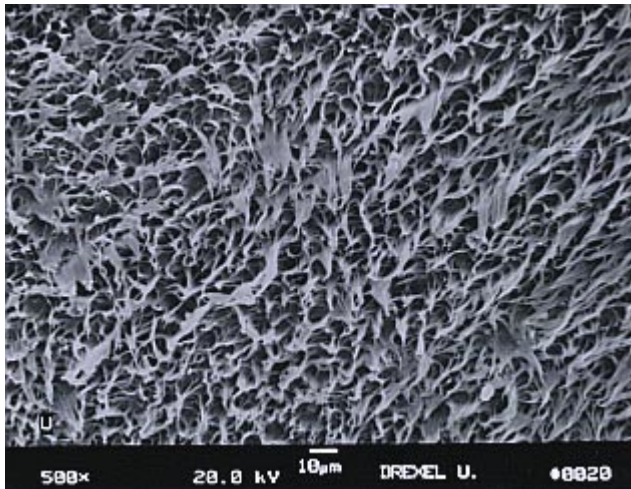
Figure 4 – A close view on the fracture surface of the crack in Sample U2, revealing a fibrous morphology

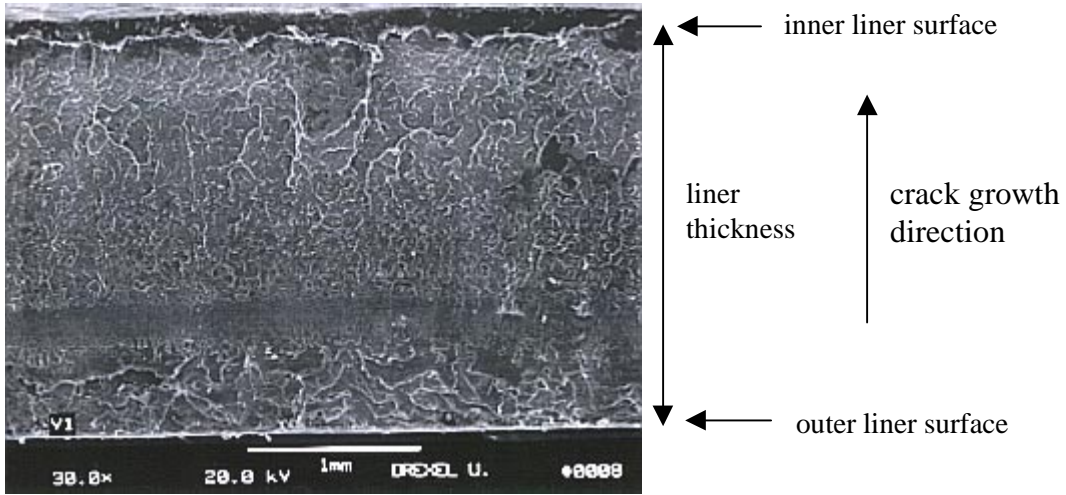
The microstructure examination of the fracture surface of the crack indicates that a rapid crack propagation was the cause of cracking.

Figure 2 – Fracture surface of the crack in Sample V1

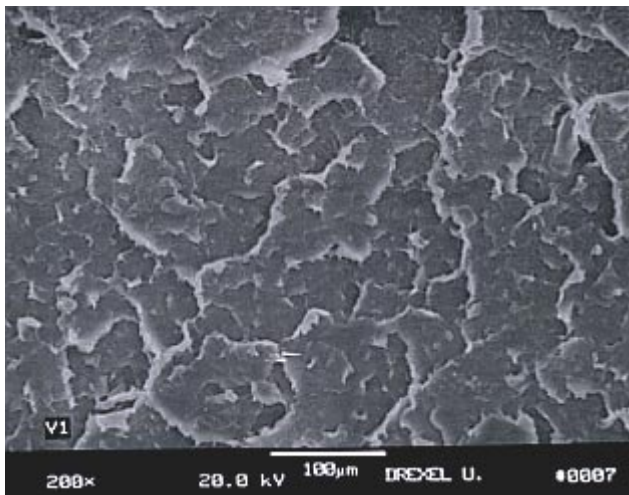
Figure 3 – A close view on the fracture surface of the crack in Sample V2, revealing a flake morphology

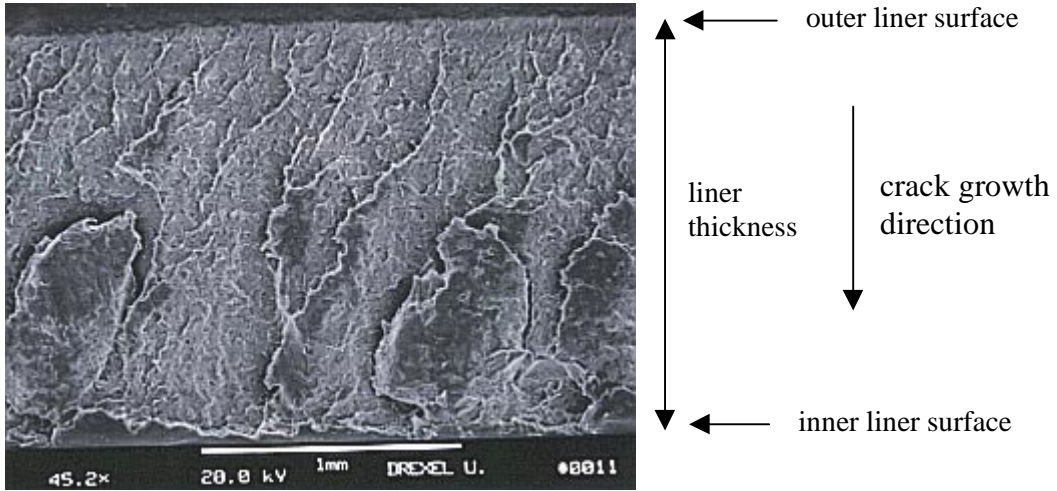
The microstructure examination of the fracture surface of the crack indicates that a rapid crack propagation was the cause of cracking.

Figure 2 – Fracture surface of the crack in Sample W1

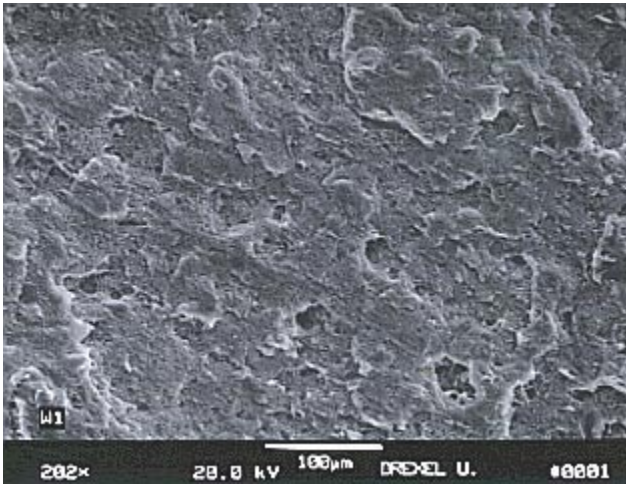
Figure 3 – A close view on the fracture surface of the crack in Sample W1, revealing a flake/fibrous morphology
