In-Depth Inspection of Arizona's Steel Bridges

MARK E. BERNHARDT, P.E.
Burgess & Niple, Ltd.

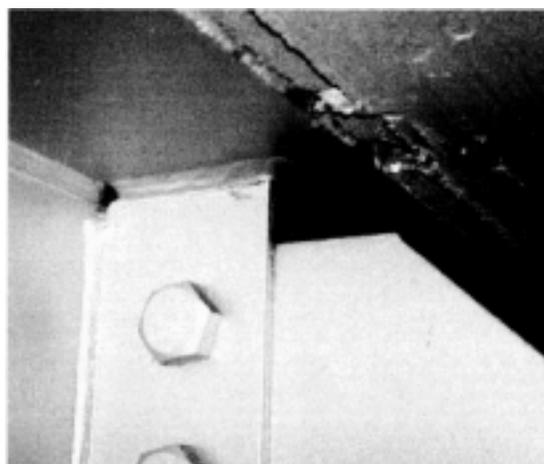
Most of the other significant deficiencies noted were fatigue or impact related. Distress was usually found at the superstructure connection details between transverse diaphragms and girders or beams. Typically, transverse diaphragms were bolted or welded to vertical stiffeners on the girder webs. When cracks were found, they were commonly located in the weld between the vertical stiffener and web or top flange. Figure 3 depicts this type of distress. This type of cracking is commonly caused by out-of-plane forces

Figure 3: Cracked connection weld between girder top flange and diaphragm connection stiffener.

induced in the girder webs by the diaphragms. Differential deflections of adjacent girders during vehicular loading are the source of these forces. On older girder bridges (those constructed around the 1950s), it was typically welds between vertical stiffeners and diaphragms that failed. Often this weld was a field weld of marginal quality. A cracked weld at a diaphragm to stiffener connection is shown in Figure 4.

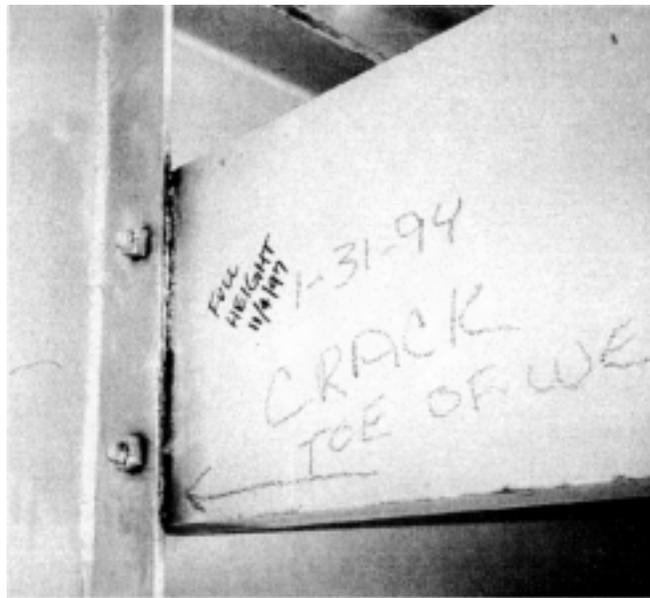
Figure 4: Cracked connection weld between the transverse diaphragm and vertical connection stiffener.

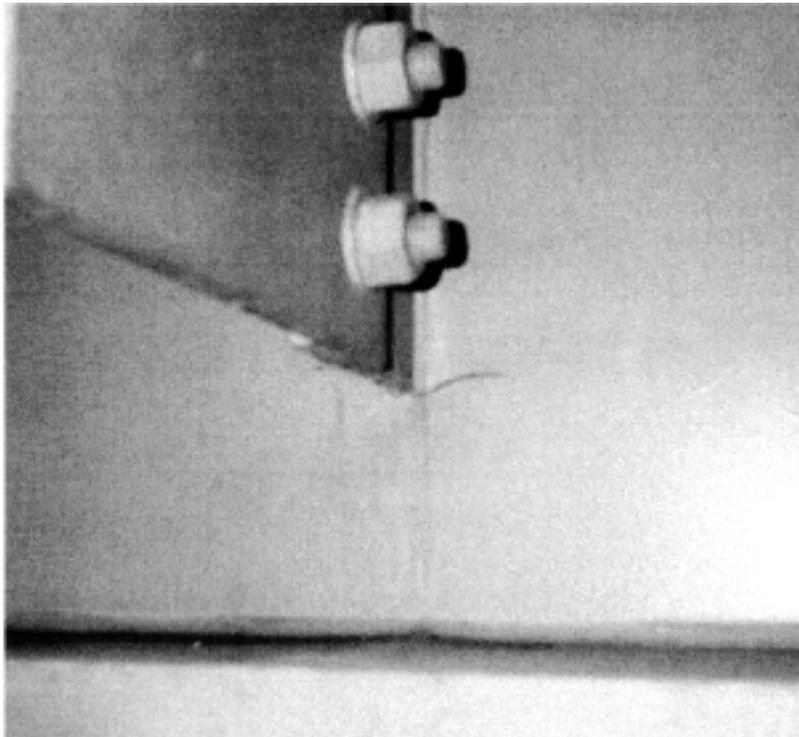
Cracks were also found in girder webs where vertical connection plates at transverse diaphragms terminated a distance above the bottom flange of the girder. This condition is depicted in Figure 5. This particular bridge was also skewed and the diaphragms were perpendicular to the girders. Out-of-plane distortions were induced in girder web plates by diaphragm connection plates. When the bottom flange is relatively thick and stiff, as was the case on this bridge, diaphragm forces are accommodated by the out-of-plane bending of the web plate between the bottom flange and toe of the connection plate. Cracks, such as the one pictured, were found in the girder webs on this and other similar bridges.

Figure 5: Crack in girder web below termination of transverse diaphragm connection plate.

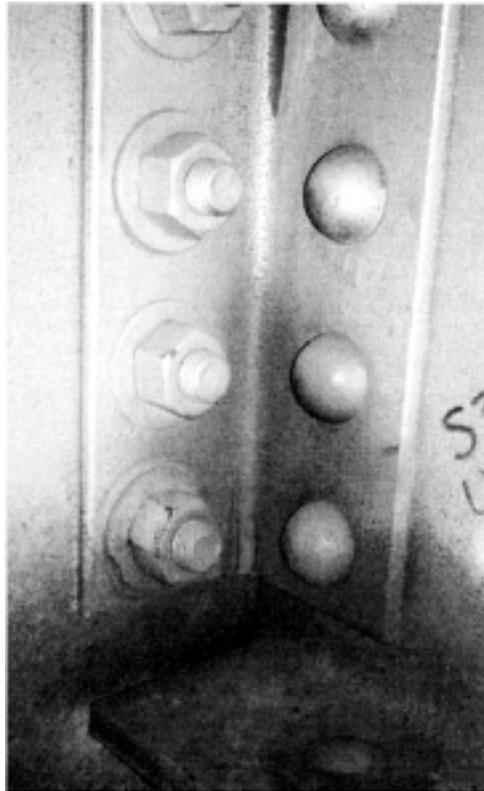
Some of the older riveted bridges inspected contained cracked clip angles at stringer to floorbeam connections. These connection angles are subjected not only to vertical shear forces, but also bending moments. Differential expansion and contraction between continuous deck sections and supporting steelwork appears to be responsible for

the cracked clip angles. A typical distressed clip angle is depicted in Figure 6. The bending axis of this connection is close to the top of the member due to the composite action with the deck. The bottom portion of the clip angle is subjected to the highest stresses. Two parallel cracks have formed near the bottom of this angle.

Figure 6: Distressed clip angle at stringer to floorbeam connection.

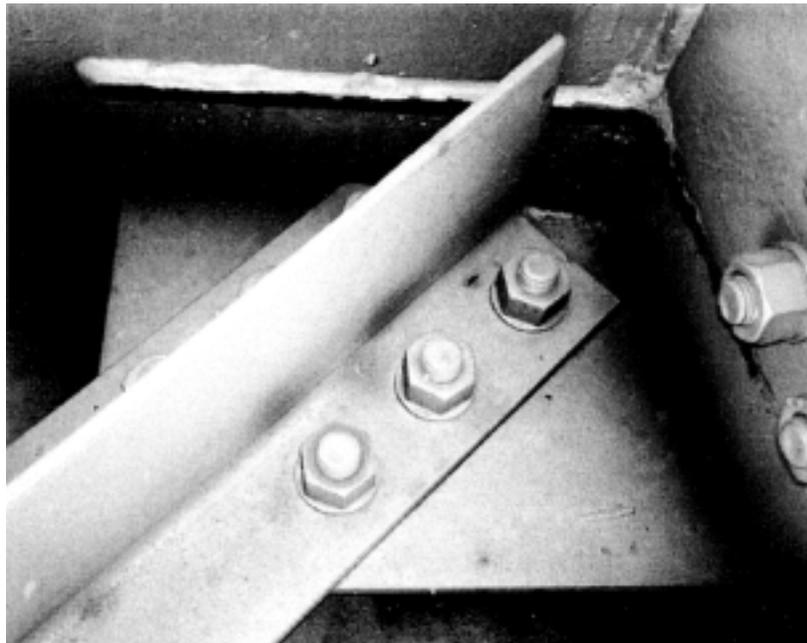
Fatigue related distress was also noted in the lower lateral bracing components of several girder bridges. In Figure 7, a gusset plate at the connection between a lower lateral brace and a girder web is pictured. The gusset plate attachment welds have completely fractured, allowing the gusset plate and bracing to drop and rest on the bottom flange of the girder. This distress can be attributed to secondary stresses induced by dynamic vertical vibrational movement and out of plane distortions caused by vehicular live load on the bridge.

Figure 7: Fractured bottom lateral gusset plate welds.
