# **NCHRP**

## **REPORT 471**

### **Evaluation of Roadside Features to Accommodate Vans, Minivans, Pickup Trucks, and 4-Wheel Drive Vehicles**

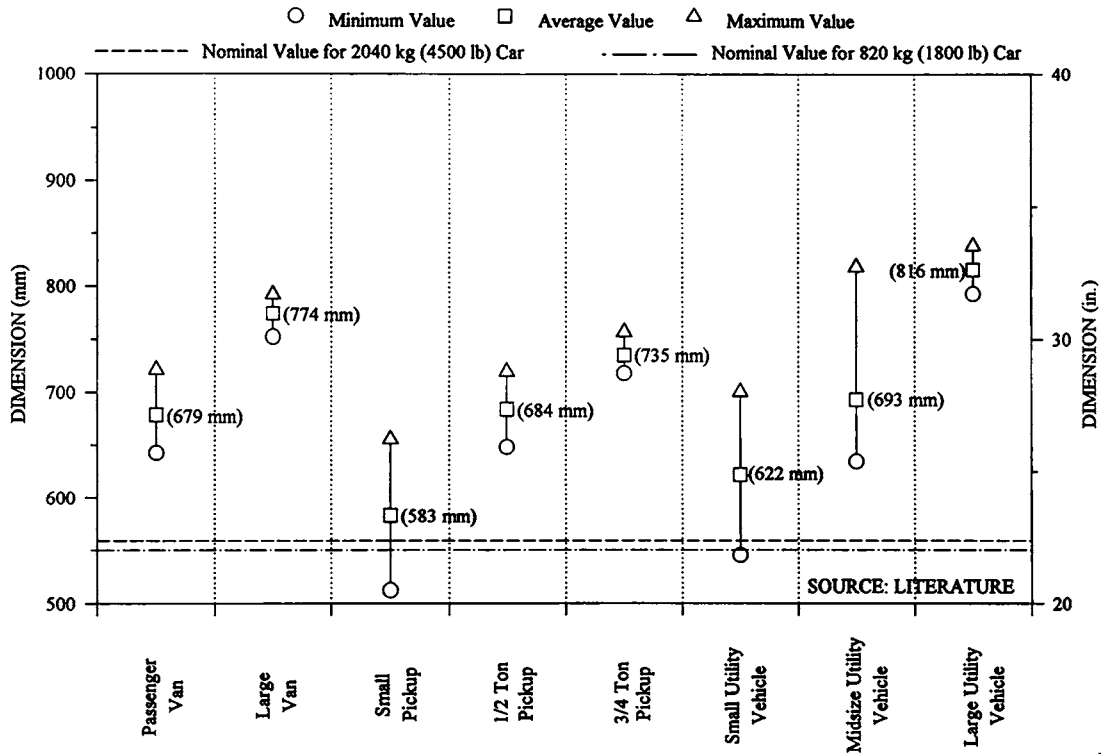
Figure 8. Center of gravity location above ground.

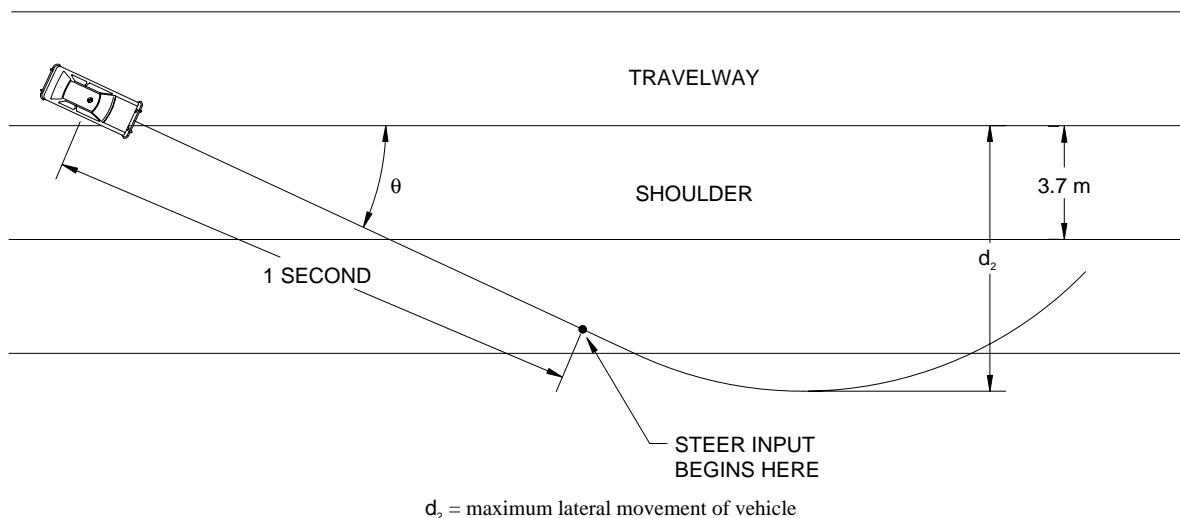
Figure 21. Fill-section encroachment parameters.

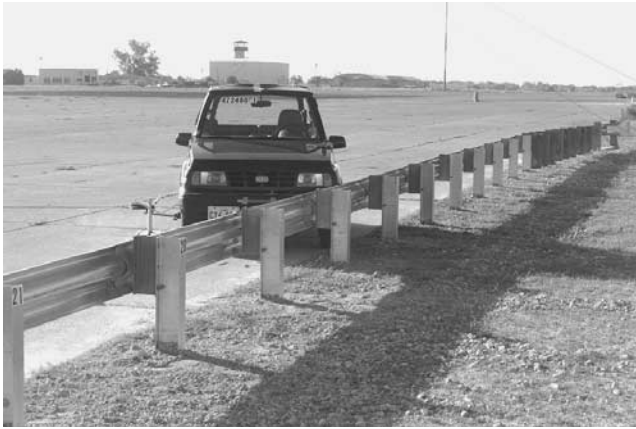
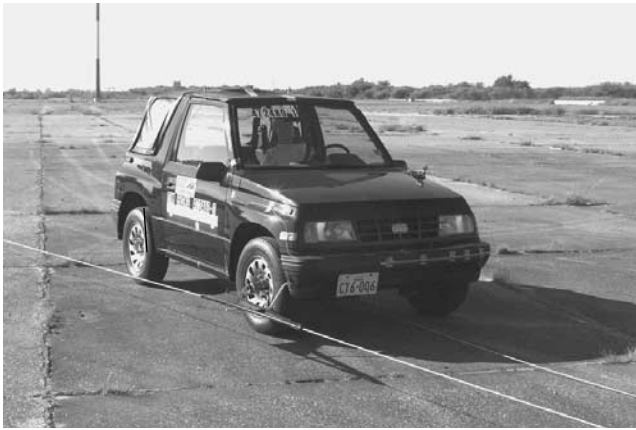
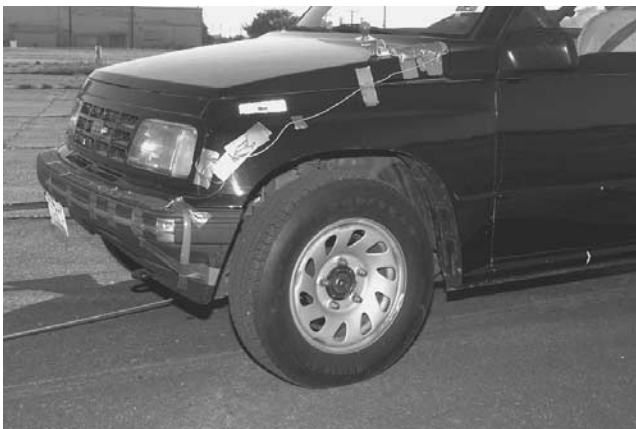
Figure 25. Vehicle/installation geometrics for test 472480-1.

The Standard G4(1S) Guardrail system had satisfactory performance for all the light truck subclasses tested for impact conditions of 100 km/h and an impact angle of 20 degrees. It can also be seen that the Modified G4(1S) Guardrail system met *NCHRP Report 350* requirements for test level 3, and for impact conditions of 110 km/h and an impact angle of 20 degrees with the 2000P test vehicle, whereas the Standard G4(1S) Guardrail system failed for the same conditions. It is thus concluded that the Modified G4(1S) will contain and safely redirect most light trucks, even at extreme impact conditions. However, under extreme impact conditions, the Modified G4(1S) Guardrail system may not contain the heavier 4-wheel drive light truck subclasses.

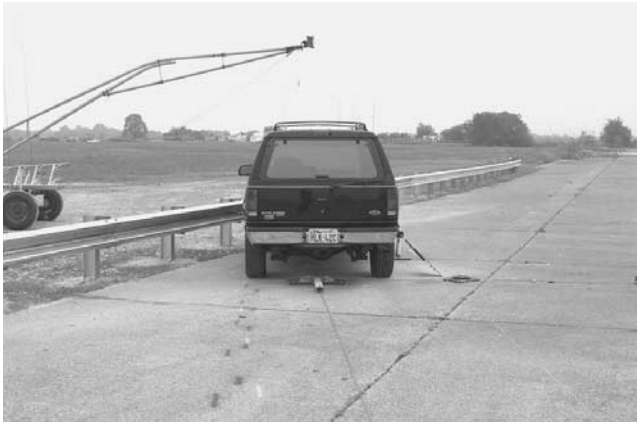
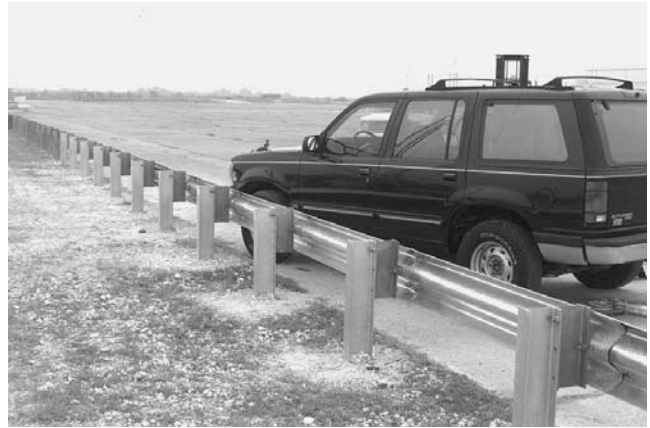
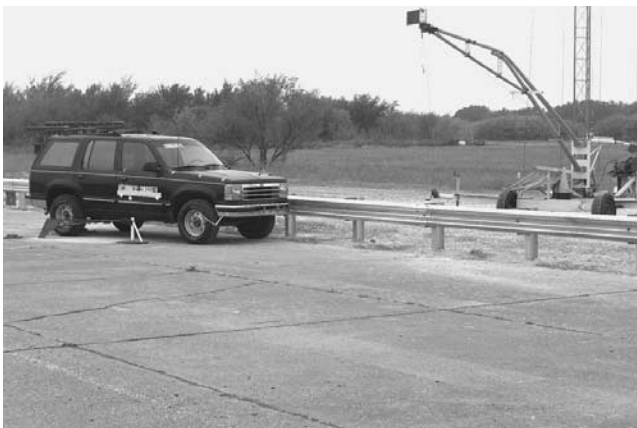
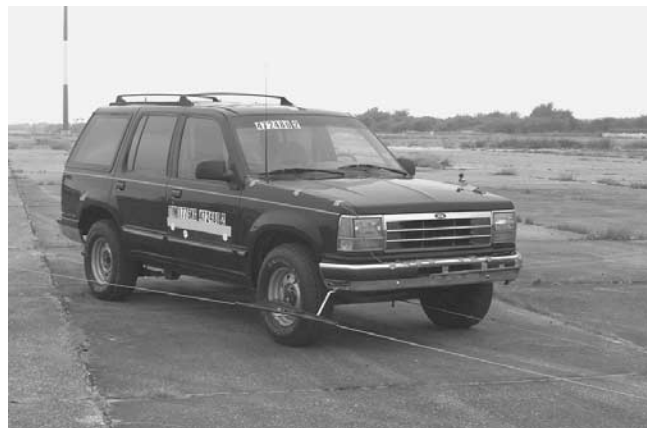
Figure 26. Vehicle/installation geometrics for test 472480-2.

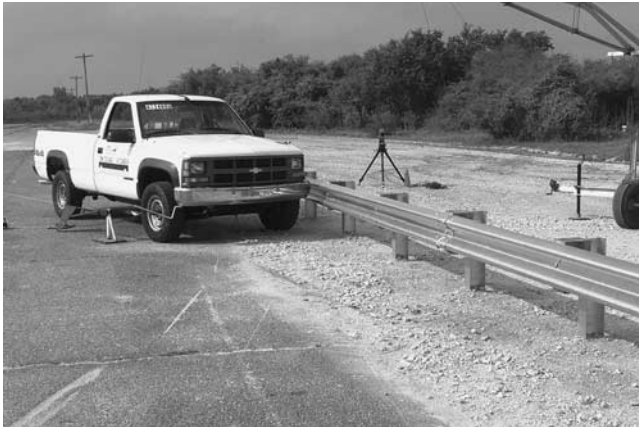
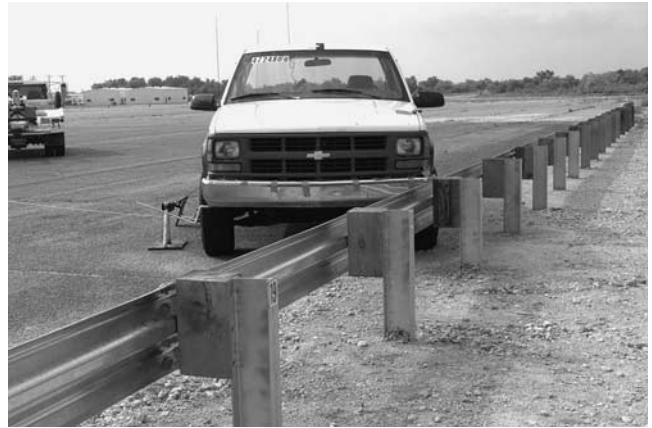
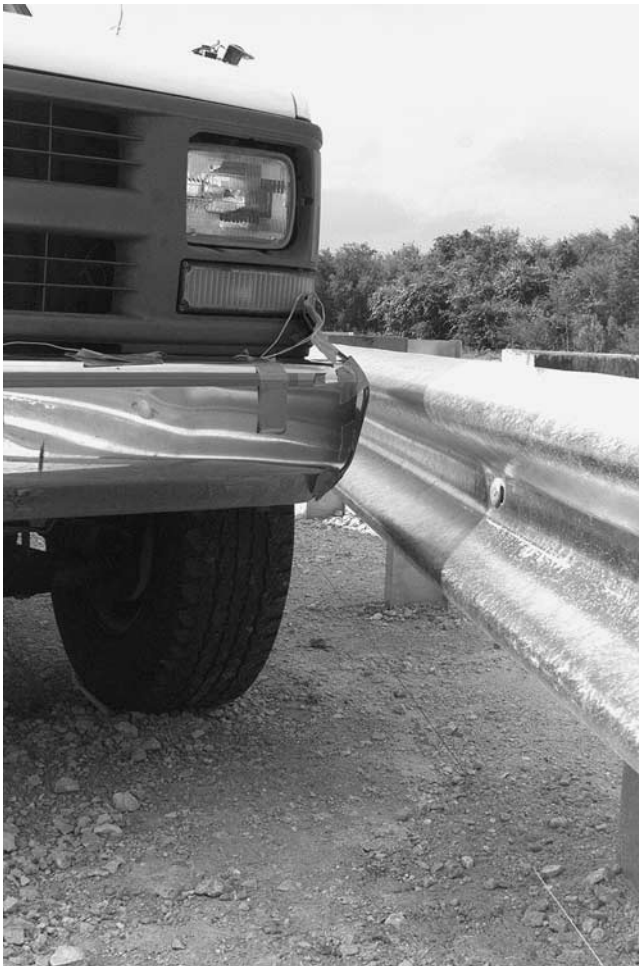
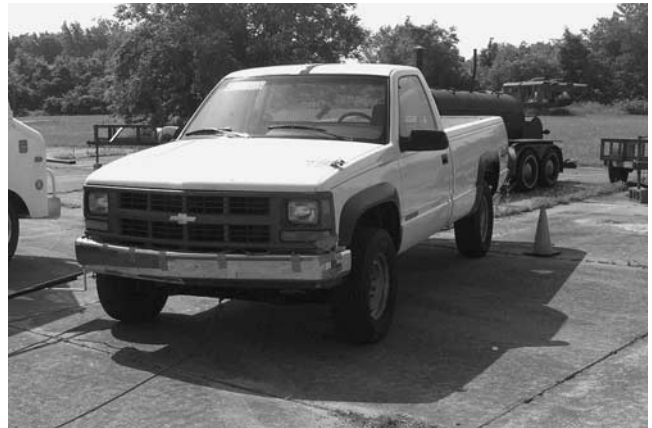
Figure 29. Vehicle/installation geometrics for test 472480-7.

Modified G4(1S)	472480-7	1995 Chevrolet 4x4 2500 Pickup	2300	103.5	19.5	4.8	12.3	Test was a failure. Rail failed and vehicle rode on top of rail.

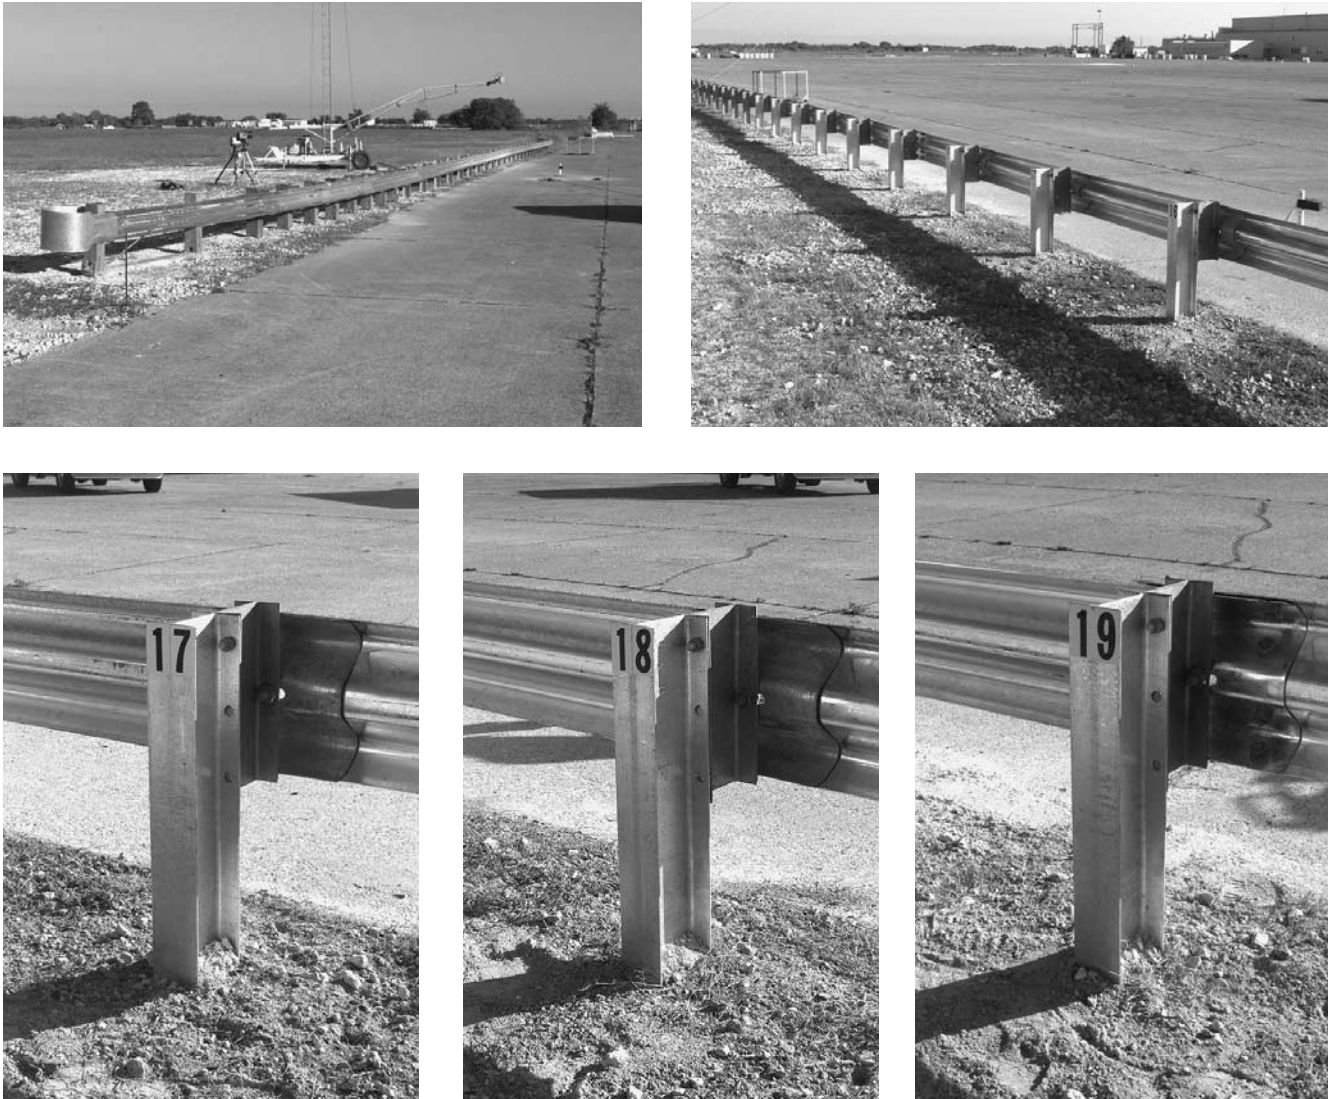
Figure 30. G4(1S) guardrail installation before test 472480-1.

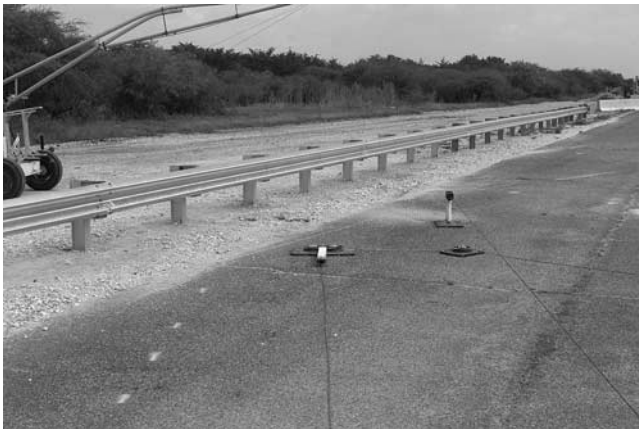
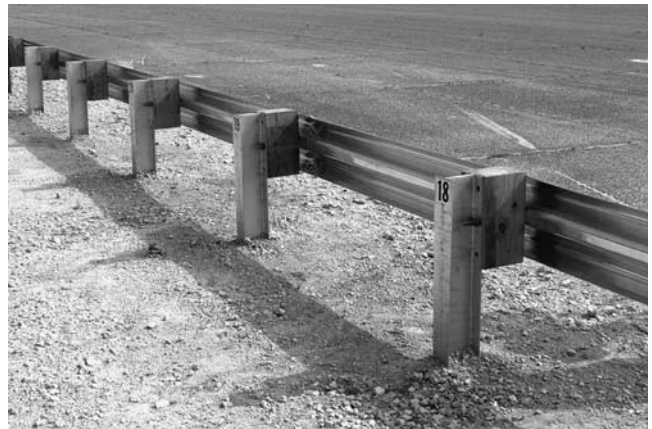
Figure 31. Modified G4(1S) before tests 472480-6 and 472480-7.

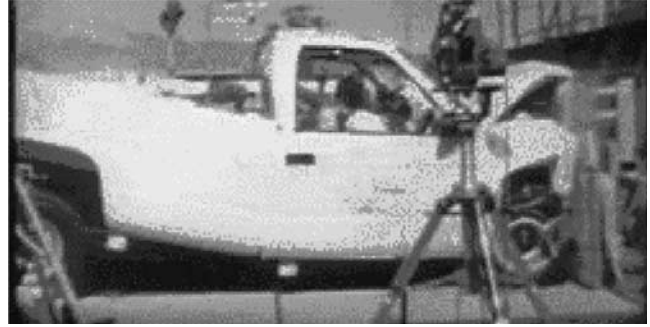
Figure 32. Top view of simulation and test for truck into rigid wall.
