REPORT 537

Recommended Guidelines for Curb and Curb–Barrier Installations

This report presents the findings of a research project to develop guidelines for the use of curbs and curb–guardrail combinations on high-speed roadways. The researchers make recommendations concerning the location of curbs with respect to the guardrail for various operating speeds. The report will be of particular interest to design engineers with responsibility for roadway design.

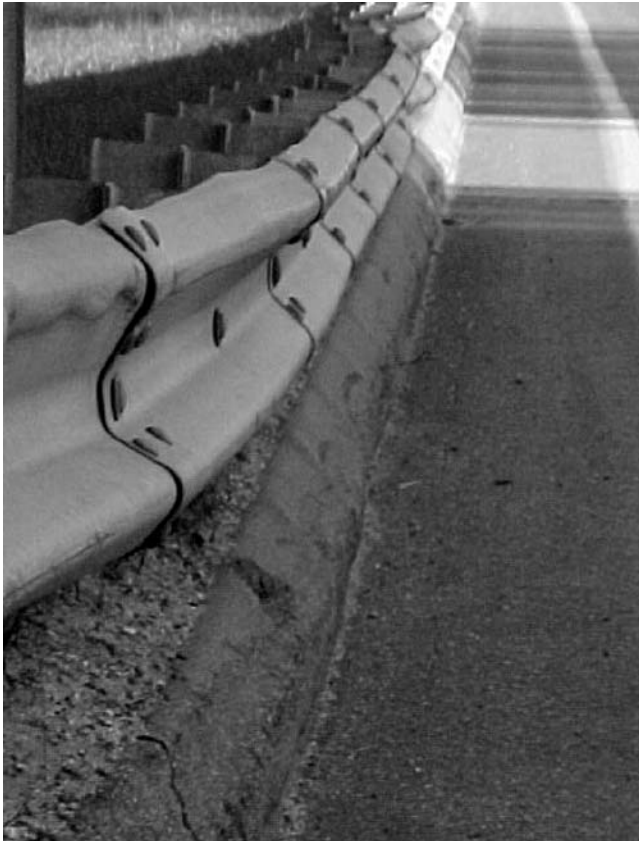
Figure 2. Sloping curb installed flush with a strong-post W-beam guardrail on a 90 km/h two-lane rural roadway in Maine.

Another similar situation occurs on roadways where a guardrail is needed to shield a steep roadside slope. Figure 2 shows a 100-mm high, sloped-face, asphalt curb installed just in front of the posts of a G4(1S) W-beam guardrail. The site is a 90 km/h rural two-lane roadway in Maine. The curb is placed at this site to provide drainage away from the steep sideslope behind the guardrail and thereby prevent erosion. The erosion would likely weaken the edge of the road, erode the soil from around the guardrail posts and cause slope stability problems. The curb is therefore necessary for proper drainage. Likewise, the guardrail is necessary for shielding errant motorists from the steep embankment. In such a situation there are few alternatives but to use a curb and traffic barrier combination.

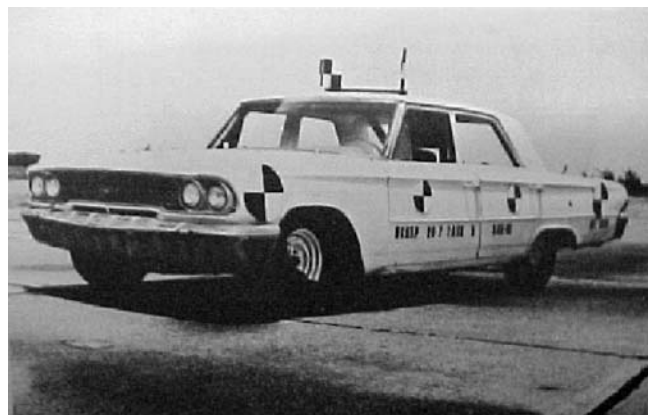
Figure 4. Vehicle used in Olsen et al.'s study (22).

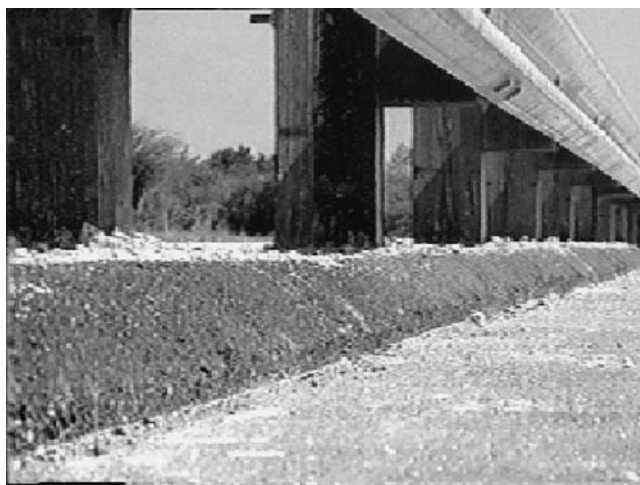
Figure 10. Guardrail-curb installation for TTI test 404201-1.

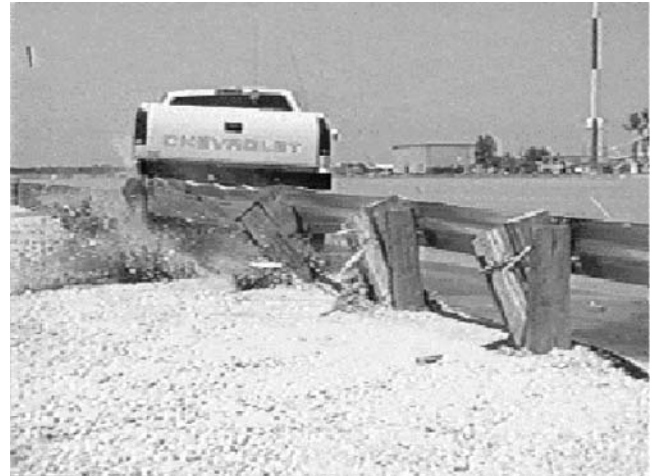
Figure 11. Guardrail damage in TTI Test 404201-1.

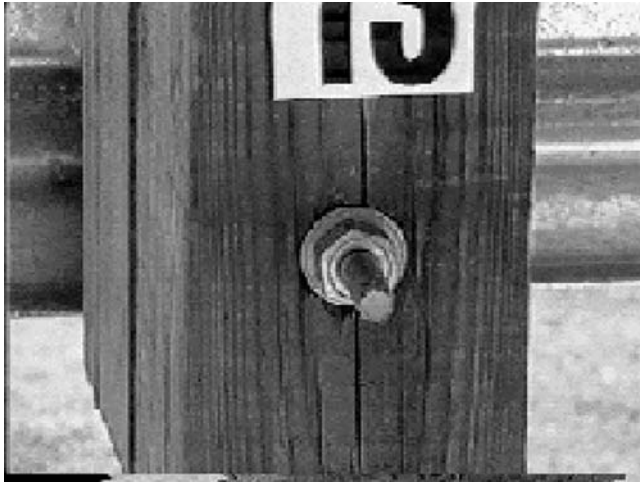
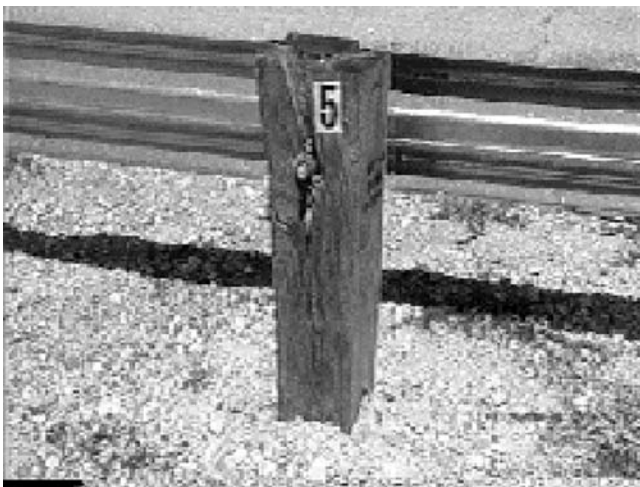
Figure 12. Posts split vertically during TTI Test 404201-1 along preexisting splits in posts.

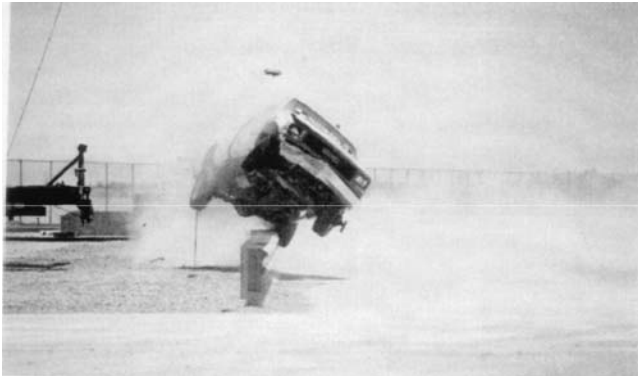
Figure 14. NCHRP Report 350 Test 3-11 impact with modified G4(1S) guardrail with nested 12-gauge W-beams and a 102-mm curb under the rail (32).

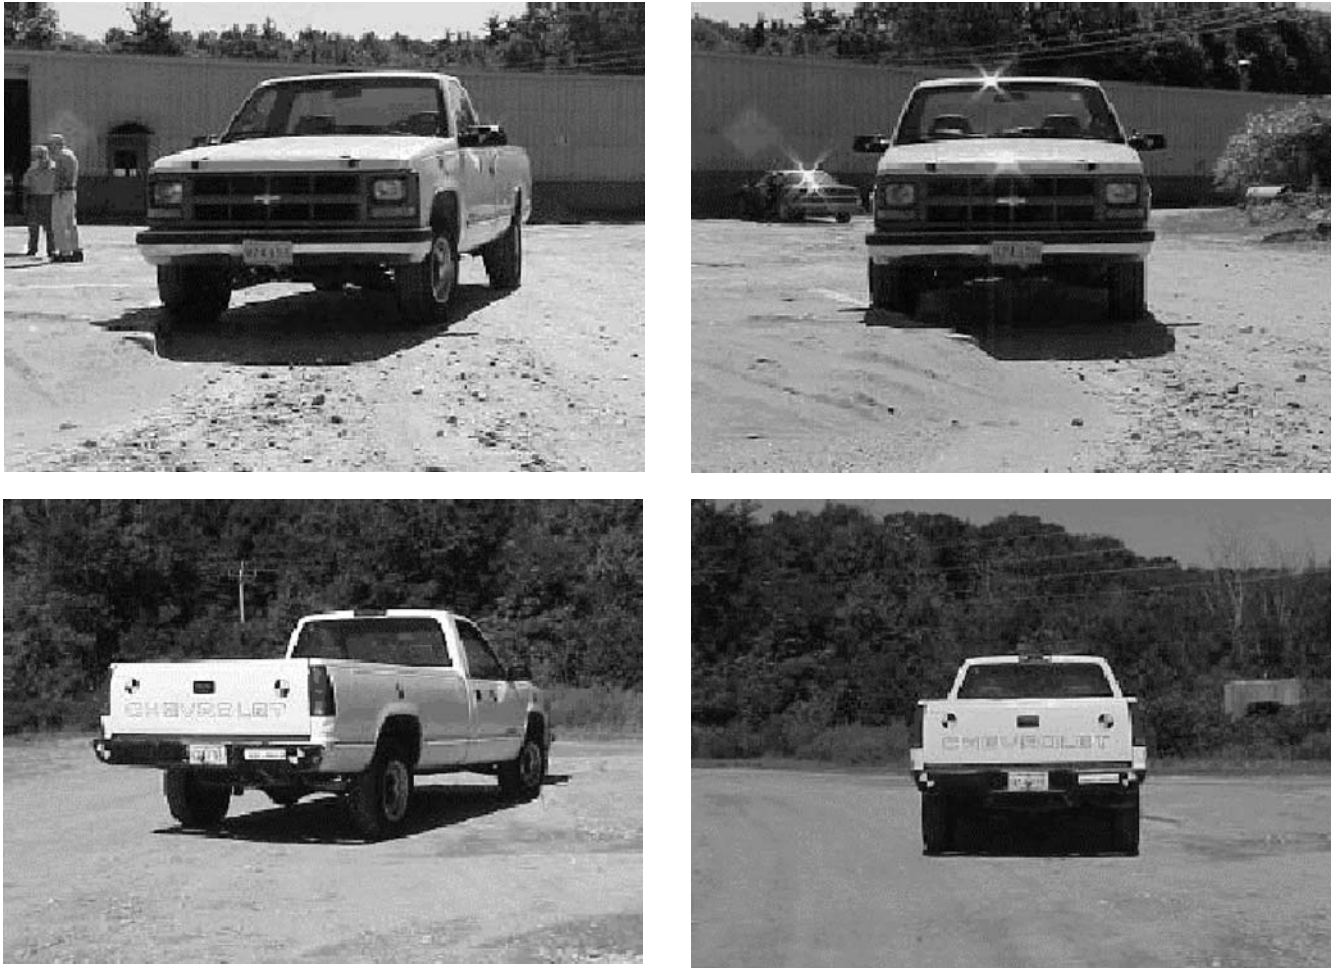
Figure 26. Full-scale curb test setup.

The vehicle path was marked on the ground using plastic strips. The driver aligned the vehicle with the strips to attain the desired approach angle, accelerated the vehicle to the desired speed, and then released the steering wheel just prior to striking the curb. After the rear wheels crossed the curb,

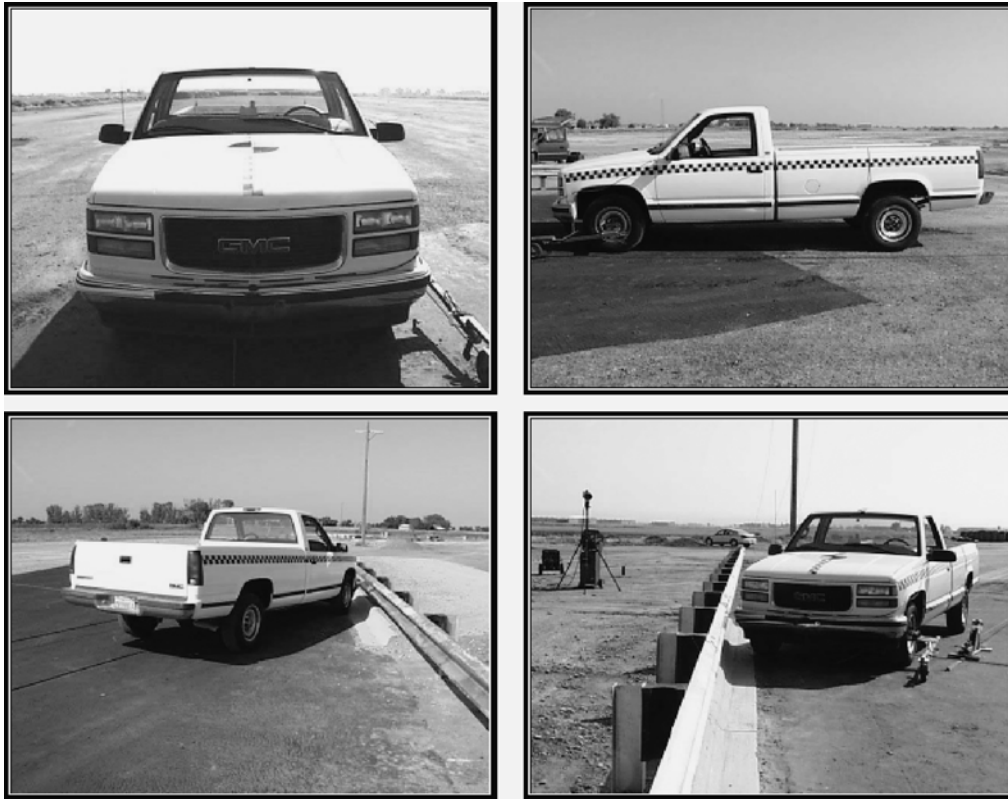
Figure 28. Test vehicle and setup for Type B curb beneath guardrail.

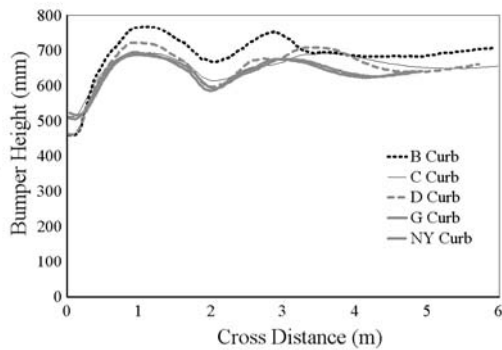
Figure 31a. Bumper height with respect to lateral distance behind curb and curb type for C2500 pickup crossing the curb at an angle of 5 degrees at 70 km/h (top) and 100 km/h (bottom).

Influence of lateral offset. For the 150-mm curbs (i.e., AASHTO types A, B, and D), there was a potential for barrier override if the barrier was positioned within 8 m behind the curb. For the 100-mm curbs (i.e., AASHTO types C and G and the NY curb), the potential for barrier override appeared

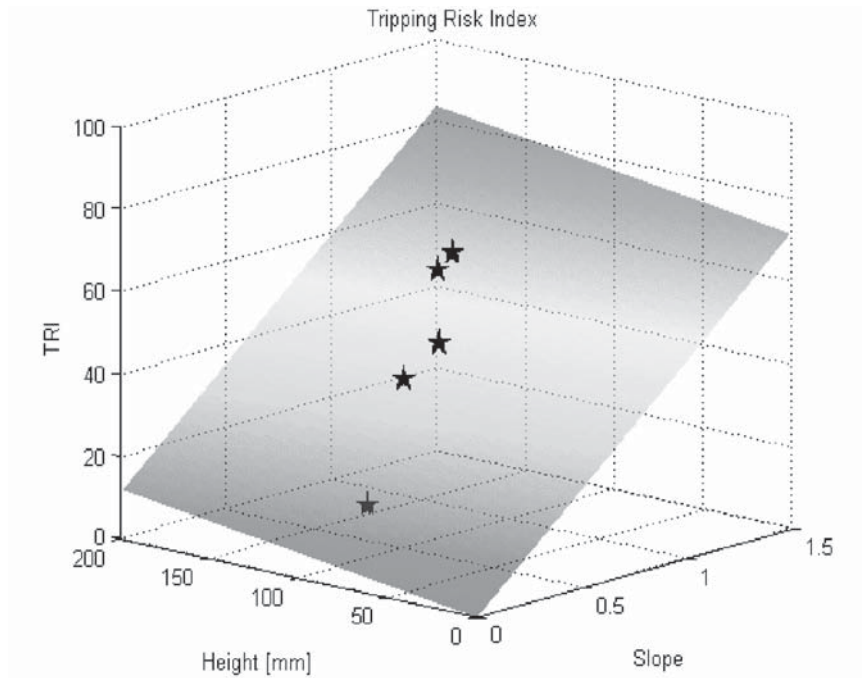
Figure 47. TRI as a linear function of curb height and slope.

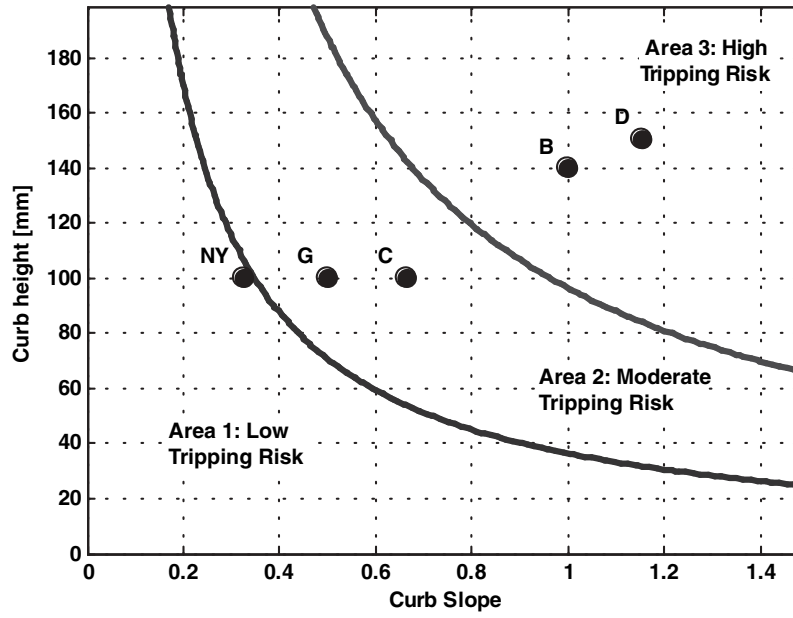
Figure 49. Curb geometric design diagram with respect to the tripping risk in nontracking impacts.
