# **Improving Pedestrian Safety at Unsignalized Crossings**

## **Appendices B to O**

**Transit Cooperative Research Program  
National Cooperative Highway Research Program**

**March 2006**

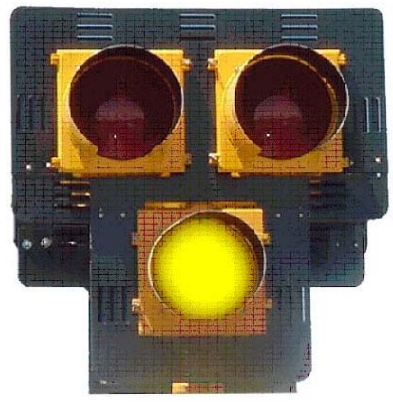
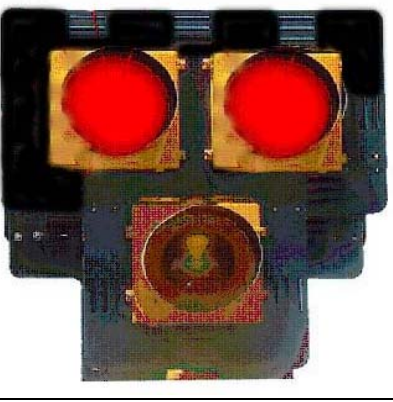
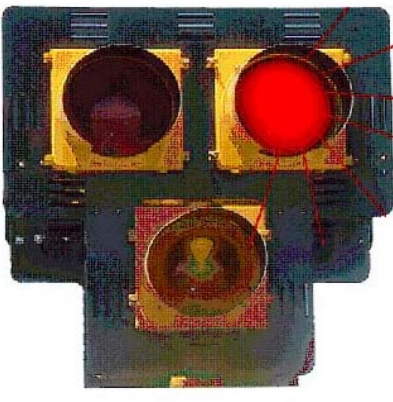
Figure B-5. Proposed MUTCD Figure 4M-1. Example of Sequence for a Pedestrian Beacon.

| <u>Dark Until Activated</u> | <u>Flashing Yellow for 3 to 6 sec</u> | <u>Steady Yellow for 3 to 6 sec</u> |
| <u>Steady Red during Pedestrian Walk Interval</u> | <u>Alternating Flashing Red During Pedestrian Clearance Interval</u> | |

**Upon actuation by a pedestrian, a pedestrian beacon shall display a flashing CIRCULAR YELLOW signal indication, followed by a steady CIRCULAR YELLOW signal indication, followed by both steady CIRCULAR RED signal indications during the pedestrian walk interval, followed by alternating flashing CIRCULAR RED signal indications during the pedestrian clearance interval (see Figure 4M-1). Upon termination of the pedestrian clearance interval, the pedestrian beacon shall revert to a non-illuminated condition.**

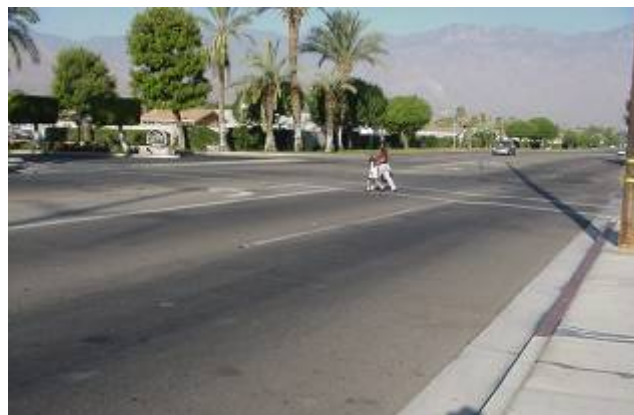
Providing marked crosswalks using two white 1-inch (2.54 cm) lines and the warning signs prescribed by various manuals as shown in Figure D-1 were found to result in higher pedestrian collisions compared to not providing marked crosswalks on multilane roads with more than one lane in each direction with average daily volumes of 10,000 vehicles per day by the FHWA study on marked crosswalks at uncontrolled locations (31). On roads with one lane in each direction and average daily volumes of less than 10,000 vehicles per day, the FHWA study found no difference in collisions involving pedestrians at marked and unmarked crosswalks at uncontrolled intersections. To respond to this finding, some agencies removed marked crosswalks on higher volume multilane facilities. Other agencies addressed this issue by experimenting with alternative treatments to improve the safety of pedestrian crossings.

*Figure D-1. Pedestrian Crossing Using Traditional Treatments.  
(Source: Nazir Lalani, Ventura, California, U.S.A.)*

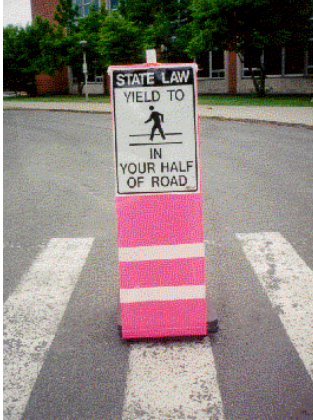
| Treatment Type | Picture of Treatment |
|---|---|
| <p><b>Roadway Signing</b></p> <p>Description – Special signs are placed in the roadway within or near the crosswalk.</p> <ul style="list-style-type: none"> <li>• Application – Crossing on higher volume multilane roads</li> <li>• Cost (Including Labor) in U.S. Dollars – \$200–\$300 per sign</li> <li>• Studies of Effectiveness – Field Evaluation Report (45), <i>Pedestrian Facilities Guidebook</i> (46)</li> <li>• Countries Where Treatment is Used – U.S.A., France, Sweden</li> </ul> | <p><b>New York, U.S.A.</b></p> |

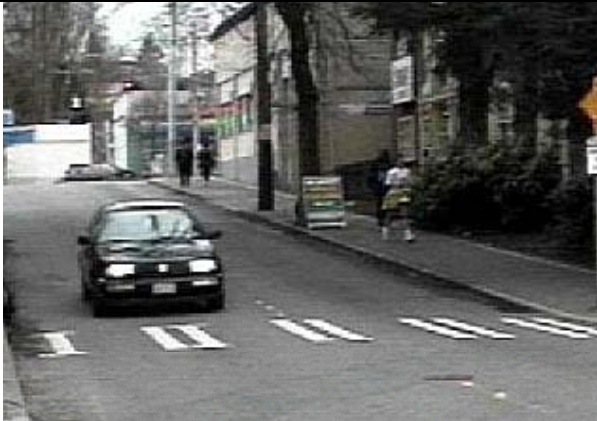
| Treatment Type | Picture of Treatment |
|---|---|
| <p><b>High-Visibility Markings</b></p> <p>Description – This method uses ladder- or “zebra”-style crosswalk pavement markings.</p> <ul style="list-style-type: none"> <li>• Application – Crossings on higher-volume multilane roads</li> <li>• Cost (Including Labor) in U.S. Dollars – \$500-\$1,000 per crossing</li> <li>• Studies of Effectiveness – See section 6.2 of ITE Informational Report (44)</li> <li>• Countries Where Treatment is Used – U.S.A., Europe, Australia, New Zealand</li> </ul> | <p><b>Puget Sound Area, Washington, U.S.A.</b></p> |

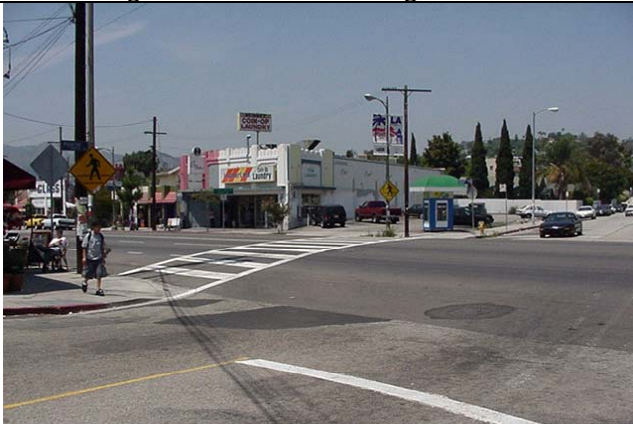
| Treatment Type | Picture of Treatment |
|---|---|
| <p><b>Double-Posted Pedestrian Crossing Signs</b></p> <p>Description – Standard pedestrian crossing signs are installed on both sides of the approaching roadway at an uncontrolled crosswalk in addition to the near-side pedestrian warning signs posted at and in advance of the crosswalk.</p> <ul style="list-style-type: none"> <li>• Application – Uncontrolled marked crosswalk</li> <li>• Cost (Including Labor) in U.S. Dollars – \$200 per sign</li> <li>• Studies of Effectiveness – None found</li> <li>• Countries Where Treatment is Used – U.S.A., Canada</li> </ul> | <p><b>Near Downtown Los Angeles, California, U.S.A.</b></p> |

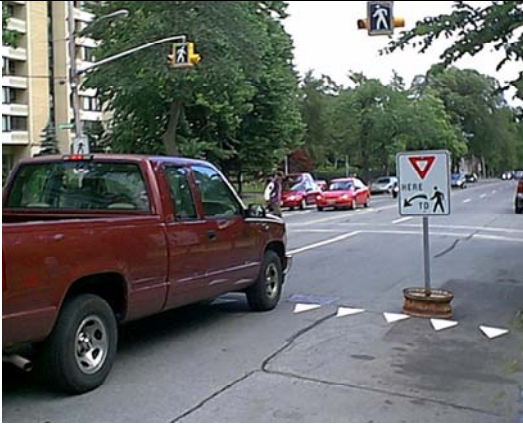
| Treatment Type | Picture of Treatment |
|---|---|
| <p><b>Advance Placement of Limit Lines</b></p> <p>Description – Standard white Stop or Yield limit lines are placed typically 20 ft (6 m) in advance of marked, uncontrolled crosswalks.</p> <ul style="list-style-type: none"> <li>• Application – Crossings on higher volume multilane roads</li> <li>• Cost (Including Labor) in U.S. Dollars – \$300-\$500 per limit line</li> <li>• Studies of Effectiveness – Van Houten and others (27, 47), Innovative Traffic Control Technology (48)</li> <li>• Countries Where Treatment is Used – U.S.A., Canada</li> </ul> | <p>A photograph showing a red pickup truck stopped at a crosswalk. A white yield sign is visible on the right side of the road. White limit lines are painted on the pavement in advance of the crosswalk. The scene is in an urban area with trees and buildings in the background.</p> <p><b>Canada</b></p> |

Advance yield/stop lines and signs have been found to be most effective on multilane streets where “multiple-threat” crashes are most likely to occur. The principle behind the advance yield/stop line is that vehicles yielding 49 ft (15 m) back from the crosswalk are less likely to screen views of the crossing pedestrian from motorists in other lanes. Additionally, motorists may be less likely to pass yielding vehicles in the next lane of travel.

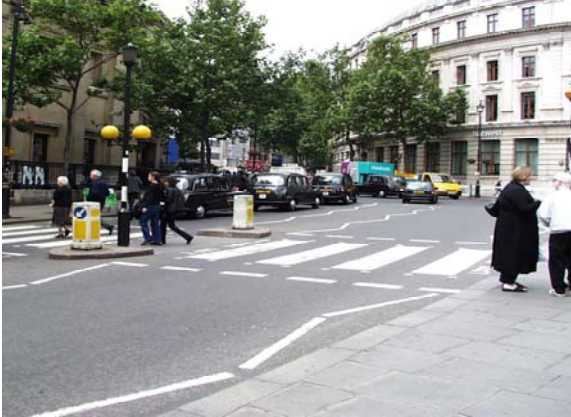
| Treatment Type | Picture of Treatment |
|---|---|
| <p><b>Zigzag and Other Approach Restrictions</b></p> <p>Description – “zigzag” markings are placed in advance of marked crosswalks. The standard pattern is four sets of markings on each approach. One set comprises two strokes (zig and zag), each approximately 6.6 ft (2 m) long.</p> <ul style="list-style-type: none"> <li>• Application – All marked crossings</li> <li>• Cost (Including Labor) in U.S. Dollars – \$1,000-\$2,000 per crossing; four sets of markings</li> <li>• Studies of Effectiveness – <i>The Highway Code</i> (49)</li> <li>• Countries Where Treatment is Used – U.K., Eire</li> </ul> | <p>A photograph of a street crossing in London, England, U.K. The pavement features white zigzag markings leading up to a crosswalk. Pedestrians are crossing the street, and cars are visible in the background.</p> <p><b>London, England, U.K.</b></p> |

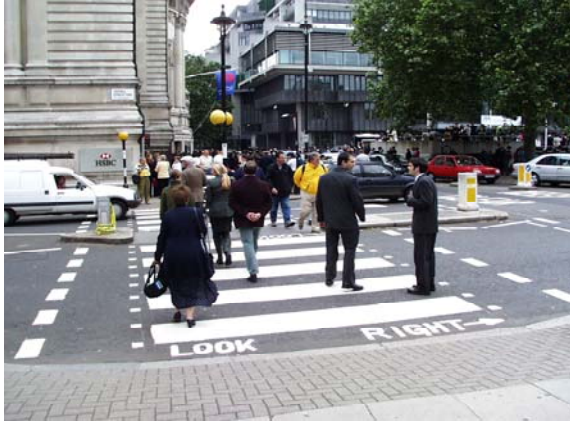
| Treatment Type | Picture of Treatment |
|---|---|
| <p><b>Pavement Legends</b></p> <p>Description – Word legends are placed on the pavement at each end of the crosswalk to be legible to pedestrians as they are waiting to cross.</p> <ul style="list-style-type: none"> <li>• Application – Marked crosswalks with high turning volumes</li> <li>• Cost (Including Labor) in U.S. Dollars – \$500 per crosswalk</li> <li>• Studies of Effectiveness – Habib (50)</li> <li>• Countries Where Treatment is Used – U.K., U.S.A.</li> </ul> | <p>A photograph of a street crossing in London, England, U.K. The pavement features the words "LOOK" and "RIGHT" painted on it, along with a white crosswalk. Pedestrians are crossing the street, and cars are visible in the background.</p> <p><b>London, England, U.K.</b></p> |

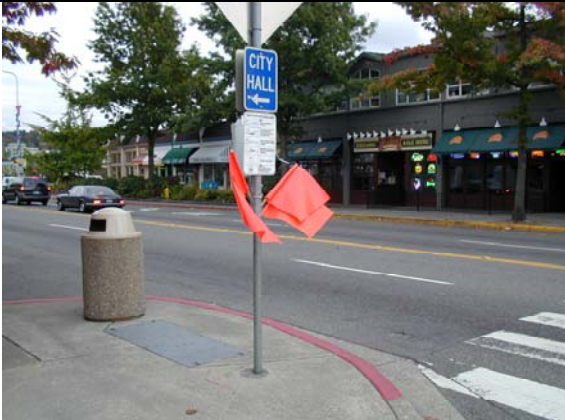
| Treatment Type | Picture of Treatment |
|---|---|
| <p><b>Flags</b></p> <p>Description – Pedestrians select a flag from those posted on each side of the crosswalk, flag traffic to let drivers know they wish to cross, then return the flag to the holder on the opposite side of the street after crossing.</p> <ul style="list-style-type: none"> <li>• Application – Crossings on higher volume multilane roads</li> <li>• Cost (Including Labor) in U.S. Dollars – \$100 including holding racks per crossing</li> <li>• Studies of Effectiveness – None found</li> <li>• Countries Where Treatment is Used – U.S.A.</li> </ul> | <p><b>Kirkland, Washington, U.S.A.</b></p> |

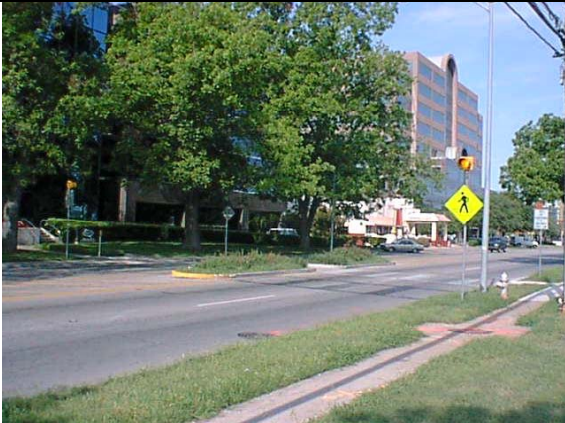
| Treatment Type | Picture of Treatment |
|---|---|
| <p><b>Fluorescent Yellow Green Signs</b></p> <p>Description – Pedestrian signs made of the FHWA-approved fluorescent yellow-green color are posted at crossings.</p> <ul style="list-style-type: none"> <li>• Application – Pedestrian and bicycle crossings including schools</li> <li>• Cost (Including Labor) in U.S. Dollars – \$200-\$300 per sign</li> <li>• Studies of Effectiveness – Kittle (51)</li> <li>• Countries Where Treatment is Used – U.S.A.</li> </ul> | <p><b>Austin, Texas, U.S.A.</b></p> |

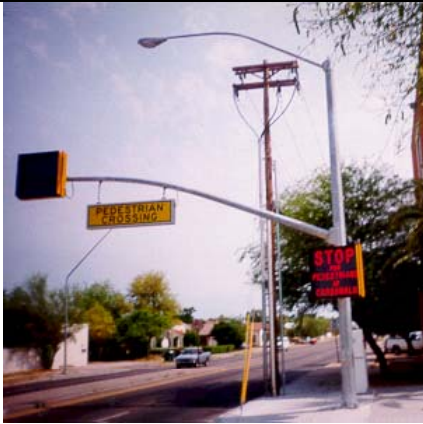
| Treatment Type | Picture of Treatment |
|---|---|
| <p><b>Overhead Signs</b></p> <p>Description – Warning signs are installed using span wire or mast arms.</p> <ul style="list-style-type: none"> <li>• Application – Crossings on higher volume multilane roads</li> <li>• Cost (Including Labor) in U.S. Dollars – \$15,000-\$25,000 per overhead sign</li> <li>• Studies of Effectiveness – None found</li> <li>• Countries Where Treatment is Used – U.S.A., Canada</li> </ul> | <p><b>Tucson, Arizona, U.S.A.</b></p> |

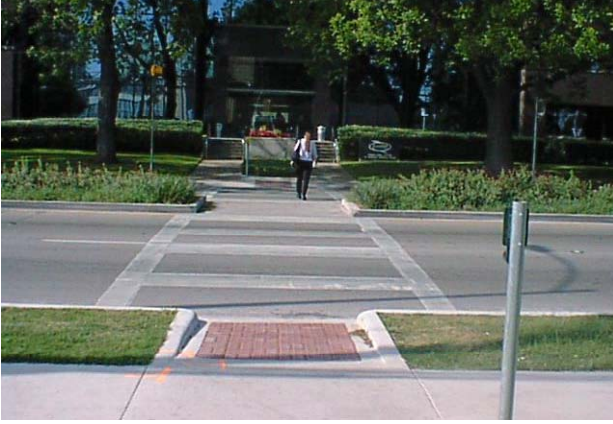
| Treatment Type | Picture of Treatment |
|---|---|
| <p><b>Refuge Islands</b></p> <p>Description – Raised islands with minimum dimension of 4-6 ft (1.2-1.8 m) wide and 8-12 ft (2.4-3.6 m) long are placed in the center of the roadway, separating opposing lanes of traffic and slotted along the pedestrian path.</p> <ul style="list-style-type: none"> <li>• Application – Marked and unmarked crossings</li> <li>• Cost (Including Labor) in U.S. Dollars – \$20,000-\$40,000 per island</li> <li>• Studies of Effectiveness – Lalani (52)</li> <li>• Countries Where Treatment is Used – U.S.A., Europe, Australia, Canada, New Zealand</li> </ul> | <p><b>Austin, Texas, U.S.A.</b></p> |

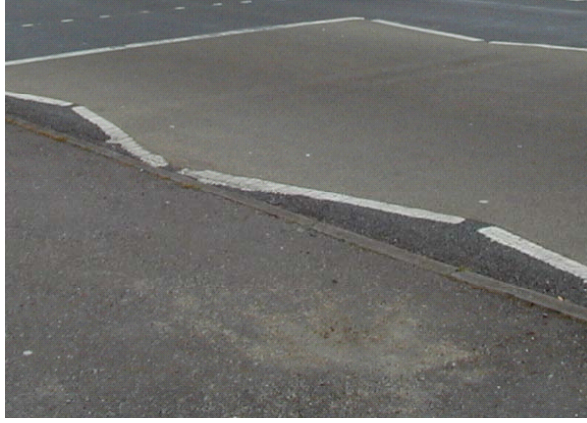
| Treatment Type | Picture of Treatment |
|---|---|
| <p><b>Anti -Skid Surfacing</b></p> <p>Description – Application to pavements of a unique surface treatment improves skid resistance during wet weather.</p> <ul style="list-style-type: none"> <li>• Application – Any pedestrian crossing</li> <li>• Cost (Including Labor) in U.S. Dollars – \$2,000-\$4,000 for two approaches</li> <li>• Studies of Effectiveness – London Research Centre (53)</li> <li>• Countries Where Treatment is Used –Europe</li> </ul> | <p><b>United Kingdom</b></p> |

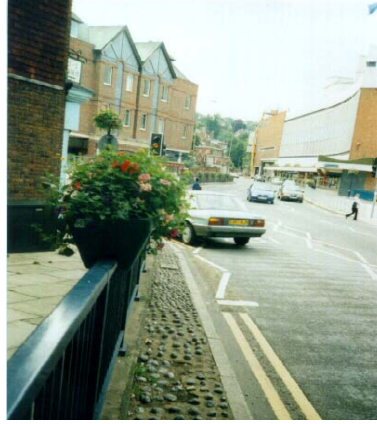
| Treatment Type | Picture of Treatment |
|---|---|
| <p><b>Pedestrian Railing</b></p> <p>Description – Railings are placed along the top of the curb; typically they must be 4 ft (1.2 m) high to be effective.</p> <ul style="list-style-type: none"> <li>• Application – Any pedestrian crossing</li> <li>• Cost (Including Labor) in U.S. Dollars – \$100 per linear meter</li> <li>• Studies of Effectiveness – Lalani (54)</li> <li>• Countries Where Treatment is Used – Europe, Australia</li> </ul> | <p><b>United Kingdom</b></p> |

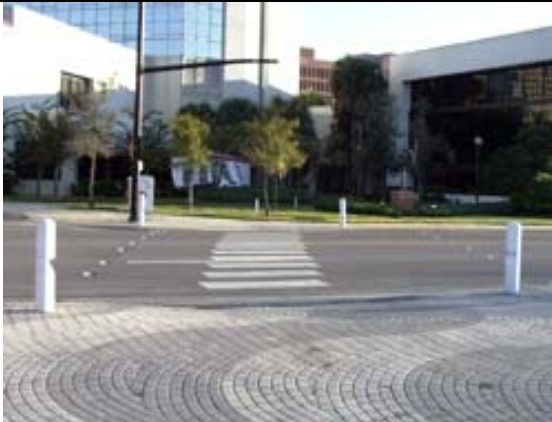
| Treatment Type | Picture of Treatment |
|---|---|
| <p><b>In-Pavement Raised Markers</b></p> <p>Description – Both sides of a crosswalk are lined with durable encased raised pavement markers, typically containing amber LED strobe lighting activated either by push buttons or by automatic detection bollards using infrared sensors.</p> <ul style="list-style-type: none"> <li>• Application – Some agencies have guidelines, see ITE Report (44)</li> <li>• Cost (Including Labor) in U.S. Dollars – \$15,000-\$40,000 per crossing</li> <li>• Studies of Effectiveness – Huang et al. (55), In-Pavement (56), Godfrey and Mazzella (57)</li> <li>• Countries Where Treatment is Used – U.S.A.</li> </ul> | <p><b>Orlando, Florida, U.S.A.</b></p> |

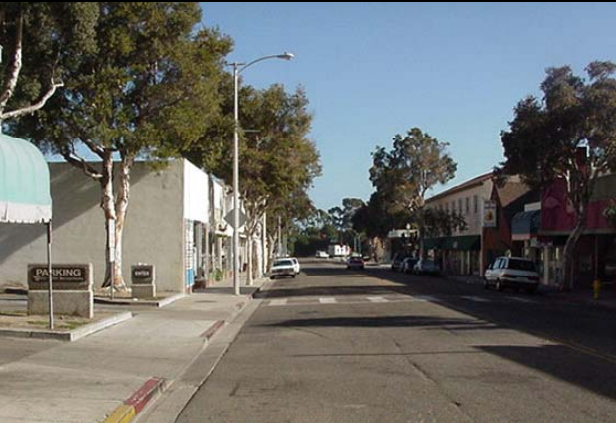
| Treatment Type | Picture of Treatment |
|---|---|
| <p><b>Street Lighting</b></p> <p>Description – Lights are installed, generally 150-watt bulbs at 100 ft (30 m) spacing, 10 to 11.5 ft (3 to 3.5 m) high, on both sides of the street.</p> <ul style="list-style-type: none"> <li>• Application – Crossings with high nighttime activity</li> <li>• Cost (Including Labor) in U.S. Dollars – \$2,000-\$3,000 per light</li> <li>• Studies of Effectiveness – Lalani (58)</li> <li>• Countries Where Treatment is Used – All Developed Countries</li> </ul> | <p><b>Ventura, California, U.S.A.</b></p> |

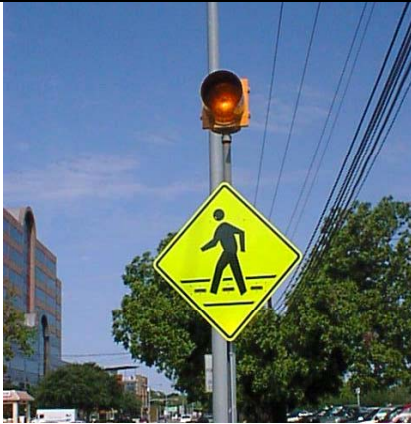
| Treatment Type | Picture of Treatment |
|---|---|
| <p><b>Flashing Beacons</b></p> <p>Description – Flashing amber lights are installed on overhead signs, signs in advance of the crosswalk, or signs located at the entrance to the crosswalk on pedestal poles.</p> <ul style="list-style-type: none"> <li>• Application – Marked uncontrolled crossings</li> <li>• Cost (Including Labor) in U.S. Dollars – \$10,000-\$40,000 per crossing depending on placement</li> <li>• Studies of Effectiveness – Van Houten and Malenfant (59)</li> <li>• Countries Where Treatment is Used – U.K., U.S.A., Australia, Canada, and New Zealand</li> </ul> | <p><b>Austin, Texas, U.S.A.</b></p> |

Sparks and Cynecki report on the use of flashing beacons for warning of pedestrian crosswalks in Phoenix, Arizona (17). The city evaluated the application of advance warning flashing beacons at four pedestrian crossing locations. The authors describe the use of several experiments in their evaluation, including before-and-after speed and crash data collection as well as treatment-and-control experiments for traffic speeds. The authors found that the advance warning flashing beacons did not decrease speeds or crashes, and in some cases the traffic speeds or crashes increased after installation of the flashing beacons. These findings led the authors to conclude “that flashers offer no benefit for intermittent pedestrian crossings in an urban environment. In addition, the longer the flashers operate the more it becomes part of the scenery and loses any effectiveness.” The authors do concede that actuated warning flashers may be beneficial in a high-speed rural environment with unusual geometrics, high pedestrian crossings, and unfamiliar drivers. However, these conditions were not tested in their study.

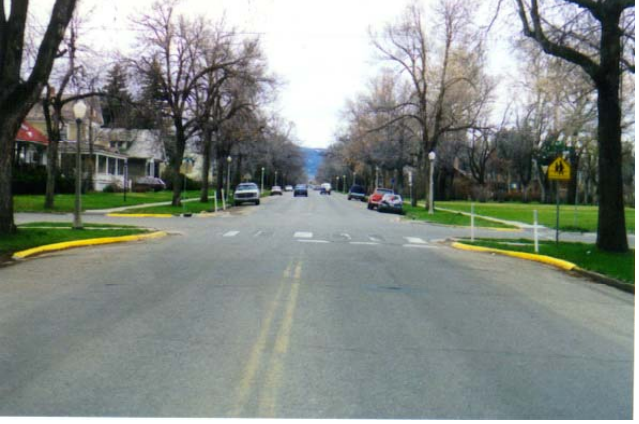
| Treatment Type | Picture of Treatment |
|---|---|
| <p><b>Curb Extensions</b></p> <p>The sidewalk extends across the parking lanes to the edge of the travel lanes to narrow the distance of the road that a pedestrian has to cross.</p> <ul style="list-style-type: none"> <li>• Application – Any crossing</li> <li>• Cost (Including Labor) in U.S. Dollars – \$5,000-\$25,000 depending on materials used</li> <li>• Studies of Effectiveness – Ewing (60) and <i>Canadian Guide</i> (61)</li> <li>• Countries Where Treatment is Used – U.S.A., U.K., Eire, Australia, Canada</li> </ul> | <p><b>Bozeman, Montana, U.S.A.</b></p> |

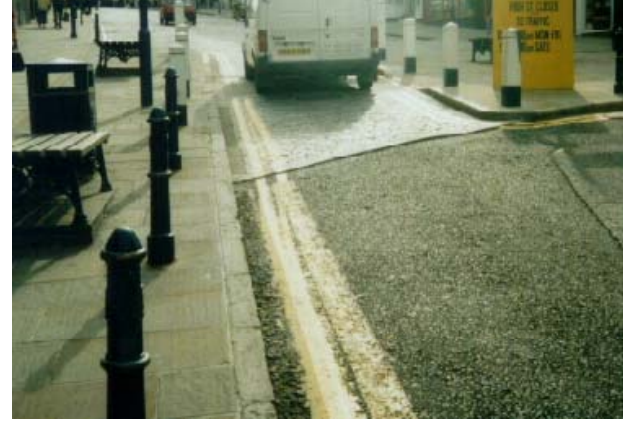
| Treatment Type | Picture of Treatment |
|---|---|
| <p><b>Lane Reductions</b></p> <p>Description – The number of travel lanes are reduced by the number of travel lanes by widening the sidewalks, adding bike and parking lanes, converting parallel parking to angled or perpendicular parking, or converting one-way streets to two-way with a center median.</p> <ul style="list-style-type: none"> <li>• Application – Segments of roadway</li> <li>• Cost (Including Labor) in U.S. Dollars – \$50,000-\$5,000,000 depending on length of project</li> <li>• Studies of Effectiveness – None found</li> <li>• Countries Where Treatment is Used – U.S.A., Canada [Example shown is U.K.]</li> </ul> | <p><b>United Kingdom</b></p> |

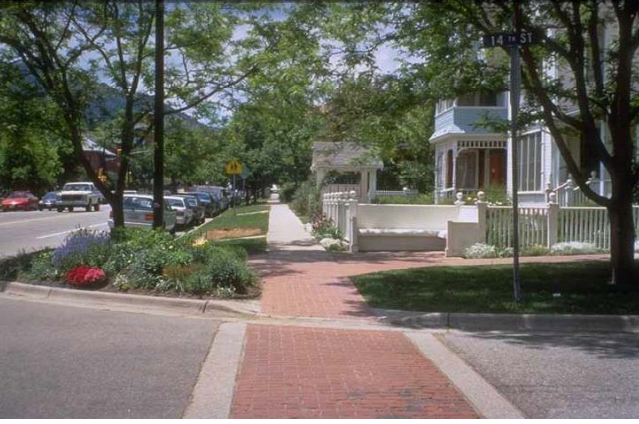
| Treatment Type | Picture of Treatment |
|---|---|
| <p><b>Textured Surfaces</b></p> <p>Description – Crosswalks are constructed with stamped concrete or asphalt, as well as brick pavers laid in a pattern.</p> <ul style="list-style-type: none"> <li>• Application – Any crossing</li> <li>• Cost (Including Labor) in U.S. Dollars – \$10,000-\$35,000 per crossing</li> <li>• Studies of Effectiveness – Ewing (60) and <i>Canadian Guide</i> (61)</li> <li>• Countries Where Treatment is Used – U.S.A., Europe, Canada</li> </ul> | <p><b>Boulder, Colorado, U.S.A.</b></p> |

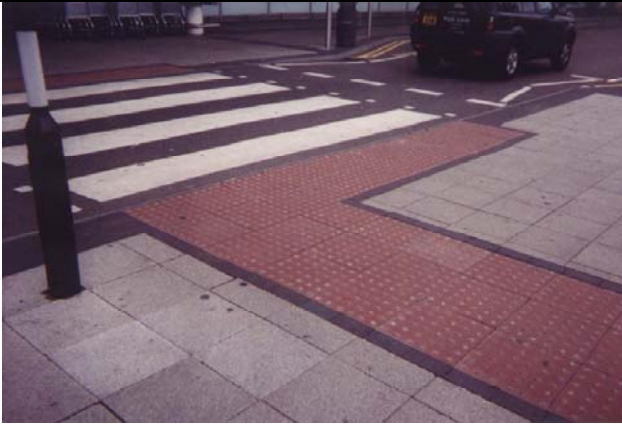
| Treatment Type | Picture of Treatment |
|---|---|
| <p><b>Tactile Ground Surface Indicators</b></p> <p>Description – Various patterned, tactile ground, or floor surfaces provide directional and hazard warning information to pedestrians who are blind or visually impaired.</p> <ul style="list-style-type: none"> <li>• Application – Any crossing used by the visually impaired</li> <li>• Cost (Including Labor) in U.S. Dollars – \$50-\$200 per square meter</li> <li>• Studies of Effectiveness – Tactile (62), Guidance (63), Savil et al. (64, 65), Japanese (66), Sawai et al. (67)</li> <li>• Countries Where Treatment is Used U.S.A., Europe/U.K., Australia, Canada</li> </ul> | <p><b>United Kingdom</b></p> |

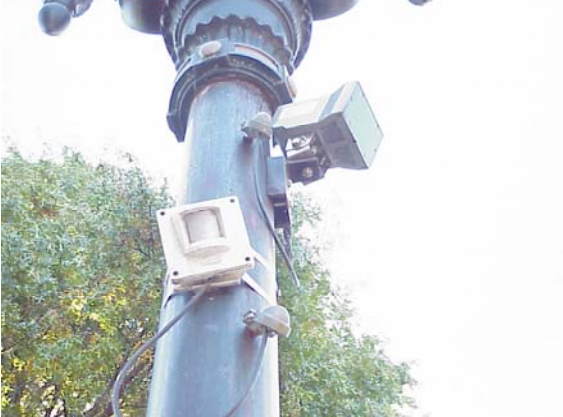
| Treatment Type | Picture of Treatment |
|---|---|
| <p><b>Automated Detection</b></p> <p>Description – Uncontrolled crosswalks are fitted with automated detection devices that activate flashing beacons, in-pavement raised markers with LED strobe lights, or other active warnings to alert drivers when pedestrians are present</p> <ul style="list-style-type: none"> <li>• Application – Any crossing with active devices</li> <li>• Cost (Including Labor) in U.S. Dollars – \$500-\$1,000 for microwave and infrared, \$15,000-\$20,000 for video cameras</li> <li>• Studies of Effectiveness – Huang et al. (55)</li> <li>• Countries Where Treatment is Used – U.S.A., Europe, Canada, Australia</li> </ul> | <p><b>Portland, Oregon, U.S.A.</b></p> |

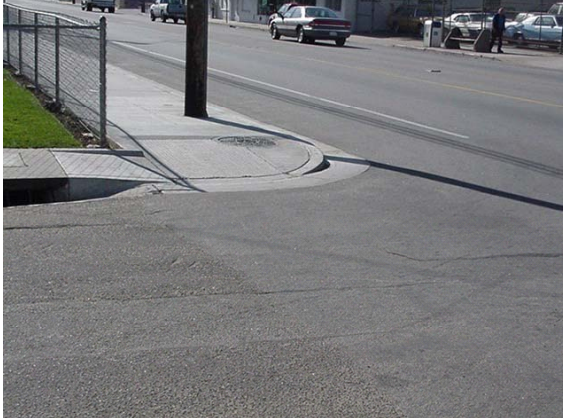
| Treatment Type | Picture of Treatment |
|---|---|
| <p><b>Reduced Curb Radii</b></p> <p>Description – Corner curbs have shorter radii to narrow the distance of the road that a pedestrian has to cross.</p> <ul style="list-style-type: none"> <li>• Application – Crossings with minimal truck turns</li> <li>• Cost (Including Labor) in U.S. Dollars – \$5,000-\$10,000 per corner</li> <li>• Studies of Effectiveness – Ewing (60) and <i>Canadian Guide</i> (61)</li> <li>• Countries Where Treatment is Used – U.S.A., Europe, Canada, Australia, and most developed countries</li> </ul> | <p><b>Ventura, California, U.S.A.</b></p> |

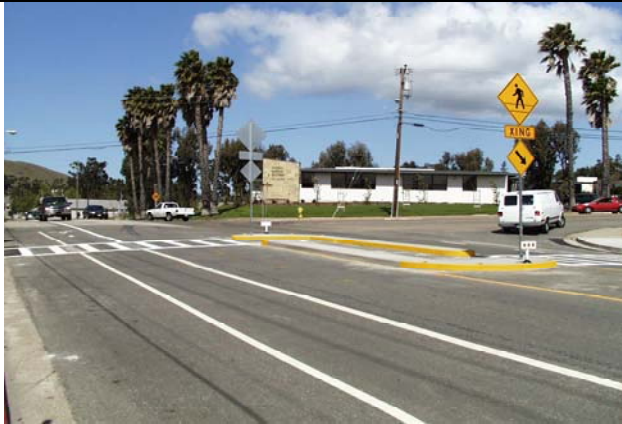
| Treatment Type | Picture of Treatment |
|---|---|
| <p><b>Staggered Pedestrian Refuge Islands</b></p> <p>Description – Raised islands laid out in a staggered configuration at uncontrolled intersections require pedestrians to walk toward traffic to reach the second half of the crosswalk.</p> <ul style="list-style-type: none"> <li>• Application – Across multilane roads</li> <li>• Cost (Including Labor) in U.S. Dollars – \$25,000-\$75,000</li> <li>• Studies of Effectiveness – Bacquie et al. (42)</li> <li>• Countries Where Treatment is Used – U.S.A., Europe</li> </ul> | <p><b>San Luis Obispo, California, U.S.A.</b></p> |

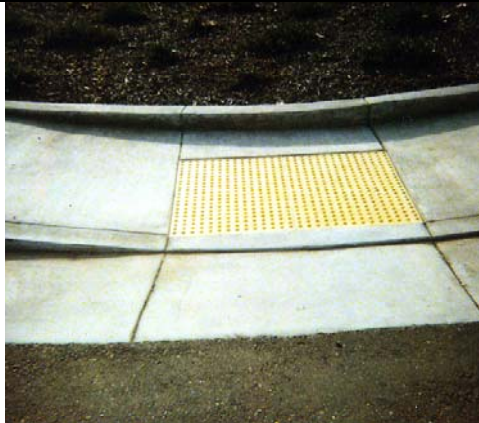
| Treatment Type | Picture of Treatment |
|---|---|
| <p><b>Detectable Warnings</b></p> <p>Description – A standardized surface feature composed of raised truncated domes that informs pedestrians who are visually impaired of the hazards immediately ahead.</p> <ul style="list-style-type: none"> <li>• Application – Ramps and curbs adjacent to crossings</li> <li>• Cost (Including Labor) in U.S. Dollars – \$200-\$2000 per ramp or curb depending on total area</li> <li>• Studies of Effectiveness – Bentzen and others (68, 69, 71, 72), Hauger et al. (69), Hughes (70)</li> <li>• Countries Where Treatment is Used – Europe, U.S.A., Australia</li> </ul> | <p><b>Roseville, California, U.S.A.</b></p> |

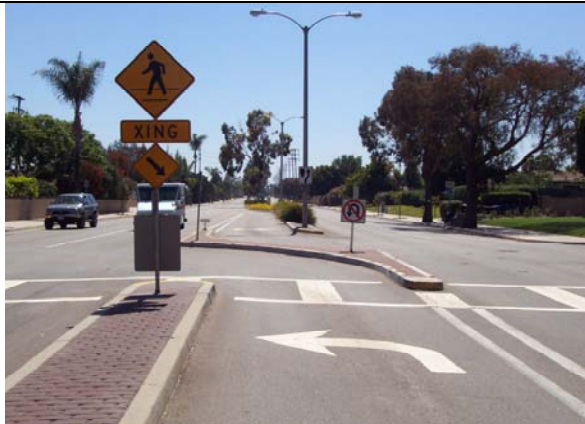
| Treatment Type | Picture of Treatment |
|---|---|
| <p><b>Left-Turn Restrictions</b></p> <p>Description – Curbed islands that restrict left turns from side street approaches onto the street where marked crosswalks are located.</p> <ul style="list-style-type: none"> <li>• Application – Uncontrolled intersections with marked crosswalks</li> <li>• Cost (Including Labor) in U.S. Dollars – \$25,000-\$35,000 per crossing island</li> <li>• Studies of Effectiveness – None found</li> <li>• Countries Where Treatment is Used – U.S.A.</li> </ul> | <p><b>U.S.A.</b></p> |

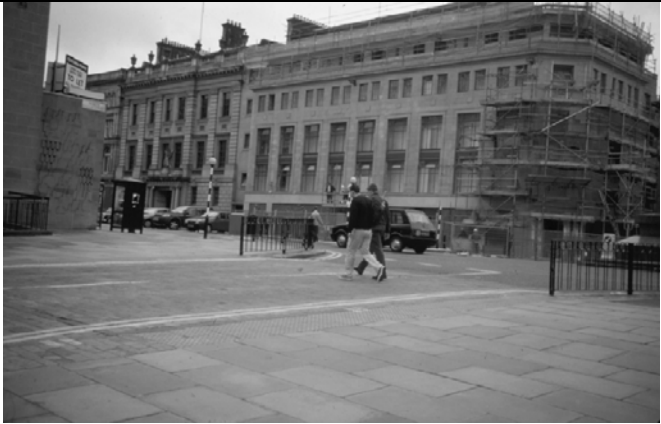
| Treatment Type | Picture of Treatment |
|---|---|
| <p><b>Setback Crossings</b></p> <p>Description – Crosswalks at unsignalized intersections are set back by 9.8 ft (3 m) or more from the cross-street flow line or curb.</p> <ul style="list-style-type: none"> <li>• Application – Narrow approaches to intersections</li> <li>• Cost (Including Labor) in U.S. Dollars – \$100 per linear meter for pedestrian railing needed for this application</li> <li>• Studies of Effectiveness – None found</li> <li>• Countries Where Treatment is Used – U.K.</li> </ul> | <p><b>Edinburgh, Scotland, U.K.</b></p> |

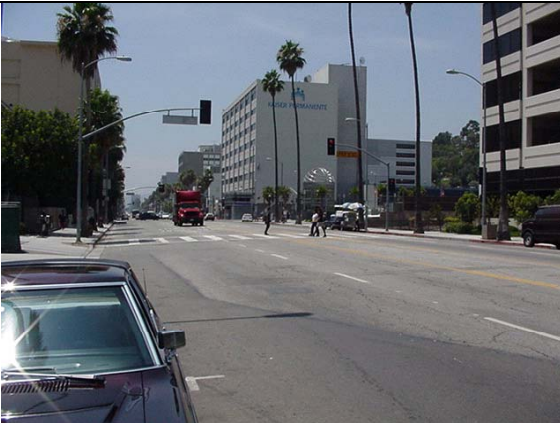
| Treatment Type | Picture of Treatment |
|---|---|
| <p><b>Midblock Signal-Controlled Pedestrian Crossings with Flashing Red</b></p> <p>Description – At a signal-controlled midblock crosswalk, drivers either stop for 12 to 20 seconds during the steady red signal indication displayed during the WALK interval or pause for 4 to 7 seconds during a flashing red indication that signals the DON'T WALK interval.</p> <ul style="list-style-type: none"> <li>• Application – Midblock locations in high pedestrian activity areas such as downtowns</li> <li>• Cost (Including Labor) in U.S. Dollars – \$50,000-\$100,000 per installation</li> <li>• Studies of Effectiveness – None found</li> <li>• Countries Where Treatment is Used – U.S.A.</li> </ul> | <p><b>Los Angeles, California, U.S.A.</b></p> |

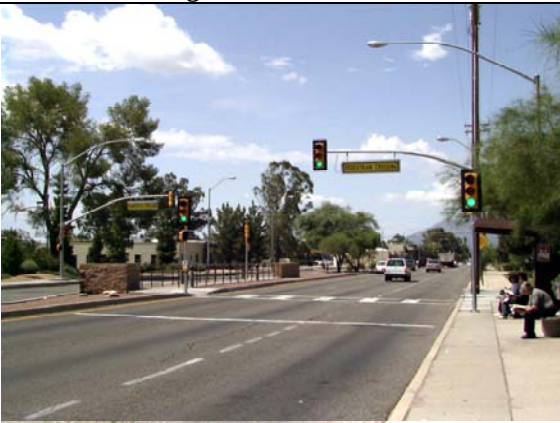
| Treatment Type | Picture of Treatment |
|---|---|
| <p><b>Midblock Signal-Controlled Pedestrian Crossings</b></p> <p>Description – At a signal-controlled midblock crosswalk, drivers stop at the steady red indication – activated by push button – displayed on either WALK or DON'T WALK intervals, and may only proceed once the signal turns green.</p> <ul style="list-style-type: none"> <li>• Application – Midblock locations in high pedestrian activity areas such as downtowns</li> <li>• Cost (Including Labor) in U.S. Dollars – \$50,000-\$100,000 per installation</li> <li>• Studies of Effectiveness – Glock et al. (4)</li> <li>• Countries Where Treatment is Used – Canada, U.S.A.</li> </ul> | <p><b>Tucson, Arizona, U.S.A.</b></p> |

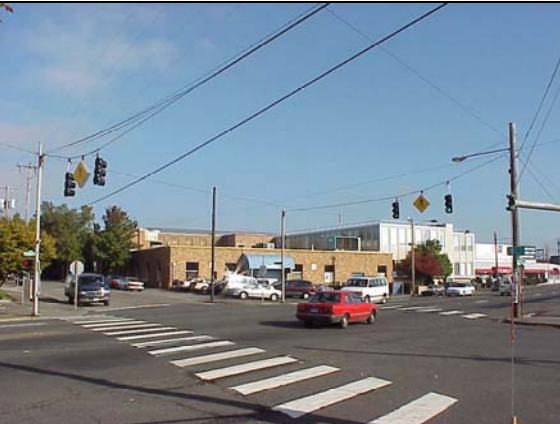
| Treatment Type | Picture of Treatment |
|---|---|
| <p><b>Intersection Pedestrian Signals (Half-Signals)</b></p> <p>Description – Signals installed at intersections control traffic at crosswalks on the major streets. The side street is controlled by STOP signs, while no signal indications are provided for the minor street traffic.</p> <ul style="list-style-type: none"> <li>• Application – Signalized pedestrian crossings with the side street STOP signs</li> <li>• Cost (Including Labor) in U.S. Dollars – \$50,000-\$100,000 per installation</li> <li>• Studies of Effectiveness – Unpublished study by City of Portland, Oregon</li> <li>• Countries Where Treatment is Used – Canada, U.S.A.</li> </ul> | <p><b>Portland, Oregon, U.S.A.</b></p> |

The pedestrian signal (or half-signal) has been used in British Columbia, Canada, for over 25 years (2). Voss and Parks describe several operational and safety issues in a 2001 report and also document a study of half-signals in British Columbia. The operational and design characteristics of half-signals do vary among municipalities within British Columbia, which adds to the safety issues noted by the authors. For example, the typical half-signal consists of a regular traffic signal on the main street with stop control on the side street. The half-signal typically dwells in a flashing green ball mode until the pedestrian phase is activated, at which time a 5-second solid green indication is shown before the yellow and red intervals. However, several municipalities do not use the solid green indication. Other inconsistencies or design variations in British Columbia's half-signals include:

Voss and Parks conducted a modest study of STOP sign compliance on side street approaches at 12 half-signal installations throughout the greater Vancouver area in the summer of 2000 (2). Despite including rolling stops as compliance, the authors found very low STOP sign compliance rates at nearly all half-signal installations. Only 2 of the 12 installations had STOP sign compliance rates above 90 percent, whereas the lowest compliance rate was 14 percent. The authors implied that the low STOP sign compliance was due in part to conflicting vehicle and pedestrian control at these half-signal installations.

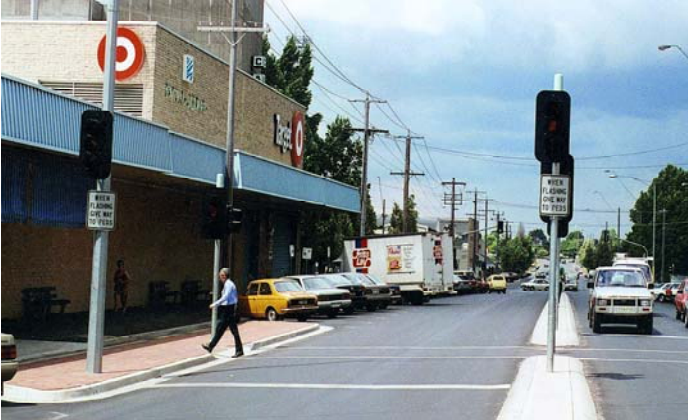
| Treatment Type | Picture of Treatment |
|---|---|
| <p><b>Pelican Crossings</b></p> <p>Description – <b>Pedestrian light controlled</b> crossings (Pelican) control vehicular traffic at midblock crosswalks with either a steady red signal (stop), flashing amber indication (proceed if no pedestrians), or steady green signal (proceed).</p> <ul style="list-style-type: none"> <li>• Application – Midblock locations in high pedestrian activity areas</li> <li>• Cost (Including Labor) in U.S. Dollars – \$50,000-\$100,000</li> <li>• Studies of Effectiveness – Lalani (54) and Traffic Advisory Unit (71)</li> <li>• Countries Where Treatment is Used – U.K., Australia, U.S.A., Eire</li> </ul> | <p><b>Victoria, Australia</b></p> |

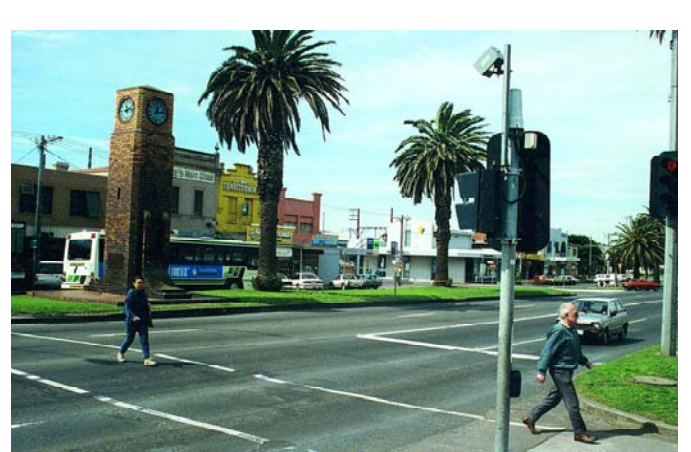
| Treatment Type | Picture of Treatment |
|---|---|
| <p><b>Puffin Crossings</b></p> <p>Description – <b>Pedestrian user friendly intelligent</b> (Puffin) crossings are similarly constructed as Pelicans, but provide more flexibility in crossing time for pedestrians, use nearside pedestrian signal heads as opposed to farside, and provide an extendable all-red crossing period using microwave, infrared, and other types of overhead detection.</p> <ul style="list-style-type: none"> <li>• Application – Midblock locations in high pedestrian activity areas</li> <li>• Cost (Including Labor) in U.S. Dollars – \$50,000-\$100,000</li> <li>• Studies of Effectiveness – Lalani (54) and Department of Transportation (72)</li> <li>• Countries Where Treatment is Used – U.K., Australia, U.S.A., Eire</li> </ul> | <p><b>Victoria, Australia</b></p> |

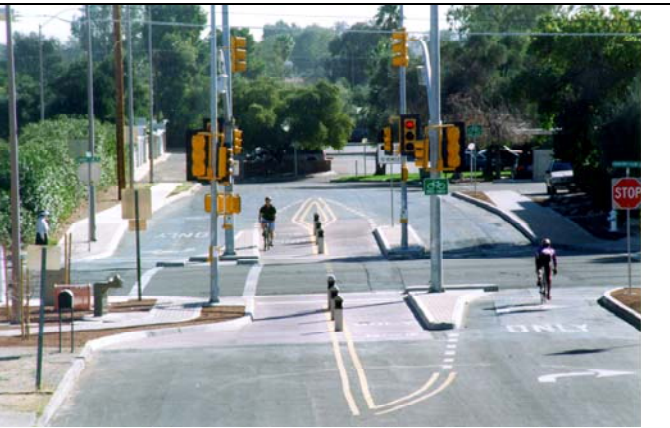
| Treatment Type | Picture of Treatment |
|---|---|
| <p><b>Toucan Crossings</b></p> <p>Description – Toucan crossings (two can cross) are similar in vehicular detection to the Pelican and Puffin crossings and in pedestrian on-crossing detector to the Puffin crossing, but differ in providing bicycle signals for bicyclists and displaying dark pedestrian/bicycle signals instead of the flashing green walking figure.</p> <ul style="list-style-type: none"> <li>• Application – Midblock locations in high pedestrian and bicycle activity areas</li> <li>• Cost (Including Labor) in U.S. Dollars – \$75,000-\$100,000</li> <li>• Studies of Effectiveness – London (73,74)</li> <li>• Countries Where Treatment is Used – U.K., U.S.A.</li> </ul> | <p><b>Tucson, Arizona, U.S.A.</b></p> |

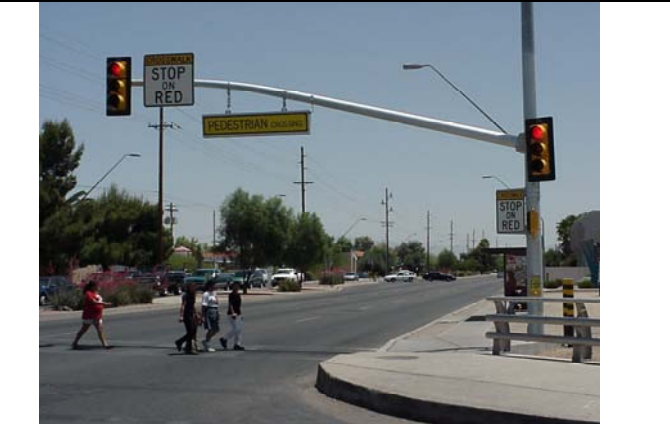
| Treatment Type | Picture of Treatment |
|---|---|
| <p><b>HAWK Crossings</b></p> <p>Description – The High-intensity activated crosswalk (HAWK) signaling system in Tucson, Arizona, is a combination of a beacon flasher and a traffic control signaling technique for marked crossings that remains off unless activated by a pedestrian.</p> <ul style="list-style-type: none"> <li>• Application – In high pedestrian areas</li> <li>• Cost (Including Labor) in U.S. Dollars – \$40,000-\$60,000</li> <li>• Studies of Effectiveness – Glock (4)</li> <li>• Countries Where Treatment is Used – Canada, U.S.A.</li> </ul> | <p><b>Tucson, Arizona, U.S.A.</b></p> |

traditional before-and-after study, the evaluation of a single HAWK crossing found that motorist yielding increased from 31 to 93 percent. The percentage of hesitating, aborting, or rushed pedestrians decreased from 24 to 10 percent. The study site was a multilane divided arterial street with a posted speed limit of 40 mph (64 km/h). Before installation of the HAWK signal, the pedestrian crossing was delineated by advance and point-of-crossing pedestrian signs, a painted crosswalk, and advance pavement legends. Nassi noted the effectiveness of this type of treatment on wide, higher speed arterial streets (3).

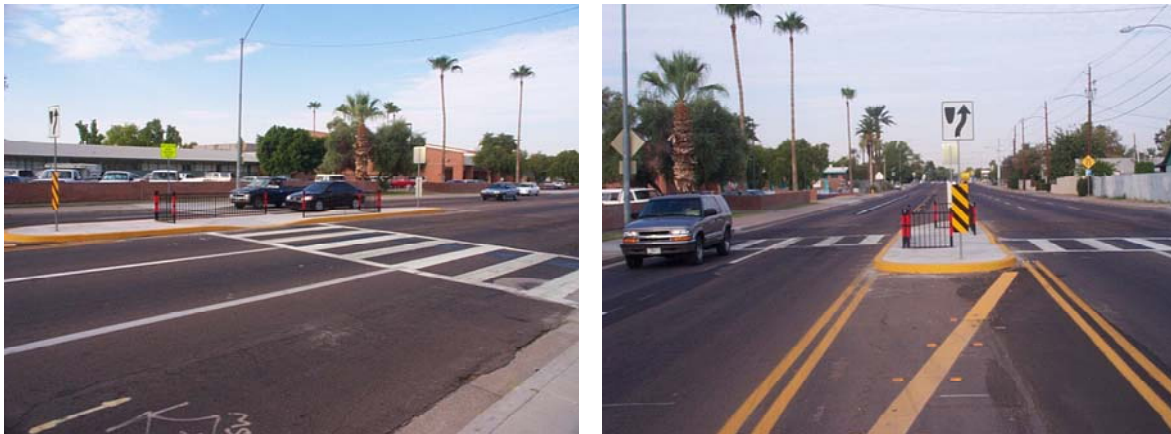
Figure D-2 shows pictures of the staggered crosswalk installation in Phoenix. Although this crossing is near a school, this type of design can be used at any crossing location.

*Figure D-2. Staggered Crosswalk in Phoenix, Arizona.  
(Source: James Sparks, Phoenix, Arizona, U.S.A.)*

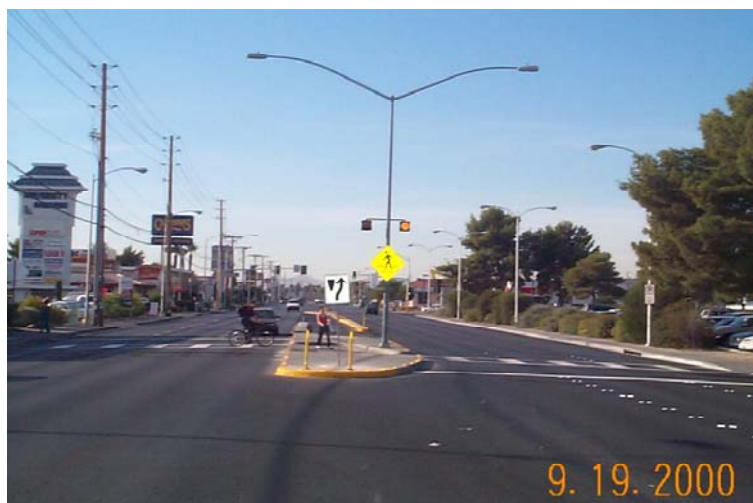
Figure D-3 shows a similar installation in the Las Vegas area of Nevada. This location does not include the pedestrian railing on the island, which is a prominent feature of the British design.

*Figure D-3. Staggered Crosswalk in the Las Vegas Area of Nevada.  
(Source: Rich Romer, Las Vegas, Nevada, U.S.A.)*

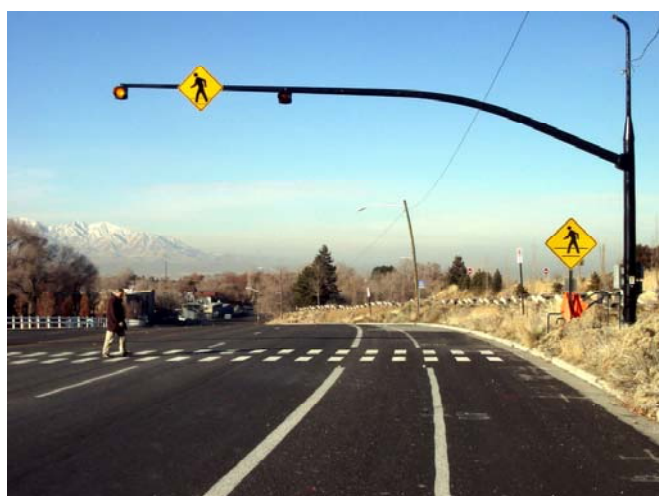
In March 2001, Salt Lake City's first pedestrian-actuated overhead flashing beacons were installed over a busy four-lane street at a high pedestrian volume crosswalk. This device consists of one beacon over each travel lane on the approach to the crossing and two pedestrian crosswalk signs mounted back to back hung overhead (see Figure D-4). The beacons flash in an alternating pattern once the pedestrian pushes the activation button for a period equivalent to the pedestrian clearance interval plus 10 seconds.

A second pedestrian-activated flashing beacon-type crosswalk has been installed and an existing constantly flashing installation has been converted to pedestrian-actuated activation. These installations cost \$9000, compared to \$25,000 for in-pavement flashing marker-type installations when used with existing utility poles with overhead power in close proximity.

*Figure D-4. Pedestrian-Activated Flashing Beacons in Salt Lake City, Utah.  
(Source: Tim Harpst, Salt Lake City, Utah, U.S.A.)*

A further enhancement of this system is the addition of crosswalk nighttime illumination activated by a pedestrian pushbutton (see Figure D-5). During nighttime hours, street lighting attached to the crosswalk mast arm configured to illuminate the crosswalk area is lit at 30 percent capacity. When the pedestrian pushbutton is activated, the light illuminates the crosswalk at full capacity during the time that the overhead flashers are activated. Salt Lake City uses this only where there are high pedestrian flows during evening hours. These installations were reported in the November –December 2002 ITE District 6 newsletter, the *Westernite* (75).

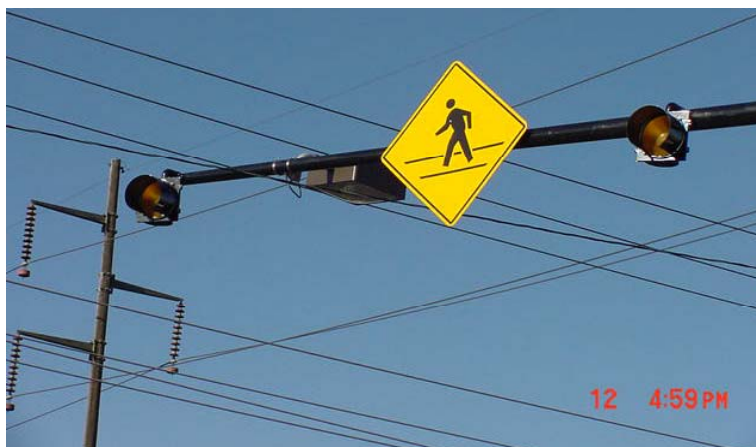
Figure D-5. Pedestrian-Activated Beacons with Light Illumination in Salt Lake City, Utah.  
(Source: Tim Harpst, Salt Lake City, Utah, U.S.A.)

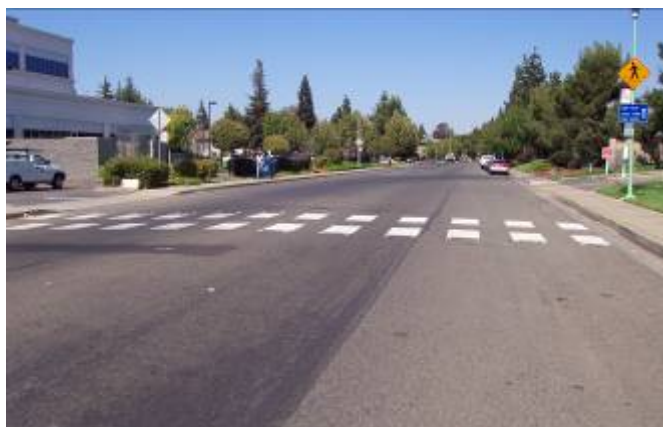
- Sufficient demand exists to justify the installation of a crosswalk;
- The location is 300 ft (91.4 m) or more from a controlled crossing location;
- The location has sufficient sight distance, or sight distance will be improved prior to crosswalk marking; and
- Safety considerations do not preclude a crosswalk.

Figure D-6 shows an example of such an installation.

*Figure D-6. Triple-Four High-Visibility Markings in Sacramento, California.  
(Source: Nazir Lalani, Ventura County, California, U.S.A.)*

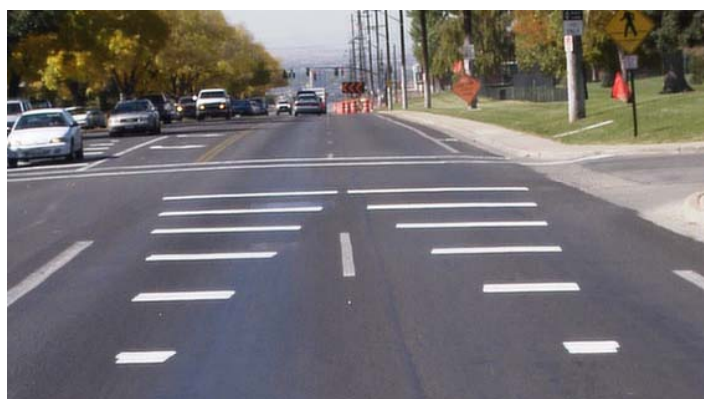
Salt Lake City staff designed a five-bar triangle advance crosswalk pattern for use at midblock crosswalks on higher speed streets (see Figure D-7). The pattern consists of five rectangular white pavement markings, sized and placed to form triangles on travel lanes in advance of midblock crossings. The markings alert the presence of pedestrians at unsignalized crossings on high-volumes streets. The pattern has been installed at four locations at a cost of \$75 per triangle per lane.

*Figure D-7. Five-Bar Triangle Advance Crosswalk Pavement Markings in Salt Lake City, Utah.  
(Source: Tim Harpst, Salt Lake City, Utah, U.S.A.)*

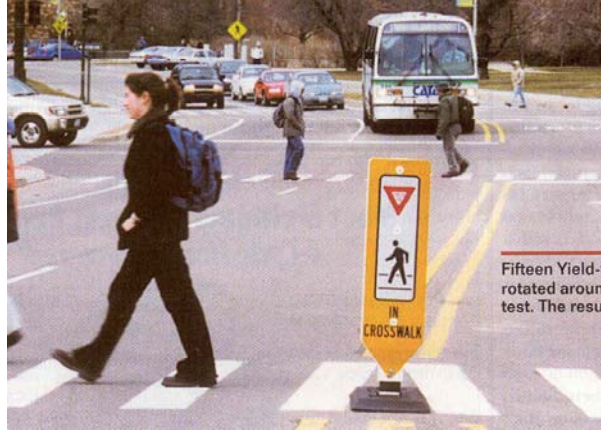
In response to a series of pedestrian-related collisions at unsignalized pedestrian crossings, Michigan State University re-engineered midblock pedestrian crossings by installing high-visibility markings and yellow triangular “Yield to Pedestrians” signs. These signs were positioned on the leading edge of the high-visibility markings (see Figure D-8). The university staff reported (77) very positive results from this treatment.

Figure D-8. In-Roadway Sign Type in East Lansing, Michigan (77).

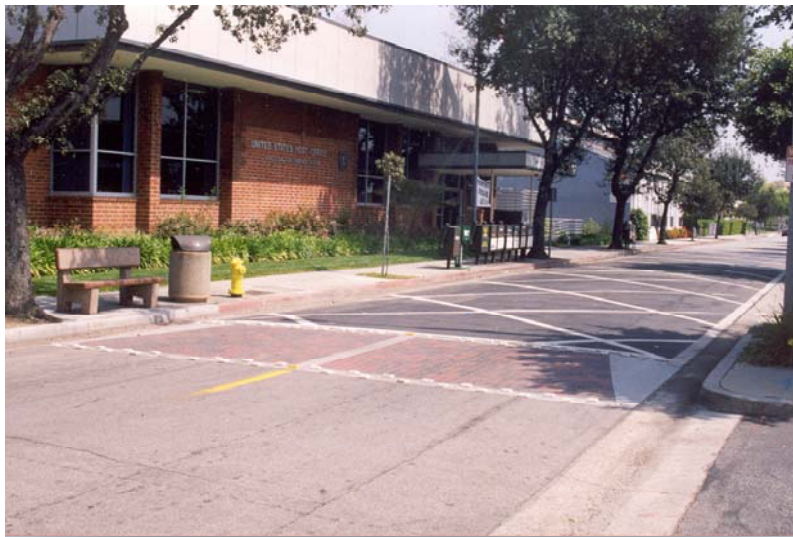
Diagonal markings highlight a pedestrian crossing area adjacent to a post office where 4000 pedestrians per day cross after parking across the street (see Figure D-9). The marked section is 110 ft (33.5 m) long and 28 ft (8.5 m) wide. The pavement was raised by 2 inches (5.1 cm) to create an elevated section. The area is bounded by patterned pavement surfacing at each end of the diagonally marked area to ramp traffic up to the elevated section. The patterned paving creates an audible rumble when vehicles travel over it, thereby giving notice to pedestrians that traffic is approaching.

Figure D-9. Crosshatched Crosswalk Markings in Arcadia, California.  
(Source: Ed Cline, Arcadia, California, U.S.A.)

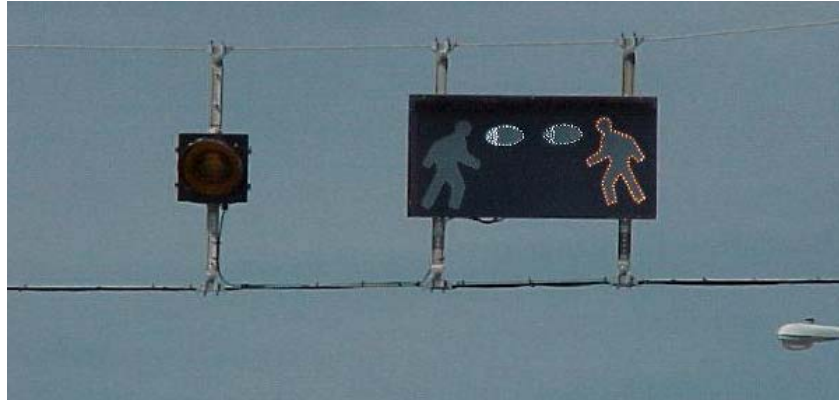
highly visible to pedestrians while limiting pedestrian signal displays to drivers. The blue LEDs present to the pedestrian a display consisting of two blue eyes with blue eyeballs that appear to scan from left to right at the rate of one cycle per second. Animated eyes displays are designed to encourage pedestrians to look for turning vehicles traveling on an intersecting path by including a prompt as part of the pedestrian signal display.

In this adaptation in the Puget Sound area of Washington, the animated eyes are displayed to drivers approaching midblock crosswalks to encourage them to look for pedestrians. A beacon also flashes when the pedestrian activates the animated eye display.

*Figure D-10. Overhead Animated Eye Display in the Puget Sound Area, Washington.  
(Source: Julie Mercer-Matlick, Olympia, Washington, U.S.A.)*

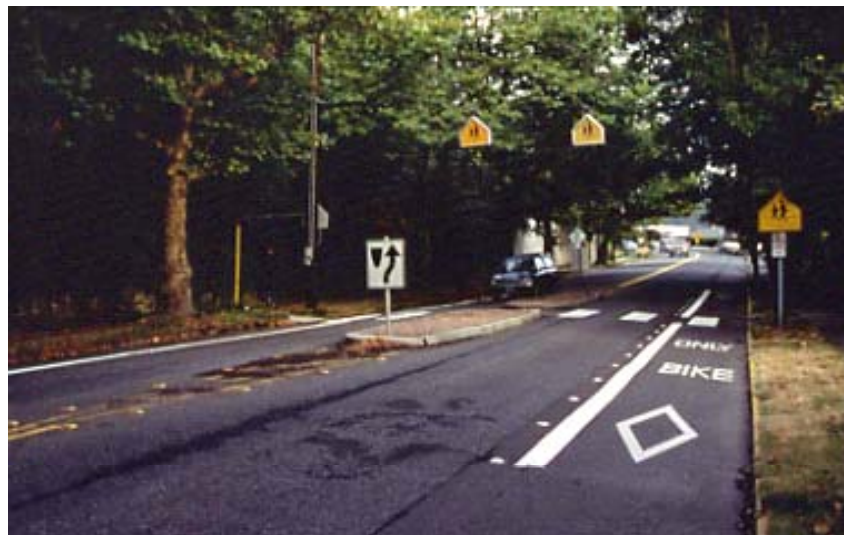
The treatment shown in Figure D-11 shows a midblock unsignalized pedestrian crossing with overhead signs, high-visibility markings, and a pedestrian refuge island.

*Figure D-11. Midblock Crosswalk with Overhead Signs and Pedestrian Refuge Island.  
(Source: Susie Stephens “Crossing the Street” Presentation at the Probike Prowalk Conference, Minneapolis, St. Paul, Minnesota, U.S.A.)*

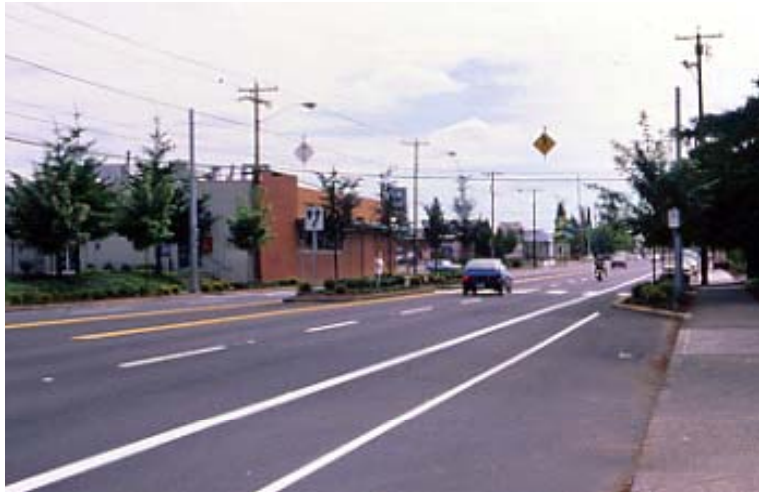
Figure D-12 shows a similar installation on a multilane arterial street which includes curb extensions in the parking lanes to narrow the crosswalk.

*Figure D-12. Midblock Crosswalk with Overhead Signs, Pedestrian Refuge Island, and Curb Extensions.*
