# **Improving Pedestrian Safety at Unsignalized Crossings**

## **Appendices B to O**

**Transit Cooperative Research Program  
National Cooperative Highway Research Program**

**March 2006**

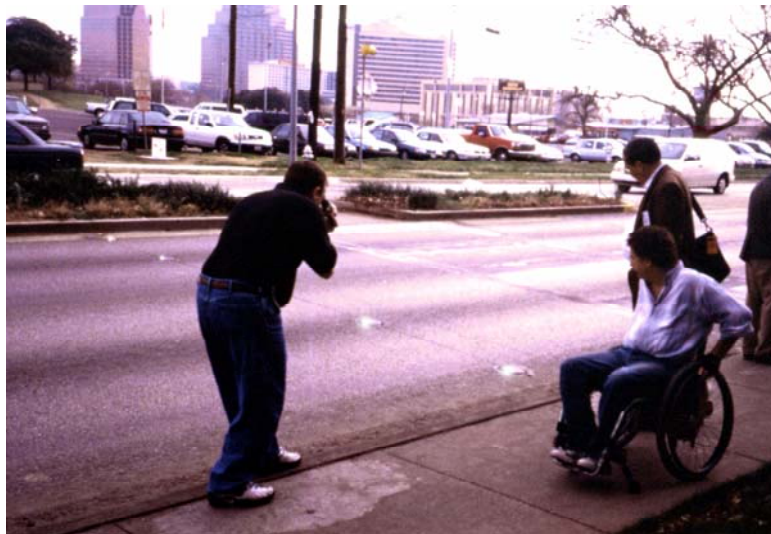
The treatment shown in Figure D-13 at a midblock crossing includes high-visibility markings, a pedestrian refuge, and in-pavement flashing lights.

*Figure D-13. Midblock Crosswalk with Median Refuge Island and In-Pavement Flashing Markers.*

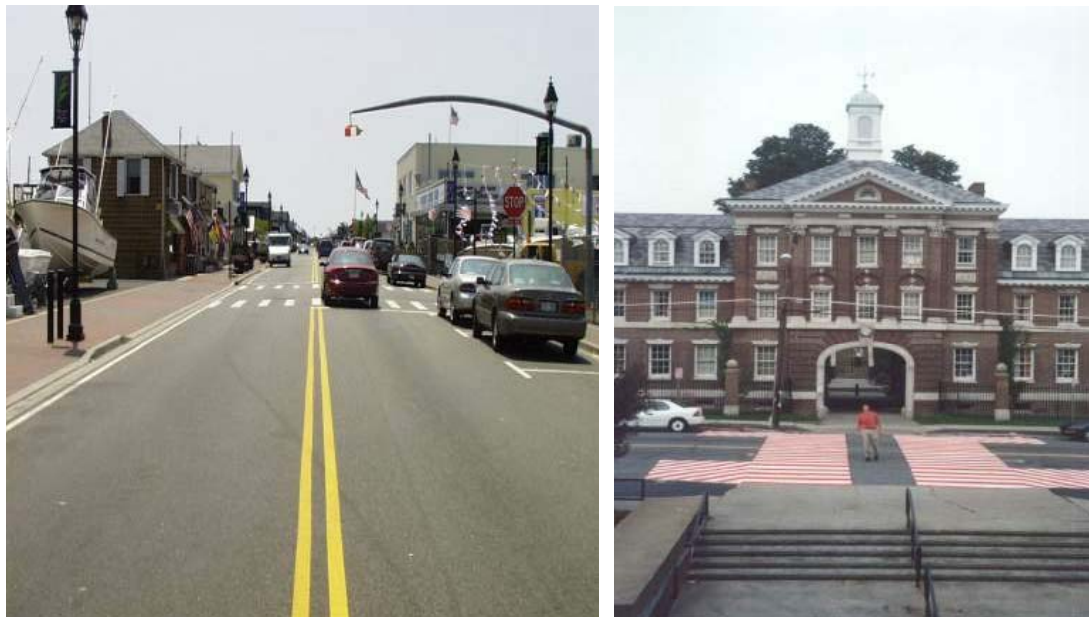
The New York Department of Transportation is creating a proposal that will be submitted to the Federal Highway Administration, as required per Section 1A.10 of the *MUTCD*, to obtain permission to install and evaluate a DP marking design for midblock pedestrian and shared use path crossings.

*Figure D-14. Crosswalk with Double Piano Style Markings in New York State.  
(Source: James Ercolano, Albany, New York, U.S.A.)*

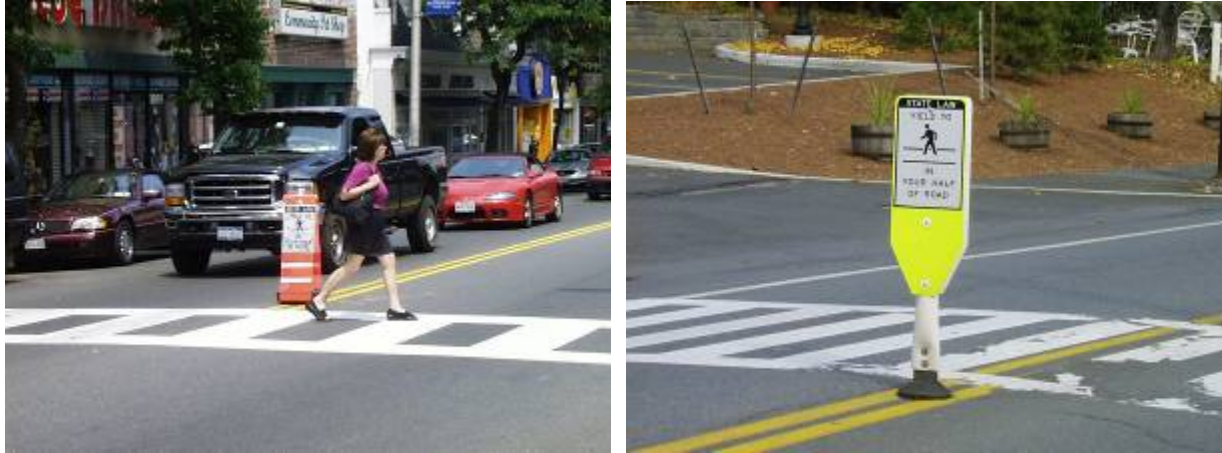
In combination with a change in law (78) to strengthen the requirement for drivers to yield to pedestrians, the State of New York DOT is deploying an in-roadway sign located in the crosswalk to reduce pedestrian-related collisions. Two types of signs used by NYDOT are shown in Figure D-15.

*Figure D-15. In-Roadway Signs at Crosswalks in New York State.  
(Source: James Ercolano, Albany, New York, U.S.A.)*

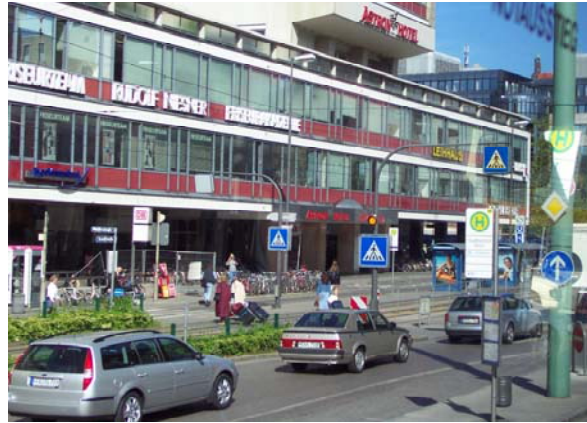
Unsignalized midblock crossings are frequently installed in the urbanized areas of Germany where there are large numbers of pedestrians needing to cross the street, especially near transit stops. Many cities have tram lines with station platforms located in the center of major streets at midblock locations. Figure D-16 shows a midblock unsignalized pedestrian crossing with four ground-mounted and overhead standard blue and white Europe pedestrian crossing signs facing each direction of approach traffic, pedestrian-activated flashing beacons, pedestrian refuge island, and high-visibility markings. Transit stops are located on each side of the crossing.

*Figure D-16. Midblock Crossing in Frankfurt, Germany.*

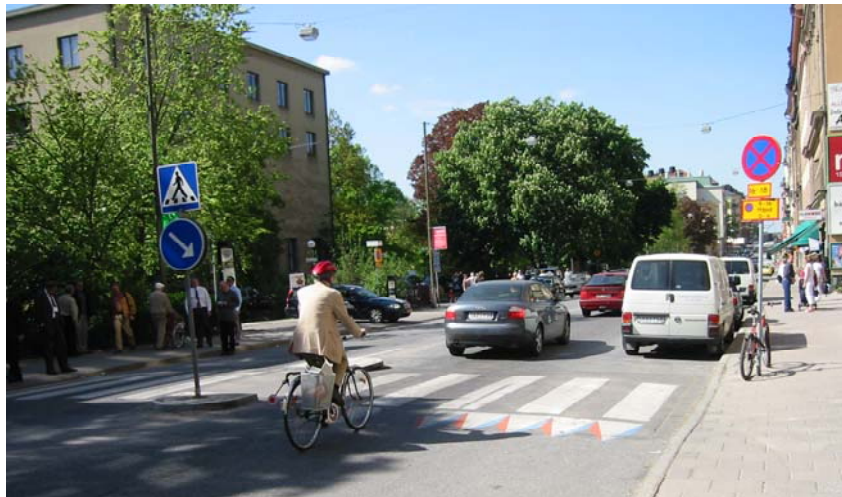
Midblock crosswalks at unsignalized locations are painted on the pavement in such a way as to create an optical illusion that there is a raised crosswalk. Multiple colors create the optical illusion. No documentation was provided as to how often the crosswalk has to be repainted or whether there are any pedestrian safety benefits. Figure D-17 shows a typical location in Stockholm.

*Figure D-17. Painted Raised Crosswalk in Stockholm, Sweden.*

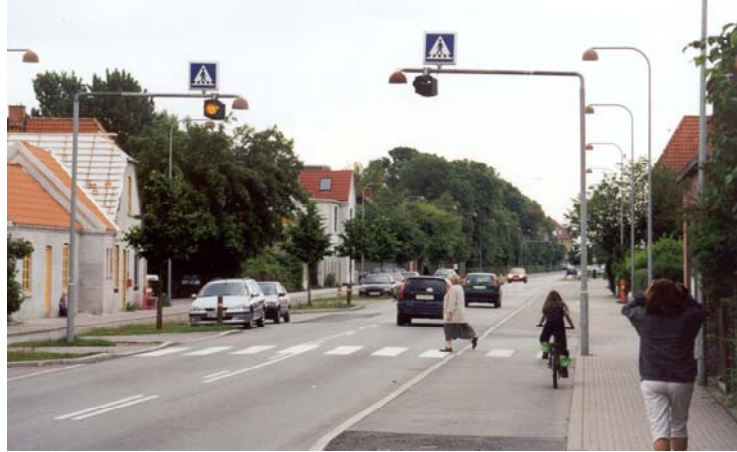
*Figure D-18. Midblock Crossing in Copenhagen, Denmark.  
(Source: Karen Whitehouse, Ventura, California, U.S.A.)*

Midblock crossings in Copenhagen are provided with high-visibility ladder-type markings, curb extensions (sometimes only on one side), and the standard European blue and white pedestrian crossings mounted overhead with flashing yellow beacons that are activated by pedestrians. Low-pressure sodium lighting is present along one side of the street. Figures D-18 and D-19 show typical midblock crossings incorporating these treatments. The second location also includes a raised crosswalk.

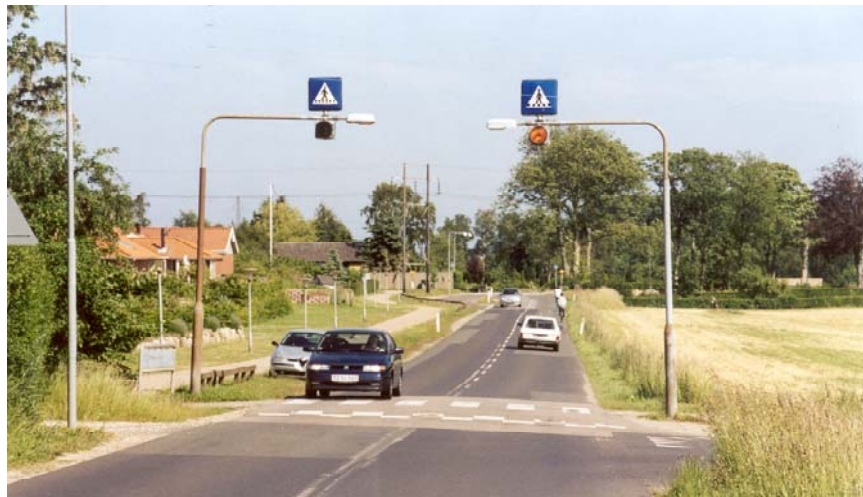
*Figure D-19. Midblock Crossing with Raised Crosswalk in Copenhagen, Denmark.  
(Source: Karen Whitehouse, Ventura, California, U.S.A.)*

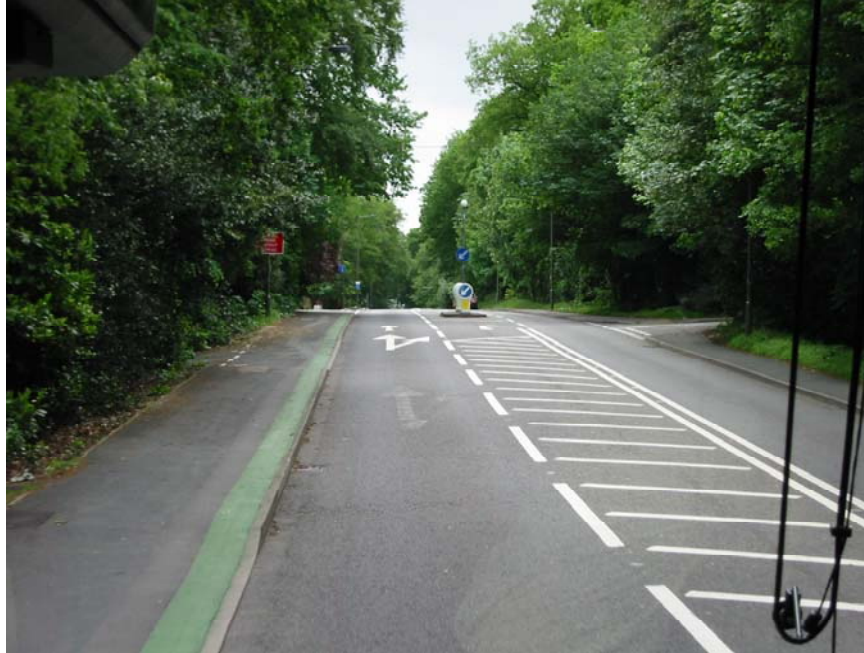
In Figure D-20, the marked midblock crossing with refuge island is provided with internally illuminated bollards to provide nighttime illumination. Standard blue and white signing is present to illustrate to drivers the correct side of the island. Figure D-21 shows the center median striped with diagonal markings and the pavement is colored with a red pigmentation to highlight the median and the center refuge island area.

*Figure D-20. Midblock Crossing with Refuge Island in the U.K.  
(Source: Nazir Lalani, Ventura County, California, U.S.A.)*

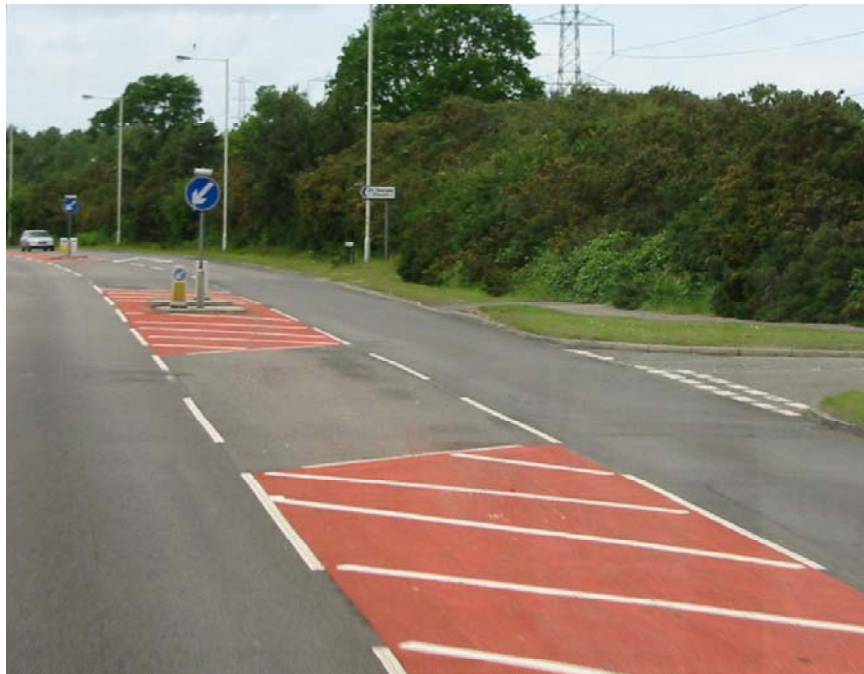
*Figure D-21. Midblock Crossing with Refuge Island and Color-Treated Median in the U.K.  
(Source: Nazir Lalani, Ventura County, California, U.S.A.)*

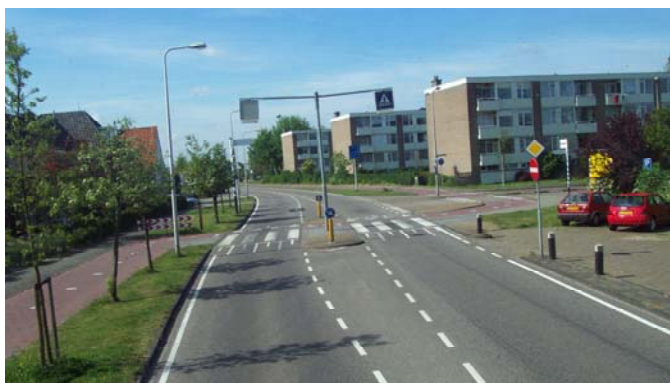
*Figure D-22. Midblock Crossing with Refuge Island in the Netherlands.*

Figure D-22 shows a midblock crossing that incorporates a raised crosswalk with the standard blue and white European pedestrian crossing signs mounted overhead, high-visibility markings, a pedestrian refuge with internally illuminated bollards, and Keep Right signs. This crossing serves high pedestrian and bicycle traffic during commute times and weekends and is part of a bike path system.

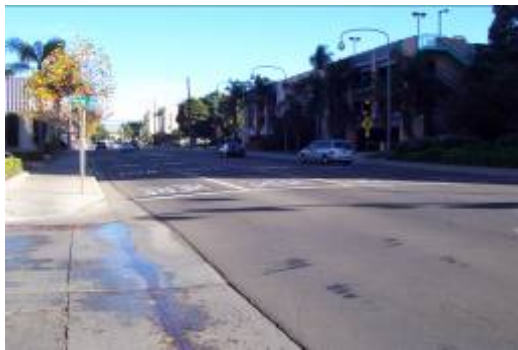
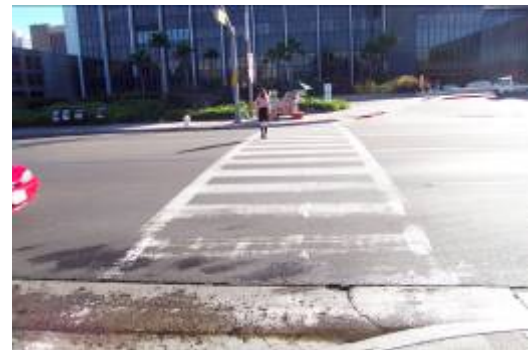
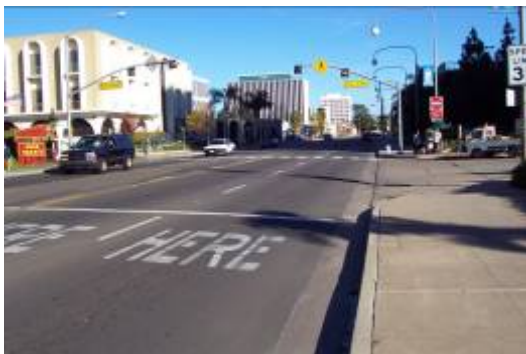
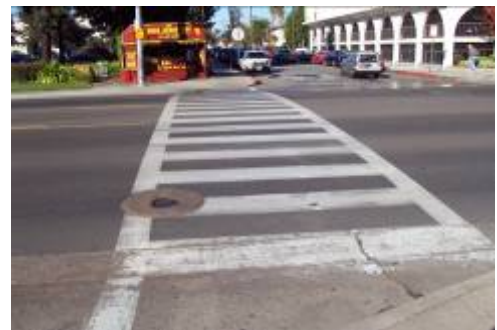
Figure I-1. Photographs of Site 7.

Pedestrian Looking East from North Side

Southbound

Eastbound

Northbound

Each participant was provided with traffic/pedestrian data, photographs, and a sketch for the eight pedestrian crossing locations. Figure I-1 shows examples of the photographs provided for Site 7. The traffic volumes were provided both in numeric format and plotted on a chart with the relevant curves for Signal Warrant 2 (4-hr vehicular volume) and Warrant 3 (peak hour). Figure I-2 illustrates the chart provided for Site 7. Tables were also provided listing the pedestrian volume (per hour and per street), intersection characteristics, and preliminary results

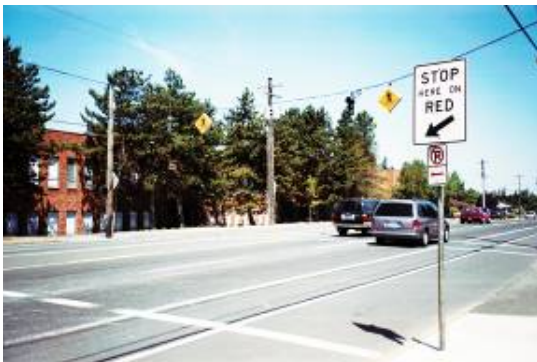
(a) Pedestrian Signal with Advance Stop Bar

Typical treatments used in Portland include intersection pedestrian signals (also known as half-signals) and pedestrian median refuge islands. Other treatments that have been installed are in-roadway warning lights and overhead or side beacons activated by passive detection. Figure J-3a is an example of a pedestrian signal with advance stop bar and STOP HERE ON RED sign. Figure J-3b is an example of a pedestrian median refuge island, and Figure J-3c is an example of an intersection pedestrian signal (half-signal). Comments made during the meeting with agency representatives are:

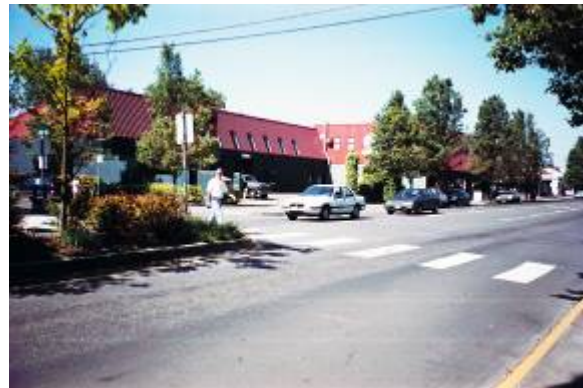
(b) Pedestrian Median Refuge Island

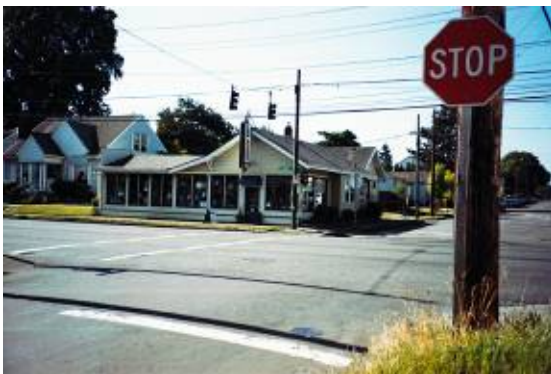
(c) (Half-Signal)

*Figure J-3. Examples of Treatments in Portland.*

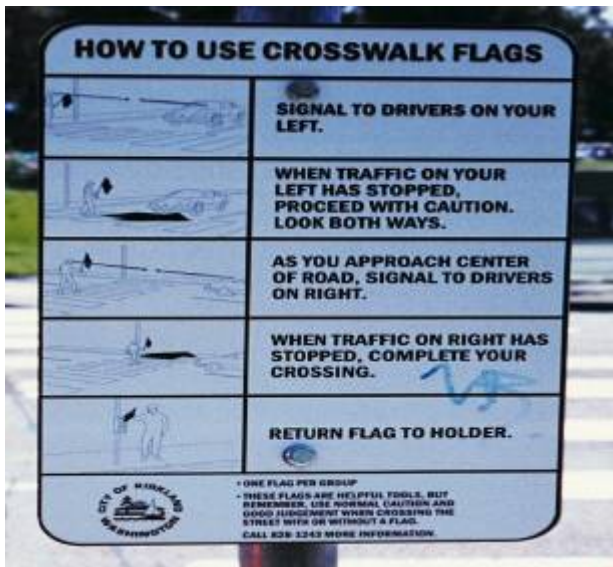
(a) Instructions for Pedestrian Flags

Typical treatments used in Kirkland include pedestrian flags and pedestrian median refuge islands. Other treatments that have been installed are in-roadway warning lights and midblock pedestrian signals. Figure J-4a is an example of the instructions for the flag treatment (see Figure J-4b). Figure J-4c is an example of pedestrian median refuge island. Comments made during the meeting with agency representatives are:

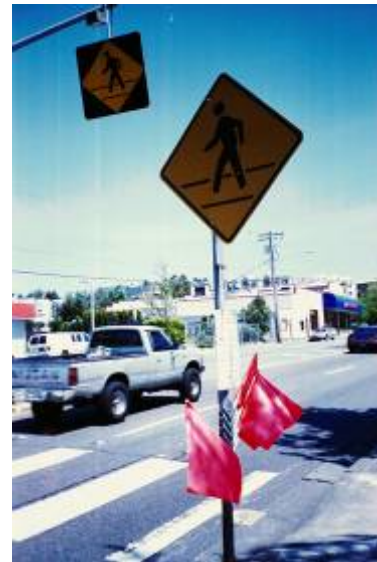
(b) Pedestrian Flags and Crossing Signs

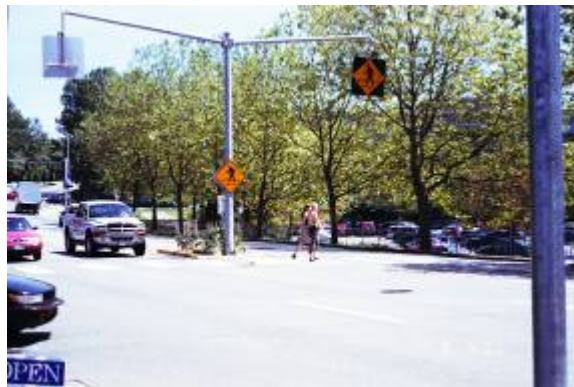
(c) Overhead Signs, Pedestrian Refuge Island at Marked Crosswalk  
*Figure J-4. Example of Treatments in Kirkland.*

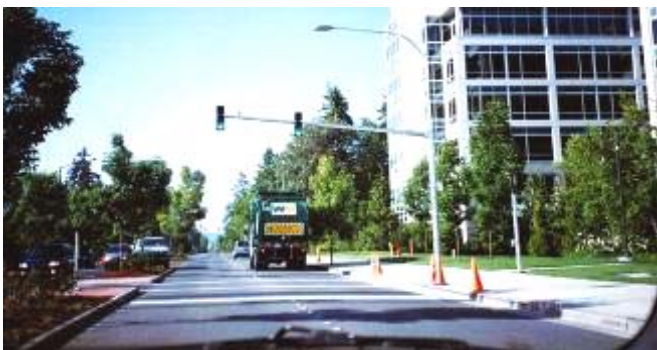
(a) New Midblock Pedestrian Signal at Microsoft

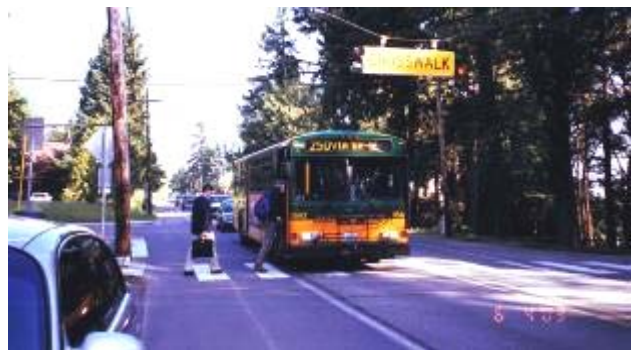
(b) Marked Crosswalk

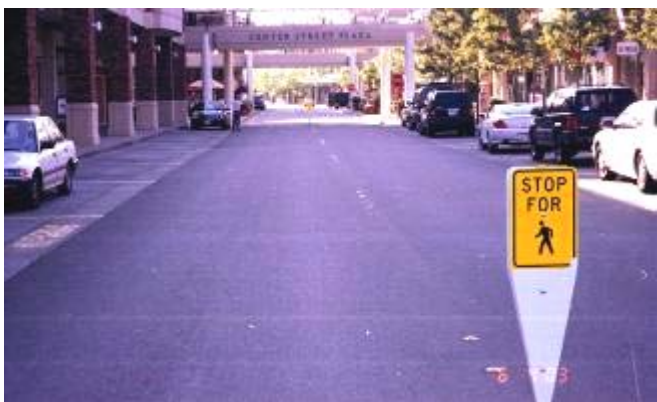
(c) In-Street Pedestrian Crossing Sign

- Are currently 6 months into a 12-month evaluation.
- Started with 14 sites; about 9 sites are currently in the study (lost some due to construction trucks).
- Installed on sites with three travel lanes or less and speeds of 30 mph (48 km/h) or less.
- Acceptance by drivers is increasing with familiarity with the signs.

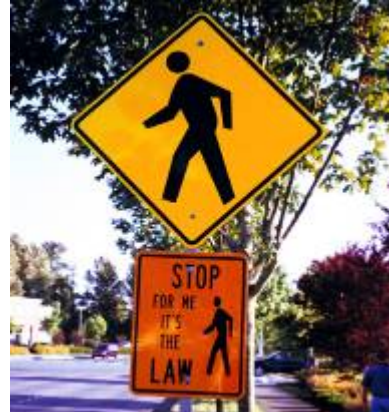
(d) Pedestrian Crossing Sign

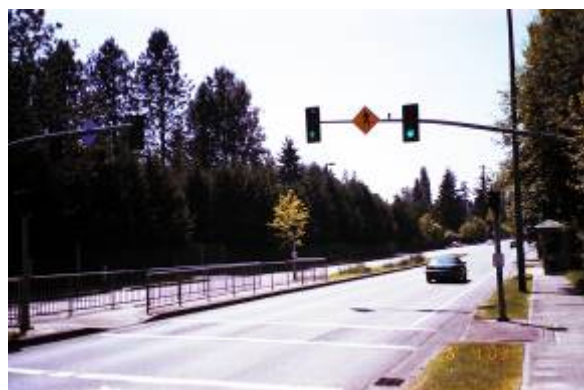
(a) Split Midblock Pedestrian Signal

Typical treatments used in Bellvue include pedestrian median refuge island at midblock crossings, overhead signing, lighting at crosswalk, and variable speed limit in school zones. Other treatments that have been installed are in-roadway warning lights, midblock pedestrian signals, and a split midblock pedestrian signal treatment. Figure J-6a is an example of a split midblock pedestrian signal, and Figure J-6b is an example of an overhead sign and median pedestrian refuge island at a marked crosswalk. Comments made during the meeting with agency representatives are:

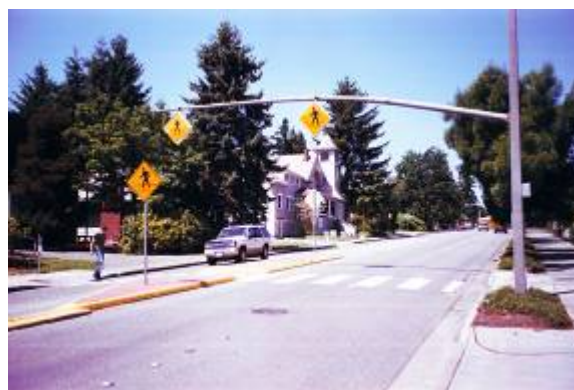
(b) Overhead Sign and Pedestrian Median Refuge Island at a Marked Crosswalk

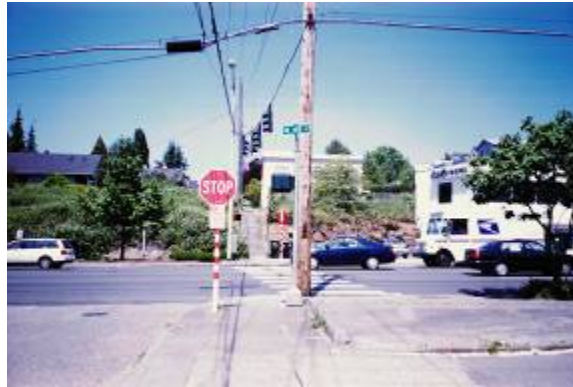
*Figure J-7. Example of an Intersection Pedestrian Signal in Seattle.*

- In-house data on intersection pedestrian signals show that they provide a safety benefit to both pedestrians and motorists.
- At the intersection pedestrian signal, the stop bar is 40 ft (12.2 m) from the crosswalk. Only one crosswalk across the major road is marked.
- The signal dwells in green, then goes to yellow, and then red. Usually gives 6 to 7 seconds of walk and then clearance based on walking speed and width.

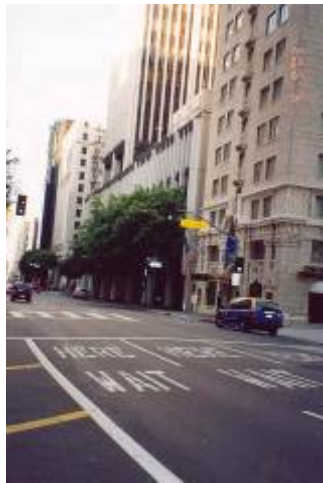
(a) Midblock Pedestrian Signal

- Dwell in green arrow, are pedestrian activated (push button), and can be coordinated with other signals.

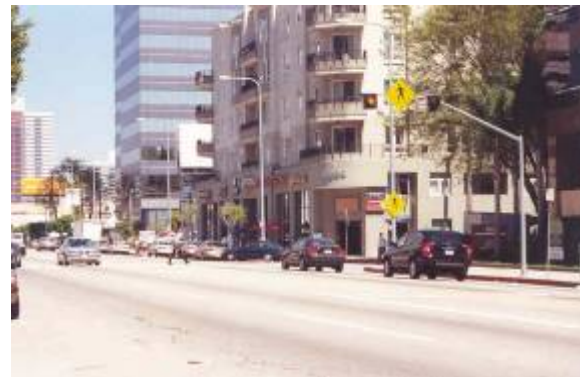
(b) Smart Pedestrian Warning

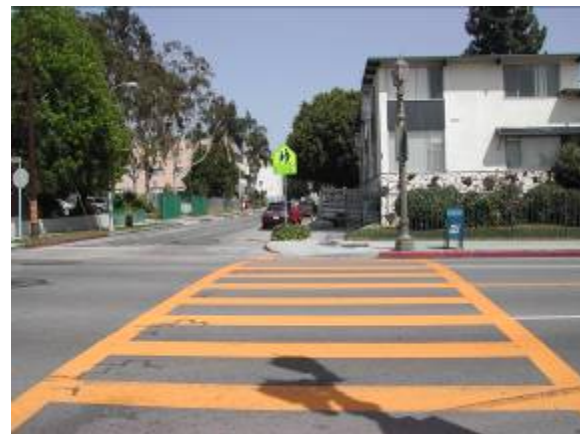
(c) Marked Crosswalk near a School

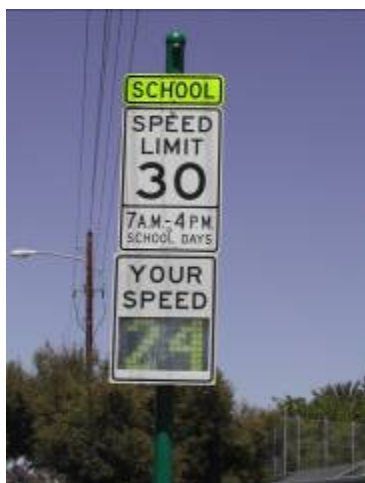
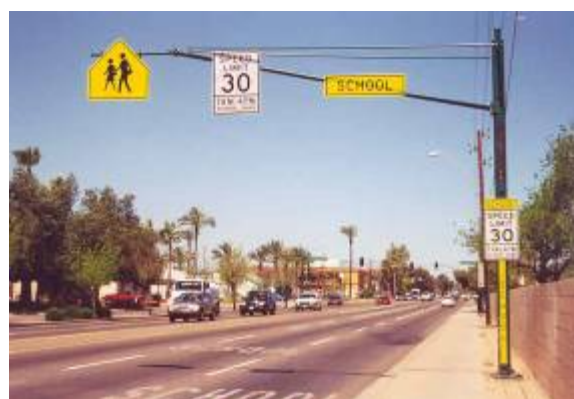
*Figure J-9. Example of Treatments Used near a Phoenix School.*

A typical treatment used in Phoenix is the fluorescent yellow-green color at school crossings. Other treatments that have been installed are flashers and rumble strips. Figure J-9 is an example of flashers and fluorescent yellow-green at school crossings. Comments made during the meeting with agency representatives include:

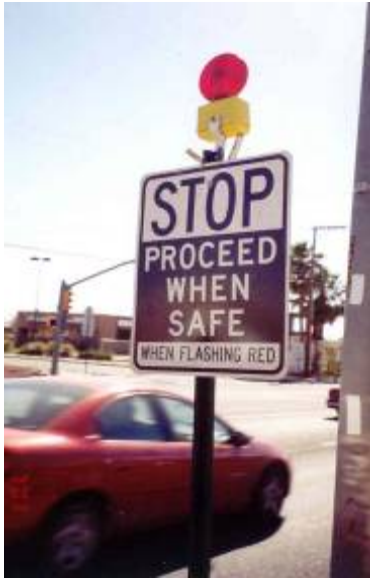
(a) Sign use at a HAWK Crossing

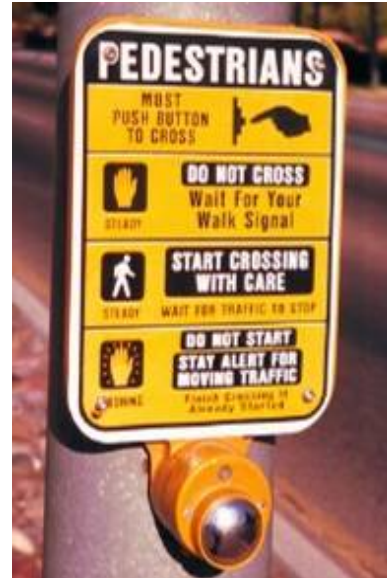
(b) Instruction Sign at a Crossing

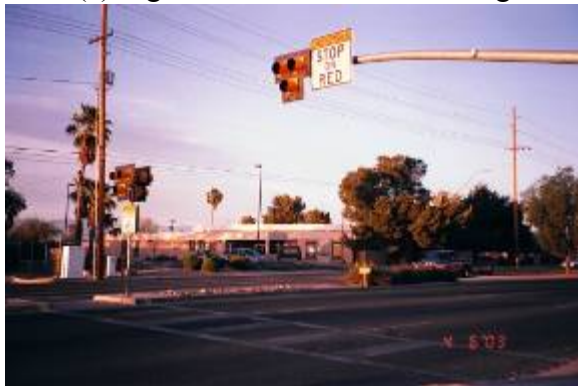
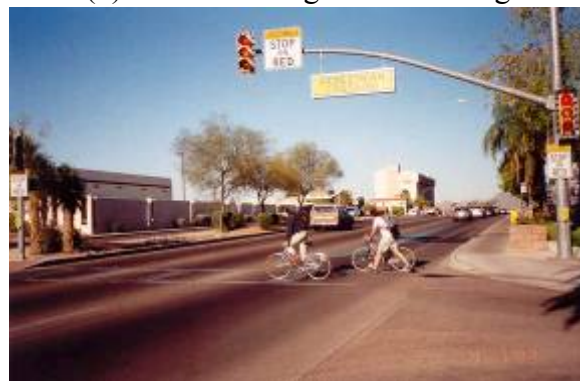
(c) HAWK

(d) HAWK

*Figure J-10. Examples of Treatments in Tucson.*

- Have installed about 15 to 20 HAWKs.
- Usually not installed within 0.25 mi (0.4 km) of another signal. Transit spacing is also at 0.25 mi (0.4 km).

- Are educating drivers about the difference between solid red (stop) and flashing red (stop and go).
- Are changing the display over time to address concerns.

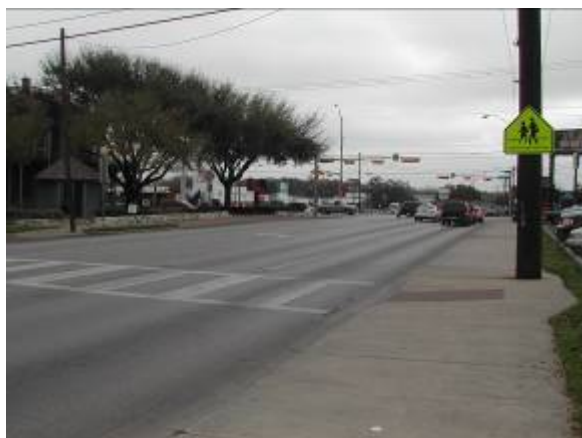
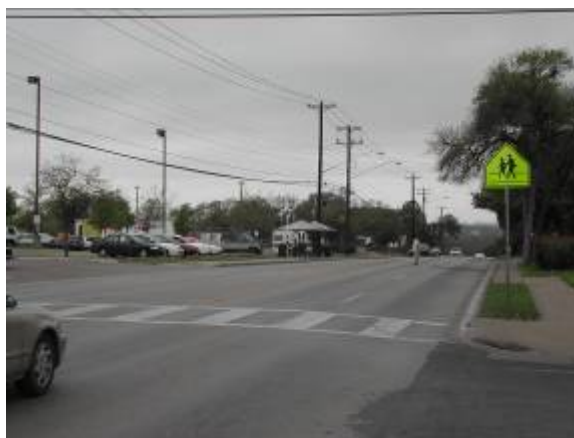
(a) Site 1

(b) Site 1

*Figure K-1. Marked Crosswalk Treatments at Sites 1 and 2.*

Two marked crosswalk treatment sites were selected (see Figure K-1). They consisted of high-visibility, ladder-style pavement markings on the roadway to delineate the crossing area. Pedestrian crossing warning signs were present and faced each direction.

Site 1 was a two-way, four-lane roadway with a two-way left-turn lane (TWLTL). The posted speed limit was 35 mph (56 km/h) and the crosswalk was located about 200 ft (61 m) from a signalized intersection (see Figure K-1a). There were transit stops on both sides of the street with benches and bus shelters. Figure K-1b shows the location that a pedestrian would cross to the transit stop if crossing the road at the bus stop. The nearby land use consisted of a grocery store, a strip mall, an elementary school, and a medical building. The population surveyed consisted of transit-dependent individuals, disabled pedestrians, and college students.

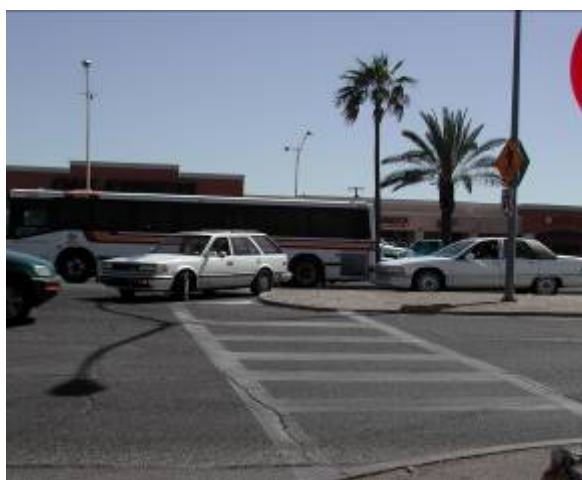
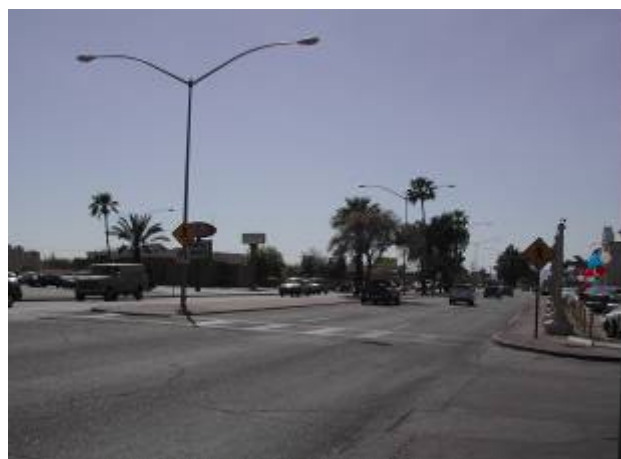
(c) Site 2

(d) Site 2

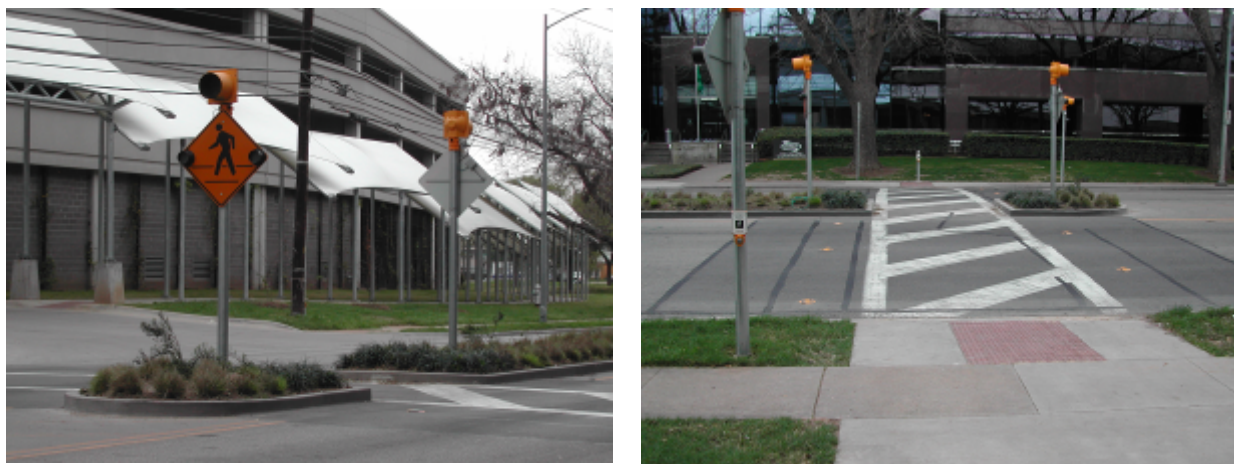
*Figure K-2. In-Roadway Warning Lights Treatment at Site 3.*

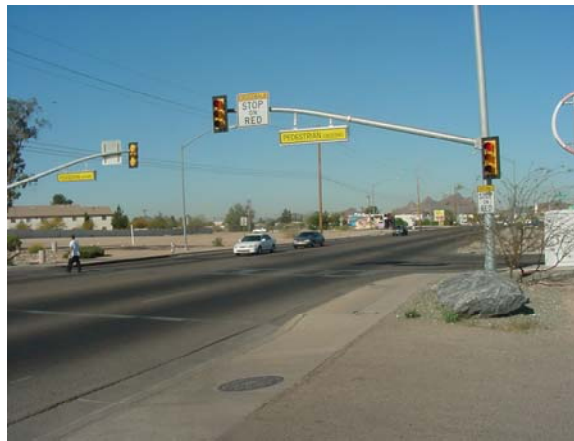
*Figure K-3. HAWK Treatment at Site 4.*

The crosswalk treatment referred to as a “HAWK” is a pedestrian crossing signal that is activated by the pedestrian. The signal is dark before activation. After activating the signal light, the progression is: flashing amber ball, solid amber ball, solid red balls, flashing red balls (wig-wag signal heads). The flashing red balls would permit stop-and-go vehicle operations during the flashing “DON’T WALK” interval if no pedestrians were in the crosswalk.

Site 4 was located on a four-lane roadway with a TWLT lane and a bike lane on each side (see Figure K-3). Ladder-style crosswalk markings were present at the crossing. The speed limit was 35 mph (56 km/h) and the pedestrian crossing signal was located at a transit center. As such, the majority of the pedestrian population at this site was transit dependent. With the exception of the transit center and a few small local businesses, the area was predominantly residential.

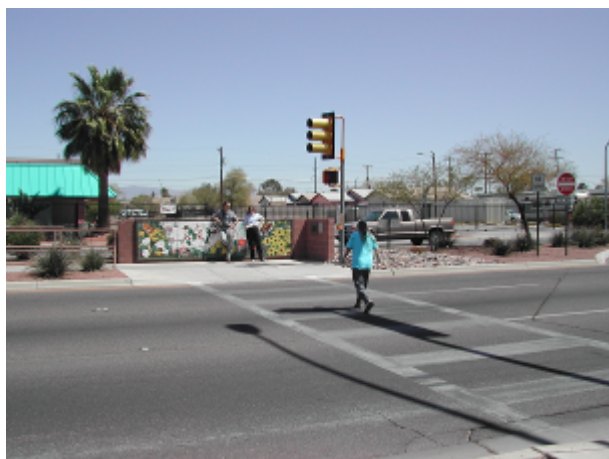
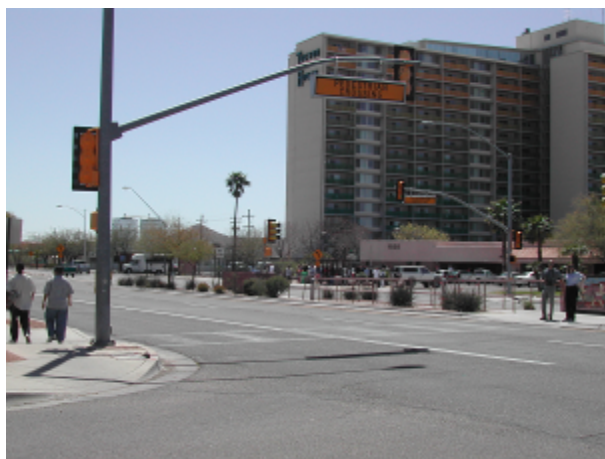
**(a) Site 5**

**(b) Site 5**

*Figure K-4. Split Midblock Signal Crossing at Sites 5 and 6.*

The split midblock signal treatment uses a traffic signal configuration where a pedestrian uses a pedestrian signal button to activate the signal and cross the first half of the street, then proceeds down a center refuge island approximately 100 ft (31 m) long to push a second pedestrian signal button and activate the second half of the pedestrian traffic signal. This treatment allows the stop time for each direction of traffic to be shorter than if one button activated the entire crossing. If one button activated the entire crossing, then the walk indication would need to be timed to allow the pedestrian to cross both directions of traffic. The split midblock signal permits the walk indication to be times uniquely for each direction.

Site 5 was a six-lane divided roadway with a raised center median (see Figure K-4a). The speed limit was posted at 40 mph (64 km/h) and curbside transit shelters existed on each side of the roadway. The land use consisted of government-supported housing and commercial properties (see Figure K-4b). The apartment building provided housing to many disabled and older transit-dependent pedestrians who were surveyed as part of this study.

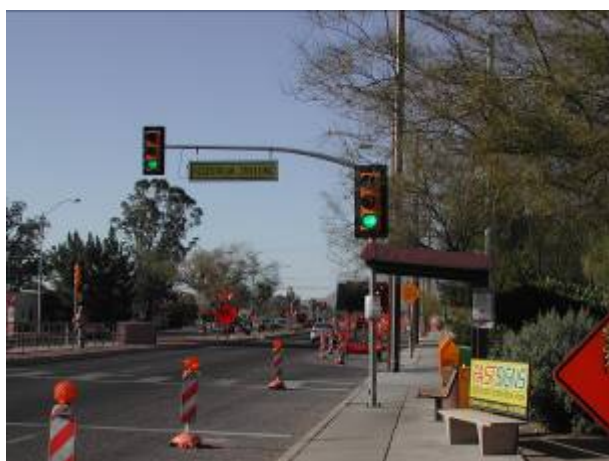
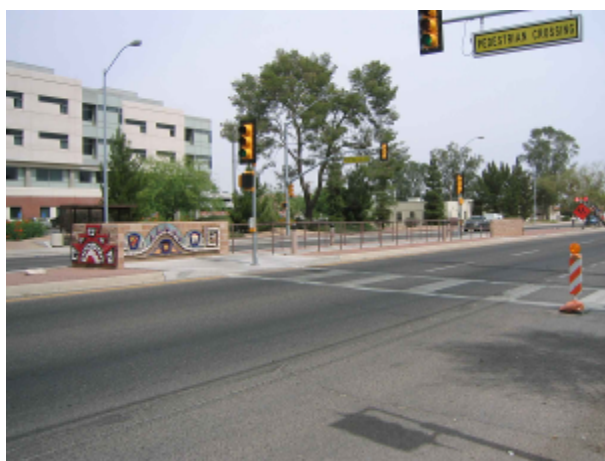
**(c) Site 6**

**(d) Site 6**

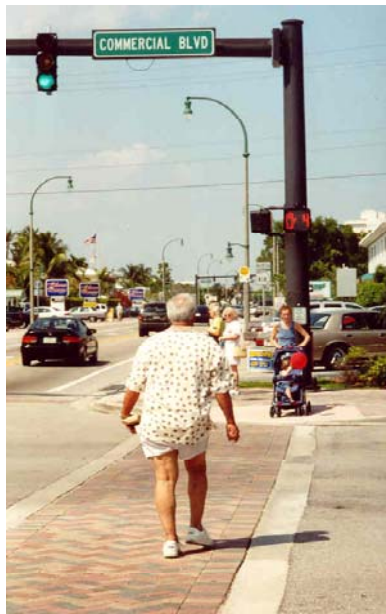
(a)

*Figure K-5. Countdown Pedestrian Signal.*

Site 7 was a signalized intersection with pedestrian crossing signals on each approach that provided a countdown display. The countdown feature started with the beginning of the flashing “DON’T WALK” phase. The site was an intersection of a four-lane roadway with a two-lane roadway. The four-lane roadway was divided by a raised median. The minor two-lane street widened to four lanes at the intersection to accommodate turns. The survey population was a mix of local residents and tourists. Figure K-5a shows one of the crossings. Note the countdown signal shows 4 seconds remaining with the flashing hand (enlargement shown in Figure K-5b). Figure K-5c shows the minor road approach.
