## RESEARCH PAYS OFF

## Caltrans Trims Footings and Costs From Concrete Median Barriers

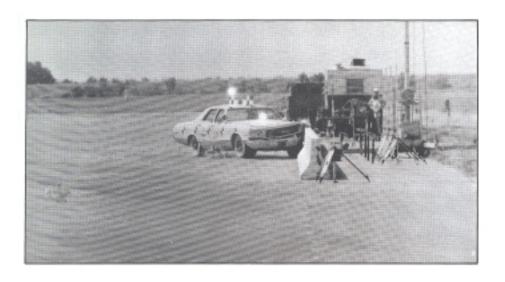
The test was conducted in 1976 with a 4,700-lb passenger car traveling 61 mph and impacting a 120-ft-long barrier at an angle of 26°-a severe proof test. No movement or damage to the barrier resulted in this test. Thus, for such conditions, Caltrans researchers determined that, except for a reinforced 10-ft-long footing at the barrier ends, footings were not required.

**APPLICATION** Caltrans amended the standard plan for concrete median barriers to eliminate the footings. One continuous No. 4 rebar was added to the existing No. 4 rebar in the upper stem to help prevent broken chunks of concrete from flying into opposing traffic lanes in severe impacts. Two continuous No. 4 rebars were added at the bottom of the barrier to minimize lateral movement and to maintain reserve strength of the barrier in very severe impacts. The redesigned barrier could be slipformed directly on top of pavement or on a compacted aggregate base in one operation. The barrier still remains connected to bridge decks by means of dowels.
