RESEARCH PAYS OFF

NEW YORK STATE DEPARTMENT OF TRANSPORTATION

NYSDOT Improves Materials and Installation Methods for Loop Detectors

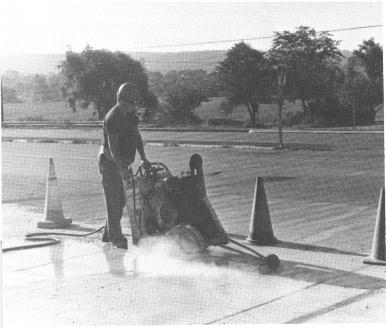
The process of sawing the slot for installation of encapsulated signal wire is improved by using an 18-hp saw rather than a 9.2-hp saw, and by "wet sawing," which reduces hazards to workers and the public due to dust and debris.

The study of installation methods revealed that making several modifications in the installation process could provide improved reliability. First, it was found that making pavement cuts for the loops with simple square corners rather than large angled corners would reduce pavement failures. Other improvements included the following: using proper hold-downs to prevent wire "float"; improving splices at curb connections; and enhancing sealer bond by better cleaning and drying in slots. Additional changes in methods resulted in improved speed, safety, and efficiency in installation.

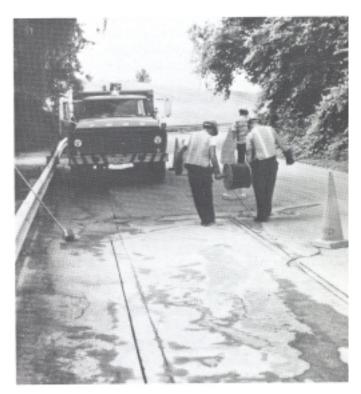
Installation of encased signal wire is as simple as using single-jacketed wire; however, life expectancy of the loop is significantly increased. Inductive loop detectors at signalized intersections, which go unnoticed by most drivers, are an integral part of today's highway systems. These detectors provide information to signal controller microprocessors about waiting or approaching vehicles, which permits changes in signal timing to accommodate changing traffic demands, in some cases for a single intersection and in other instances for a whole network. When this equipment performs successfully, motorists can save significant amounts of time and fuel. When it fails, inconvenience and serious delays to the traveling public can result.

The study also led to changes in the type of wire materials and sealants used. On the basis of laboratory and field test evaluations, procedures for which were developed in the study, hot bituminous-based sealants were replaced by an approved list of coldapplied sealers for embedding the loops. An encased wire, to decrease breakage and water infiltration, is now used. In sum, major specification changes included the use of (a) No. 14 AWG stranded, single-conductor wire encased in a continuous vinyl or polyethylene plastic tube; (b) improved loop-embedding sealer; and (c) chipped-out or cored corners instead of diagonal sawcuts in the slots cut for the loops.
