## FIBER-REINFORCED POLYMER COMPOSITES FOR STRENGTHENING BRIDGES IN OREGON

H. MARTIN LAYLOR AND DAMIAN I. KACHLAKEV

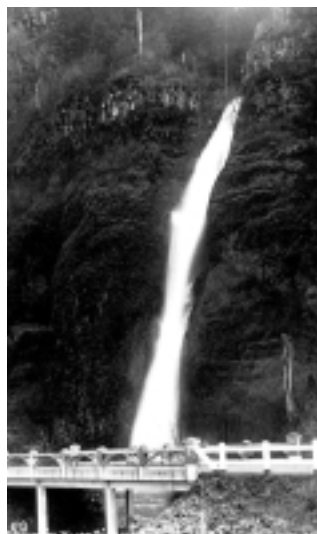
FIGURE 1 Historic Horsetail Falls Bridge, circa 1914.

The historic Horsetail Falls Bridge is located in the Columbia River Gorge, 30 miles east of Portland, Oregon (see Figure 1). Built in 1914 at a cost of \$1,817.70, this 60-foot by 24-foot reinforced concrete bridge consists of three 20-foot spans. This bridge and many others are an important part of the state's cultural heritage. They were built in the early 20th century as the advent of the automobile created a need for highway routes through Oregon's rugged mountains and coastal terrain.

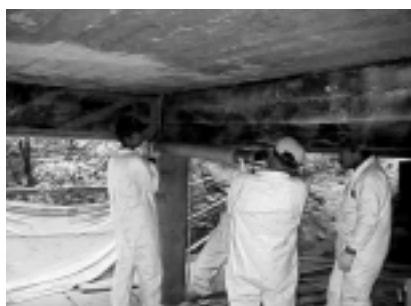
FIGURE 2 Installation of carbon-epoxy sheets on bridge beams.

All delaminated and unsound concrete was removed from the Horsetail Falls Bridge. Epoxy resin was injected into the cracks and used to fill any delaminated areas. The surfaces of all the beams were prepared by repeated filling, grinding, and needle gun scaling. Fiber-optic sensors were installed in precut slots in the concrete to measure shear and flexural strain. Carbon FRP sheets impregnated with resin were then adhered to the bottom and lower portion of the sides of all transverse beams on the structure for flexural strengthening (see Figure 2). Impregnated glass FRP sheets were placed around the transverse and longitudinal beams to enhance their shear capacity. Once the composite installation was complete, the second set of sensors was installed in the new materials. Since this bridge is a historic structure, a special cosmetic coat of paint was placed over

the FRP composite and sensors to match the appearance of the original concrete.
