APPENDIX F

REPORTS ON EIGHTEEN INVESTIGATED FIELD SITES

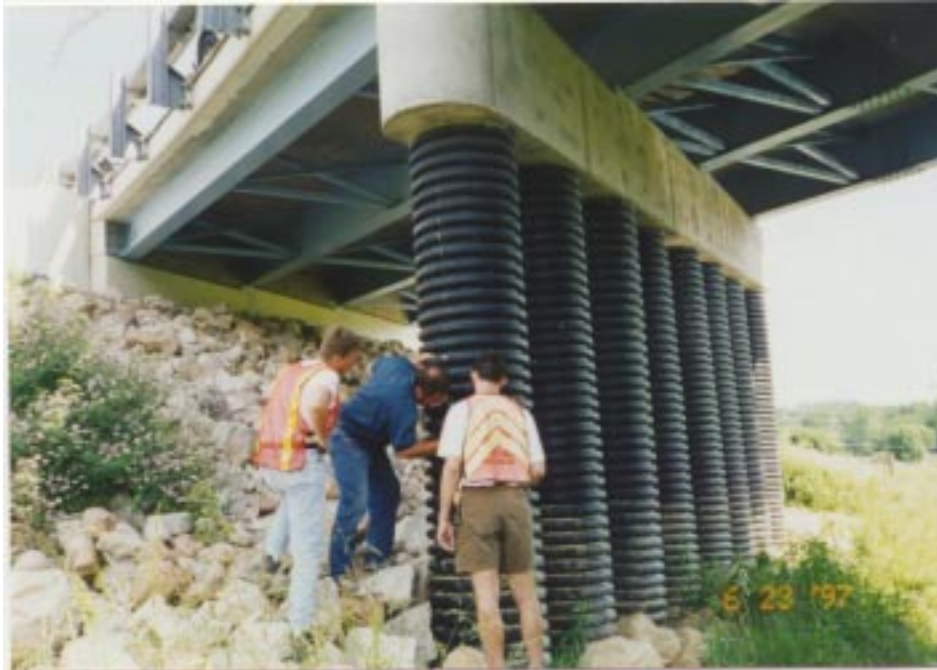
A Type C-annular HDPE pipe was being used as concrete column formwork under a highway bridge. During the inspection in June 1997, 2 years after the installation, a single longitudinal crack along the entire length of the pipe was observed. The microstructure examination of the fracture surface of the crack indicates that a slow crack growth was the cracking mechanism. Cracks might be initiated from the center of the pipe wall and grew toward the edges. The cracking was induced by a circumferential tensile stress likely the result of thermal expansion caused by the hydration of wet concrete.

Figure 1 – A view of the eight concrete columns with pipe as the formwork

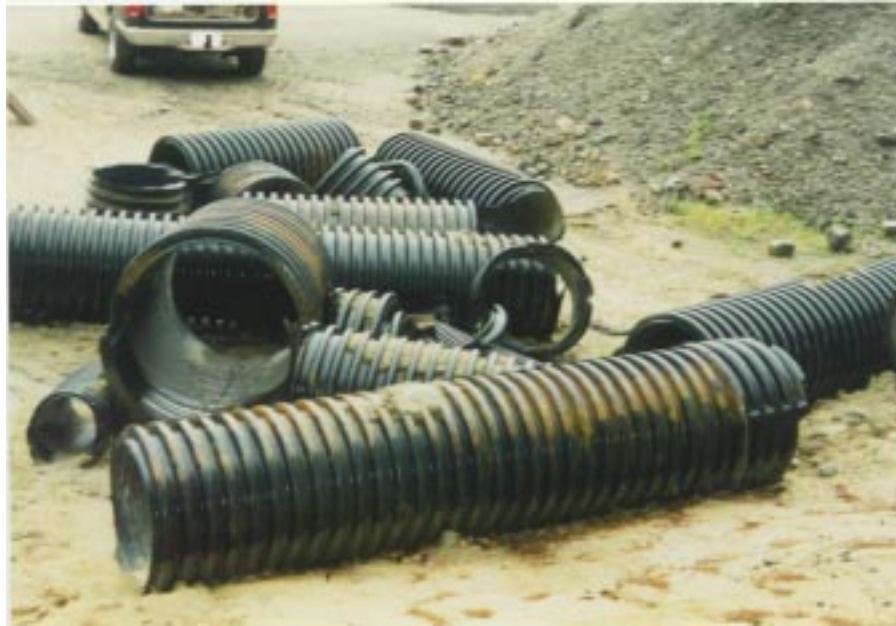
Four different diameter HDPE pipes with both Type S-annular and helical profile were being used as a culvert under 0.15 to 1.9 m of fill. Deflection, buckling, and cracking were observed in these pipes prior to their removal. The inspection, in June 1997, was made after removal.

The microstructure examination of the fracture surface of the crack indicates that slow crack growth was the cause of circumferential cracking. Cracks were initiated from outer surface of the liner and grew towards the inner surface. The failure mechanism of the longitudinal crack in Sample J2 is not well defined, but has more of the morphology of the slow crack growth mechanism than rapid crack propagation.

Figure 1 – The already removed pipes at Site J

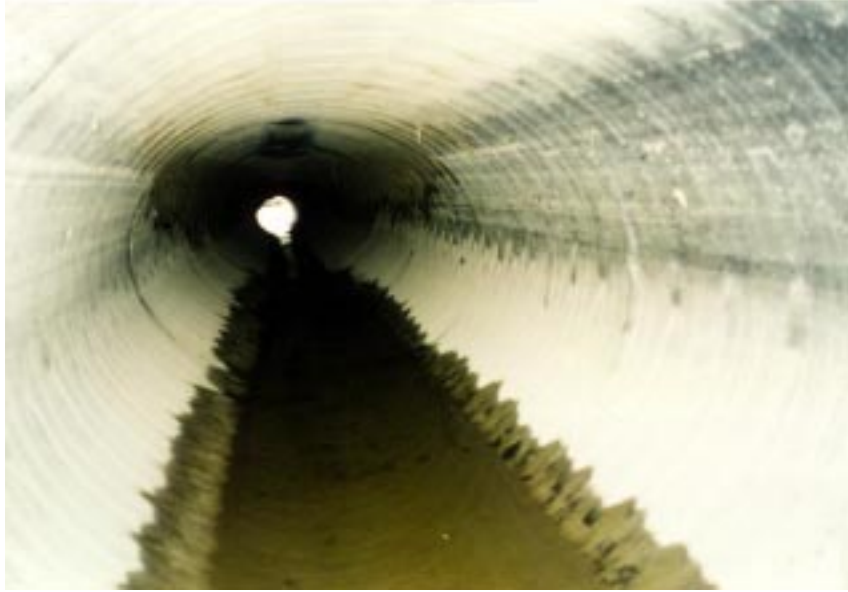
A Type S-helical HDPE pipe was being used as a storm drain under 3 m of fill. During the inspection in June 1997, 6 year after the installation, deflection, buckling, and cracking were observed in the pipe.

The microstructure examination of the fracture surface of the crack indicates that a slow crack growth was the cause of cracking. Cracks were initiated from the outer surface of the liner and grew towards the inner surface at the junction between liner and corrugation.

Figure 1 – a general view in the interior of the pipe at Site K

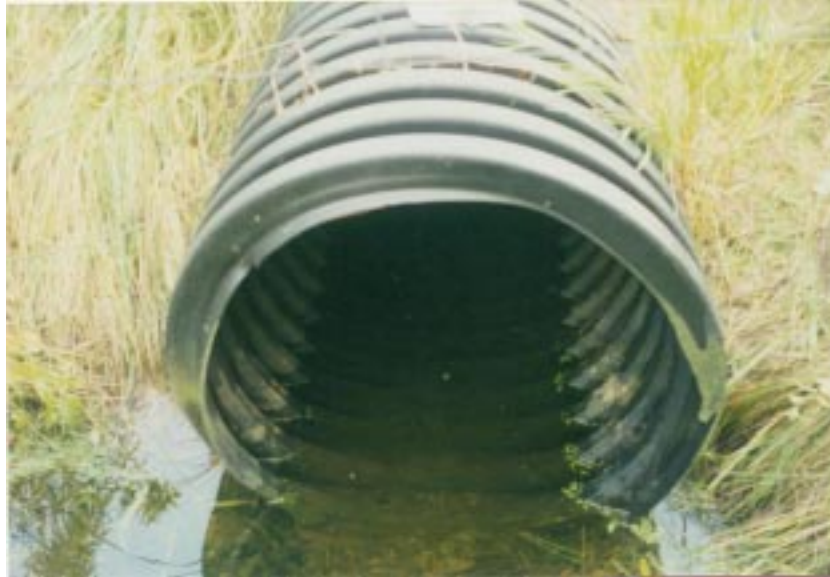
A Type C-helical HDPE pipe was being used as a cross drain. During the inspection in October 1997, 8 years after the installation, some deflection of the pipe was observed.

Figure 1 – A general view on the pipe at Site L

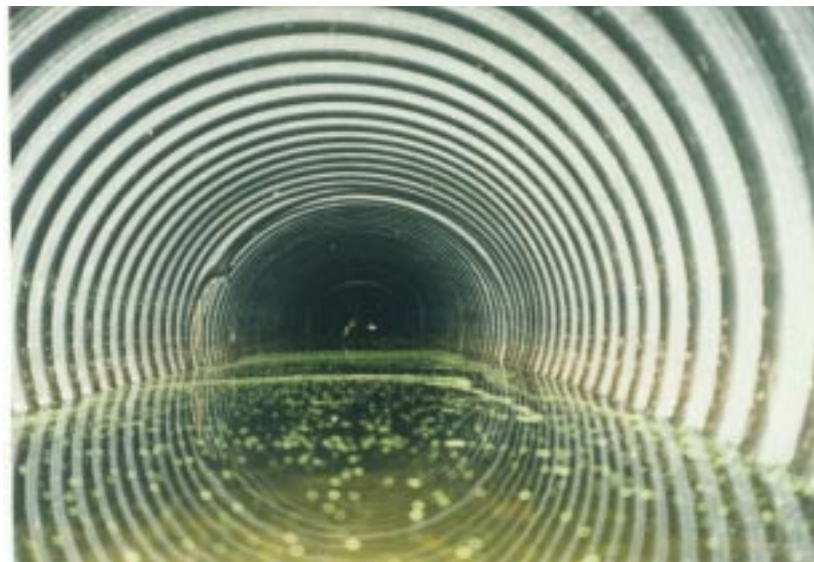
Figure 2 – An interior view of the pipe from outlet end

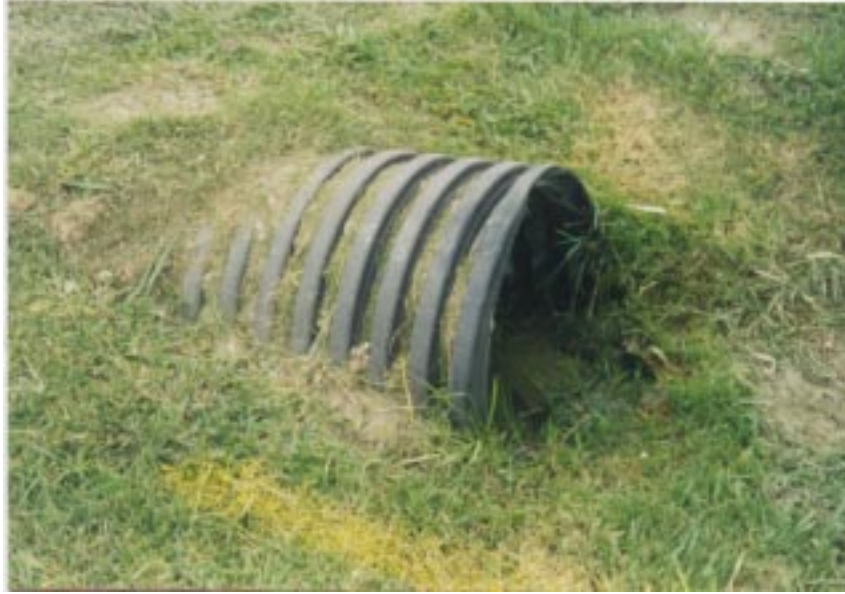
A Type C-helical HDPE pipe was being used as a cross drain. During the inspection in October 1997, 12 years after the installation, some deflection of the pipe was observed.

Figure 1 – A general view on the pipe at Site N

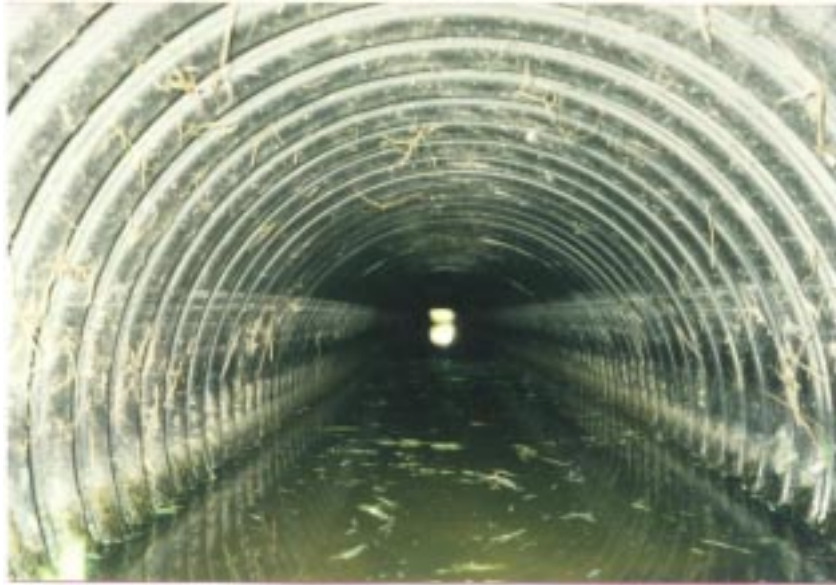
Figure 2 – An interior view of the pipe from the outlet end

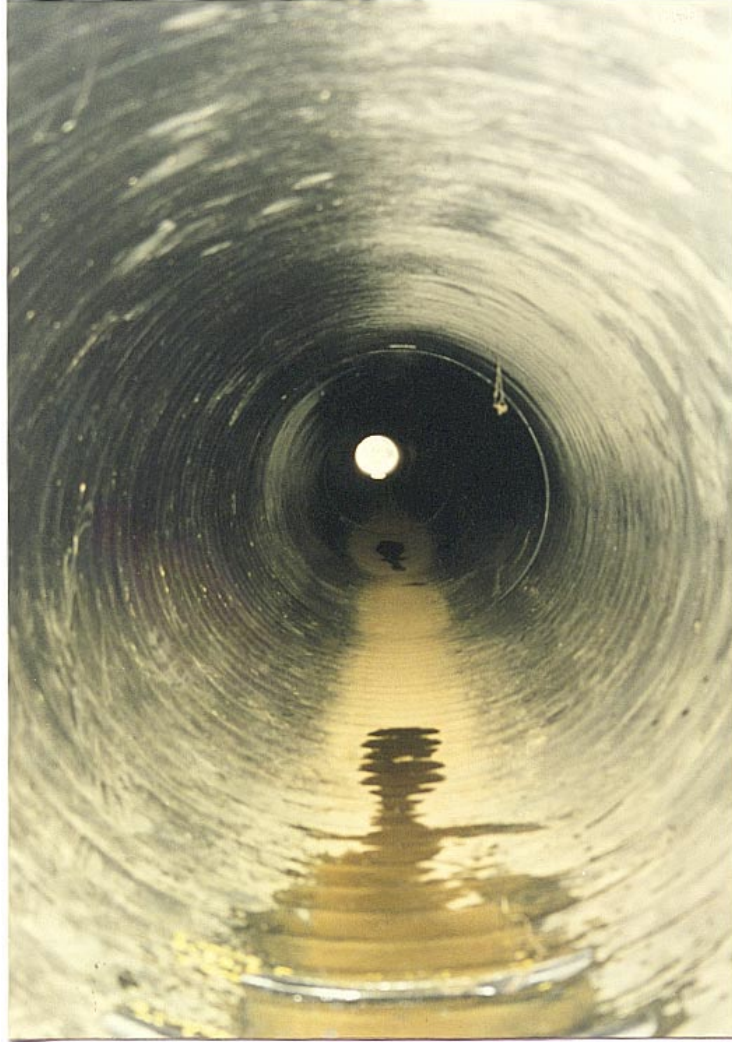
A Type S-annular HDPE pipe was being used as a storm-drain under 1.3 m of fill. During the inspection in December 1997, 3 year after the installation, small deflection and cracking were observed in the pipe.

The microstructure examination of the fracture surface of the crack indicates that a slow crack growth was the cause of cracking. Cracks were initiated from the outer surface of the liner and grew towards the inner surface.

Figure 1 – An interior view on the pipe at Site P

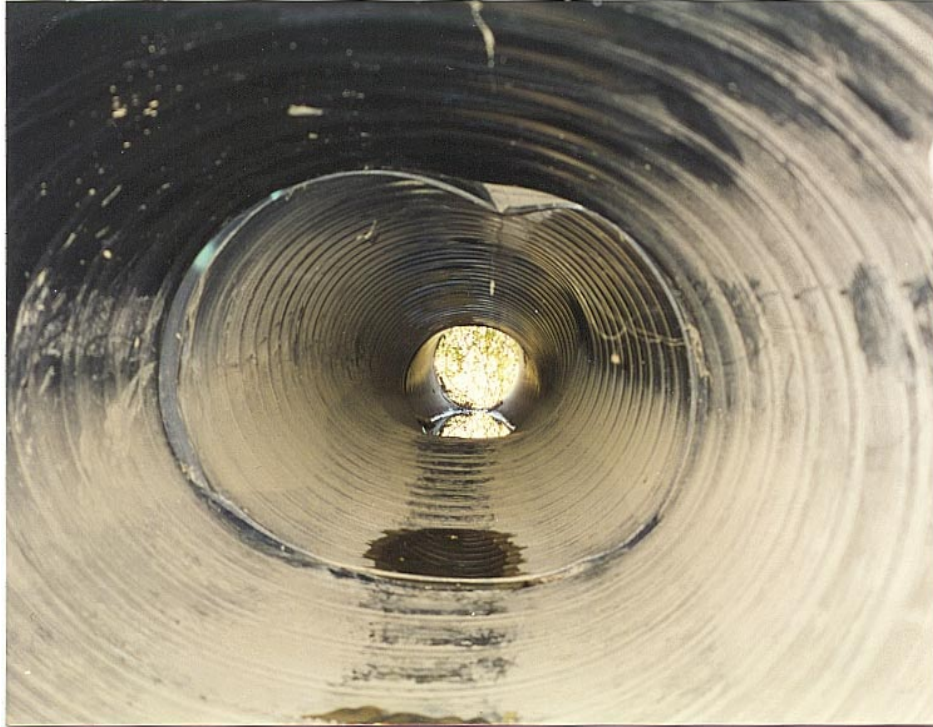
A Type S-helical HDPE pipe was being used as a storm drain under 0.5 m of fill. During the inspection in December 1997, 2 year after the installation, deflection and cracking were observed in the pipe.

The microstructure examination of the fracture surface of the crack indicates that a slow crack growth was the cause of cracking. Cracks were initiated from the outer surface of the liner and grew towards the inner surface.

Figure 1 – An interior view of the pipe at Site R

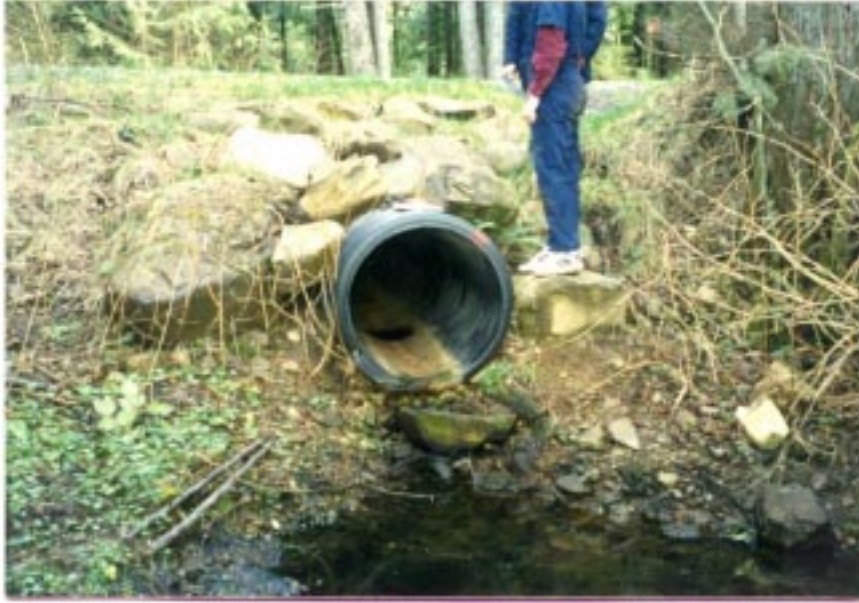
A Type S-helical HDPE pipe was being used as a storm-drain under 1 m of fill. During the inspection in February 1998, 3 year after the installation, only circumferential cracks were observed. There was no measurable deflection in the pipe.

The microstructure examination of the fracture surface of the crack indicates that a rapid crack propagation was the cause of cracking.

Figure 1 – A view on the outlet section of the pipe at Site V

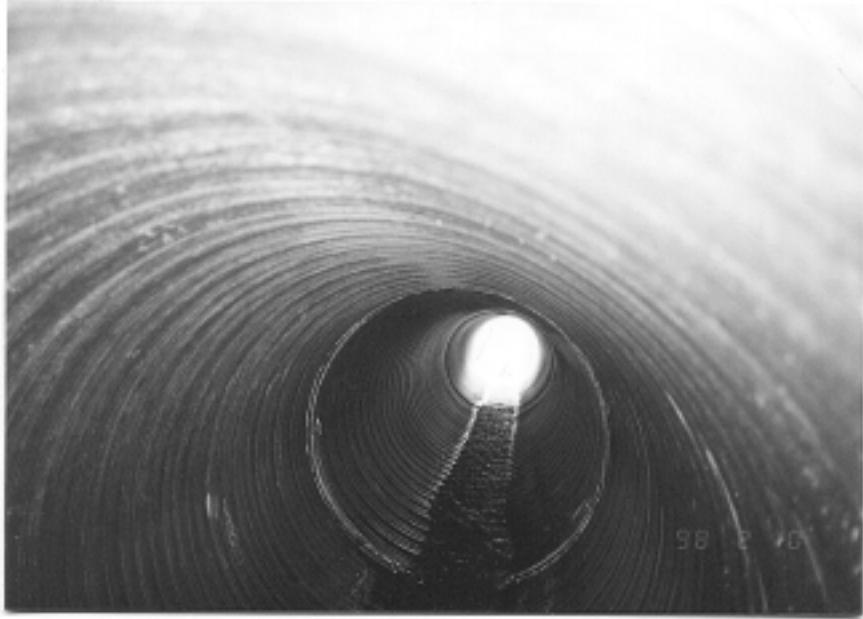
A Type S-honeycomb HDPE pipe was being used as a storm drain under 1.3 m of fill. During the inspection in February 1998, 1 year after the installation, small deflection, severe buckling, and cracking were observed.

The microstructure examination of the fracture surface of the crack indicates that a rapid crack propagation was the cause of cracking.

Figure 1 – An interior view of the pipe at Site W
