Salt Marsh Restored

When the F. J. Torras Causeway connecting St. Simons Island to the mainland near Brunswick, Georgia, required widening from a two-lane to a four-lane highway, it was realized that the construction would require some filling of the adjacent salt marsh. Part of the impact mitigation package for the project involved restoration of several unvegetated spoil sites paralleling the causeway to a smooth cordgrass (*Spartina*

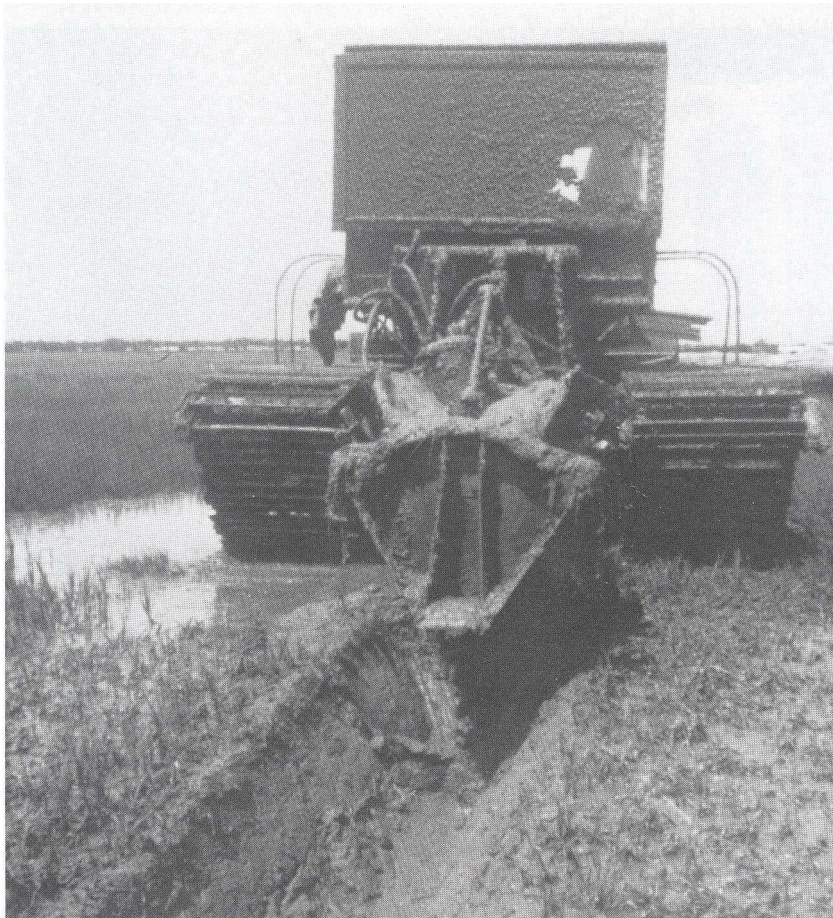
Amphibious rotary ditcher used in mosquito control can simultaneously traverse and ditch salt marshes.

The Mosquito Control Departments of both Glynn and Chatham Counties had employed an innovative method of ditching mosquito breeding areas by using an "amphibious" rotary ditcher. This device can simultaneously traverse and ditch areas of unstable substrates such as salt marshes. Over several years, both mosquito control departments noted not only a reduction in mosquitoes at recently ditched sites, but also enhanced growth of salt marsh vegetation.

The rotary ditching technique was tried in an experiment along the Torras Causeway to determine whether the damaged areas could be restored. An amphibious rotary ditcher owned by the Glynn County Mosquito Control Department was used to construct approximately 3,000 feet of channels at one of the spoil sites along the causeway. The discharge was dispersed evenly to either side of the ditcher onto the marsh, eliminating the need for an upland disposal site.

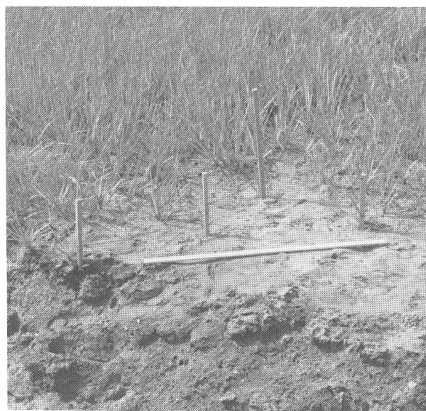
Rhizomatous growth indicator plot, April 1986.

An unchannelized comparison site was set up to determine the degree of restoration achieved. Study results show no permanent damage from the sidecast material and indicate that the discharge may have enhanced the smooth cordgrass on either side of the channel. Random sampling of harvested smooth cordgrass shows that it more than doubled between 1986 and 1988. Fiddler crab burrows also increased by a similar amount. The channelized site not only increased tidal frequency and duration, but also reduced standing water and improved soil drainage after tidal

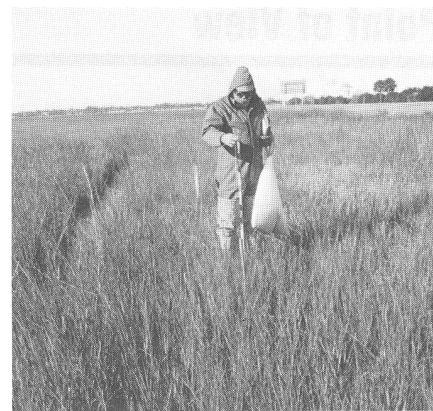
Rhizomatous growth indicator plot, December 1988.

cycles. Aerial photography revealed a 58 percent increase in the vegetated area on the channelized site after only two years.
